Countdown to Disaster:

The Obed Mine Spill

By Nick Pink, AWA Conservation Specialist

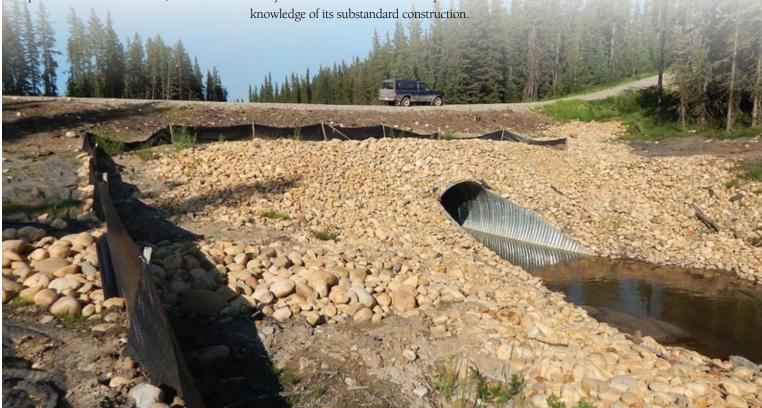
Rebuilt road and culvert along Apetowun creek. The wall of water and sludge that rushed down this creek blew out the original road. PHOTO: © P. BELANGER

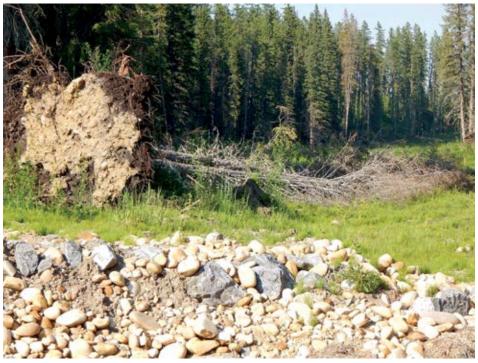
The initial release tore a deep 1.75 kilometre long gully from the Main Tailings Pond into Apetowun Creek. The streambed and banks of the uppermost portion of the Apetowun Creek were eroded and degraded seriously by the wave of wastewater from this failure. Nearly all the riparian vegetation was washed away and large quantities of sediment were deposited in their place. The price tag to rehabilitate this portion of Apetowun Creek alone is estimated to still require more than \$6 million.

The force of the wastewater was powerful enough to uproot large trees. PHOTO: © P. BELANGER

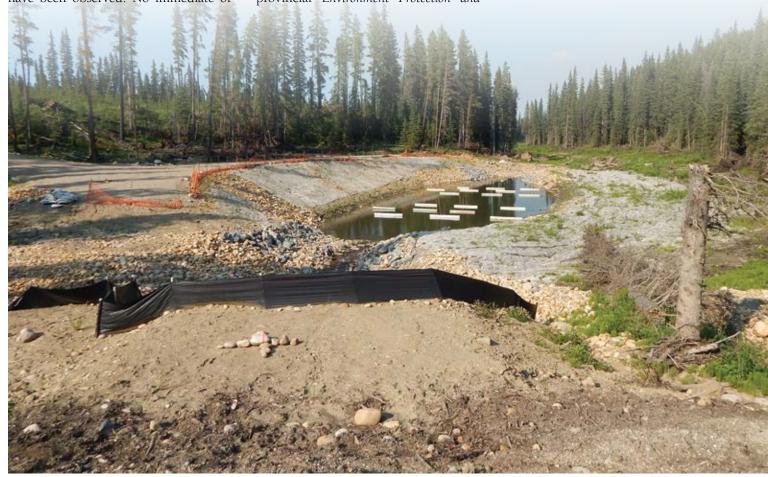
Part of the reclamation efforts along Apetown creek. PHOTO: $\@$ P. BELANGER
