Alberta Wilderness Association

BIGHORN BACKCOUNTRY REPORT

OHV use in the Bighorn

Results of the 15 years of research and monitoring of trails in the Bighorn.

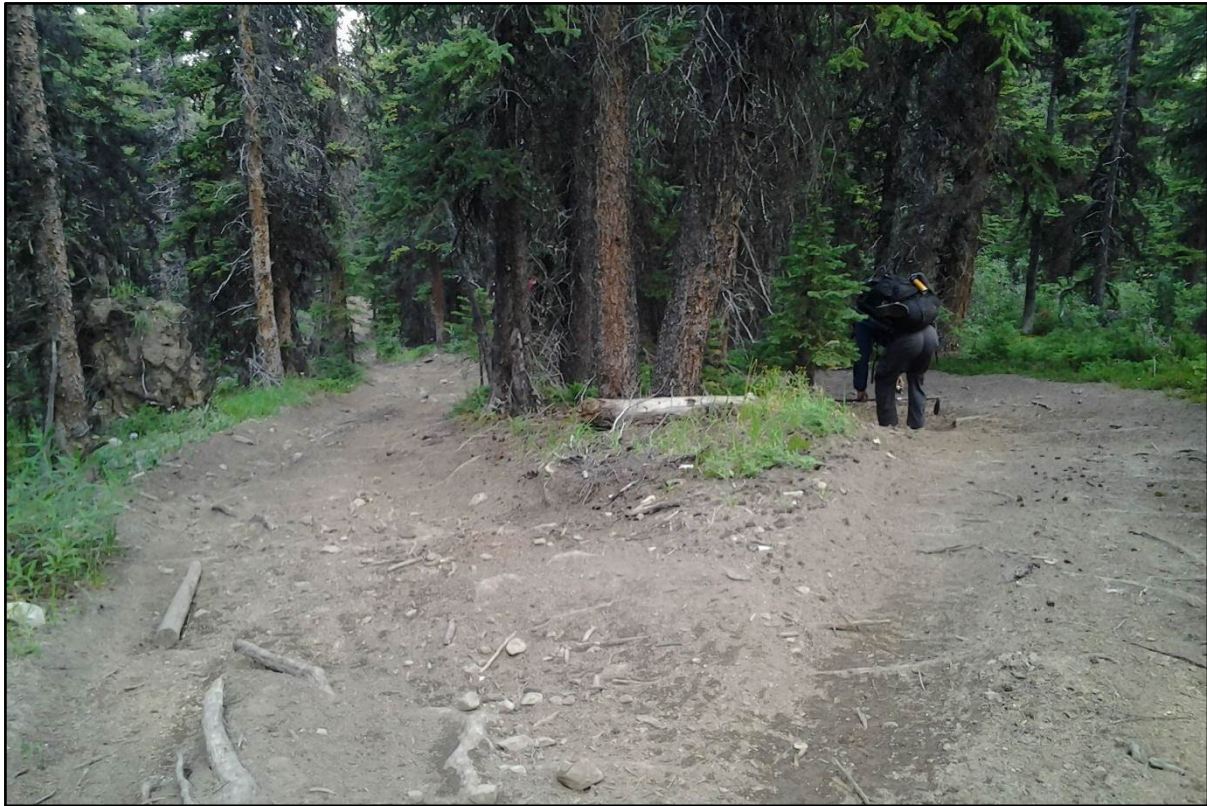
Figure 6 Braiding

Where relevant, damage sites were further assigned attributes of braiding, education, stewardship, frolic area or vandalism. *Braiding* indicates a site in which a trail had branched off and ran parallel to the original trail, only to return back to the trail (**Figure 6**). In cases where braids overlapped, the number of braids was determined by counting the number of “diamonds” formed by overlapping braids. The overall dimensions were then recorded by measuring the width of the braids at their widest point, and pace-counting the length of the main trail to the point where all braids collapsed back to the original trail. *Education sites* indicate an attempt to inform users about the area, such as signage and flagging. *Stewardship sites* are areas in which attempts to improve the trail were made through the placement of culverts, landscape fabrics, diversion ditches, water bars, and other forms of trail maintenance (**Figure 7**, right). *Frolic sites* are areas in which OHV tracks are noted to have intentionally gone off trail (e.g., run up and down slopes, run through muddy areas, etc.). *Vandalism* indicates suspected deliberate destruction or damage to the trail or surrounding environment.

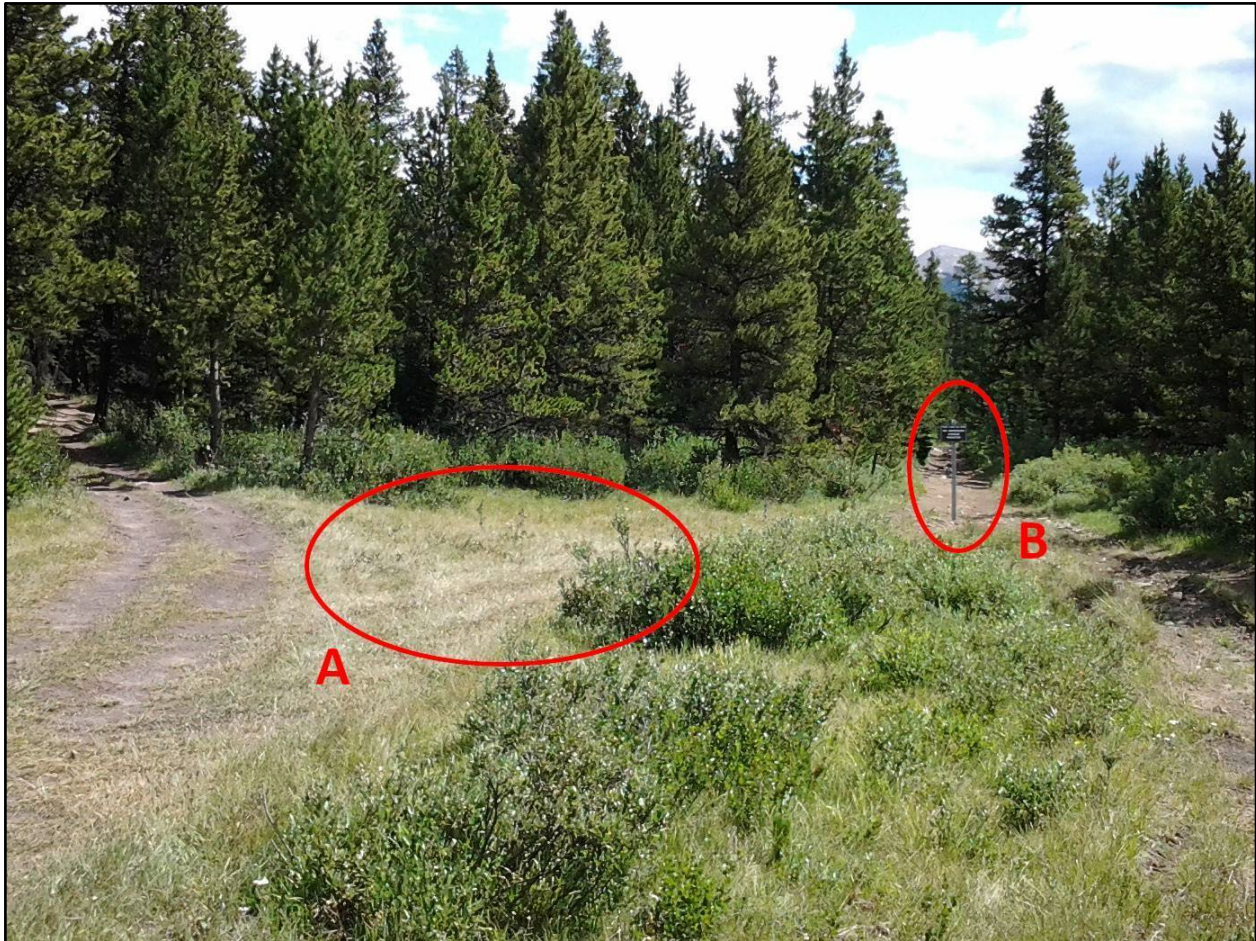
Figure 8

We noted trail re-routing on HUM in 2014, the first year this trail was re-surveyed. The re-routed section showed a lot of instability, with loss of the trail likely in a high-water event. In 2015, AWA monitored the entire length of HUM and BTN, which had not been surveyed since 2008. In a few locations, the old HUM trail had slumped, and a new trail was built adjacent to it, and on one section Hummingbird Creek ran along the length of the trail. We also observed an absence of signage to identify the correct route in areas where HUM was re-routed. In many cases the trail was only marked with pieces of flagging. Where signage was present, fresh tire tracks during trail closures indicated illegal trail use (**Figure 8**).

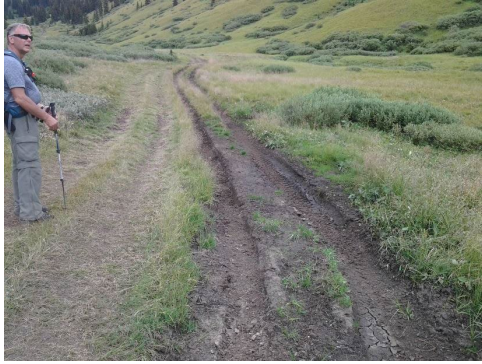
BTS braiding
Taken 2013-08-23
Severity: 3
L: 30m, braids: 1

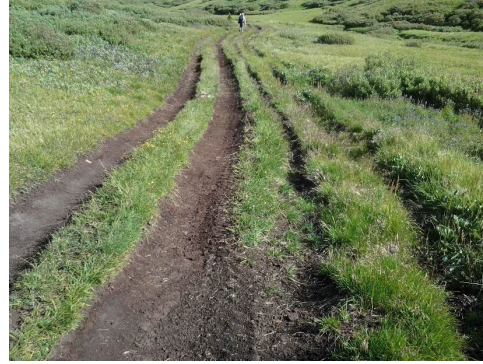
BTS braiding
Taken 2016-07-07
Severity: 2
L: 30m, braids: 1

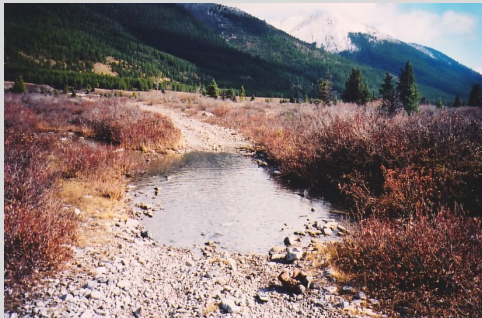
HUM water crossing
Taken 2004-09-29
Severity: 1

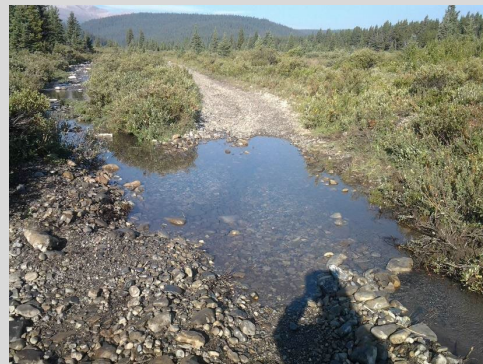
HUM water crossing
Taken 2017-08-15
Severity: 1
L: 5m, W: 5m, D: 37cm

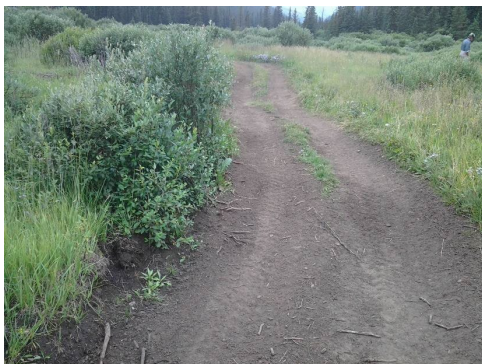
CAN damage site
Taken 2014-08-12
Severity: 2
L: 40m, W: 3m, D: 40cm

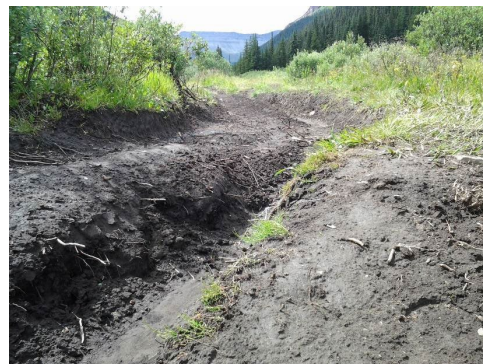
CAN damage site
Taken 2017-07-24
Severity: 5
L: 72m, W: 3m, D: 55cm

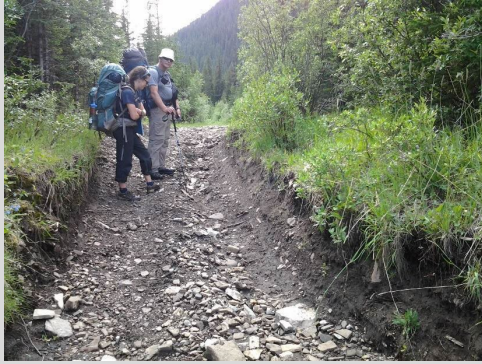
CAN damage site
Taken 2012-07-18
Severity: 4
L: 30m, W: 3m, D:130cm

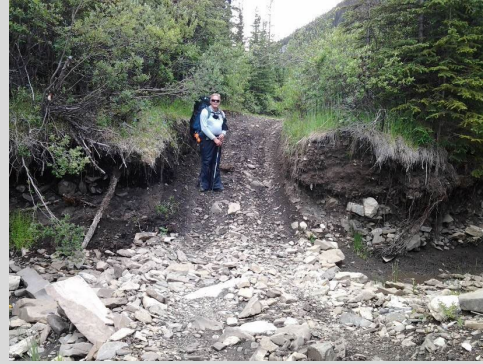
CAN damage site
Taken 2016-07-06
Severity: 4
L: 15m, W: 3m, D: 120cm

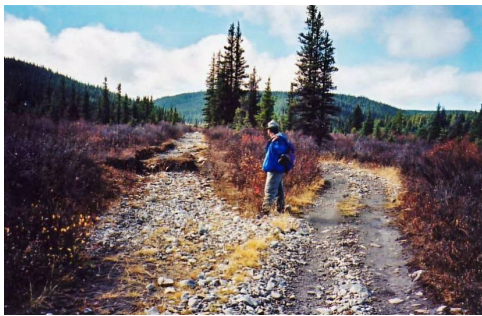
HUM damage site
Taken 2004-09-29
Severity: 5

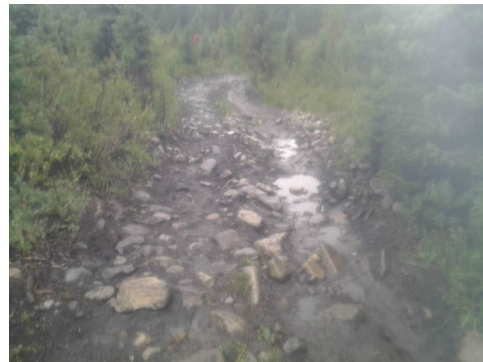
HUM damage site
Taken 2016-08-03
Severity: 3
L: 50m, D: 25cm

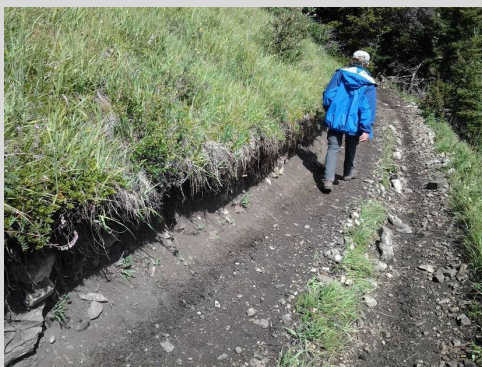
BTN damage site
Taken 2015-07-16
Severity: 3
L: 80m, W: 1m, D: 100cm

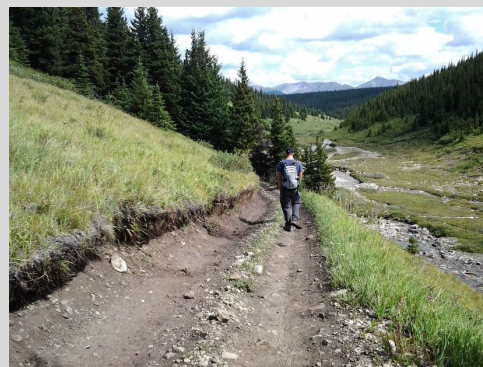
BTN damage site
Taken 2016-08-04
Severity: 3
L: 76m, W: 1m, D: 60cm

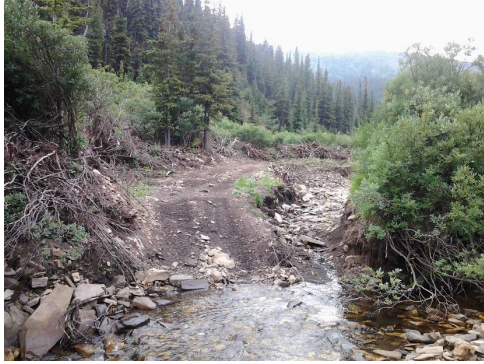
CAN water crossing
Taken 2014-08-13
Severity: 5
L: 40m, W: 12m, D: 120cm

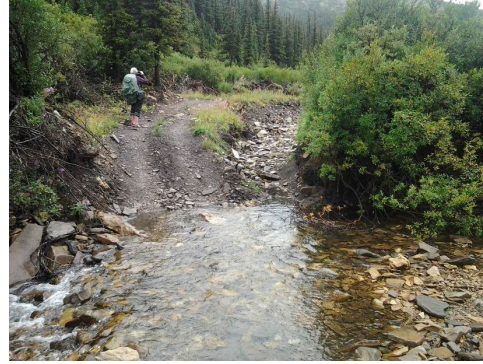
CAN water crossing
Taken 2015-08-15
Severity: 5
L: 54m, W: 12m, D: 100cm

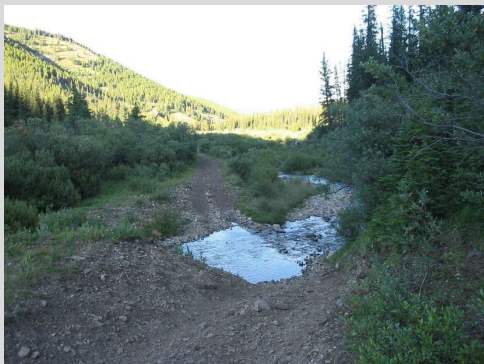
CAN water crossing
Taken 2005-08-03
Severity: 5

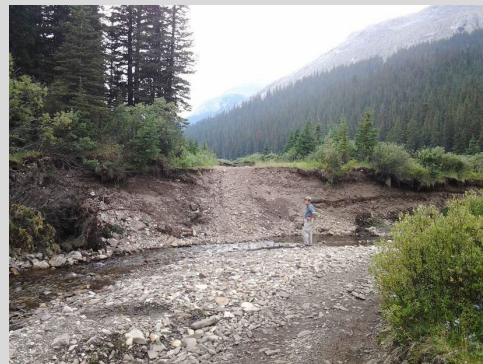
CAN water crossing
Taken 2014-08-12
Severity: 5
L: 15m, W: 3m, D: 250cm

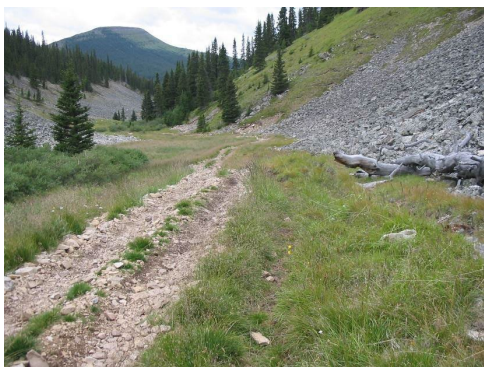
BTR damage site
Taken 2005-08-11
Severity: 1
L: 76m, W: 5m, D: 24cm

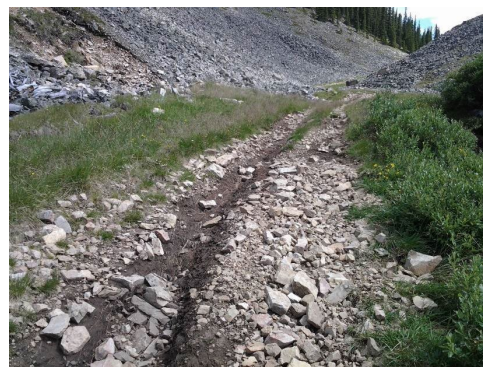
BTR damage site
Taken 2012-07-19
Severity: 2

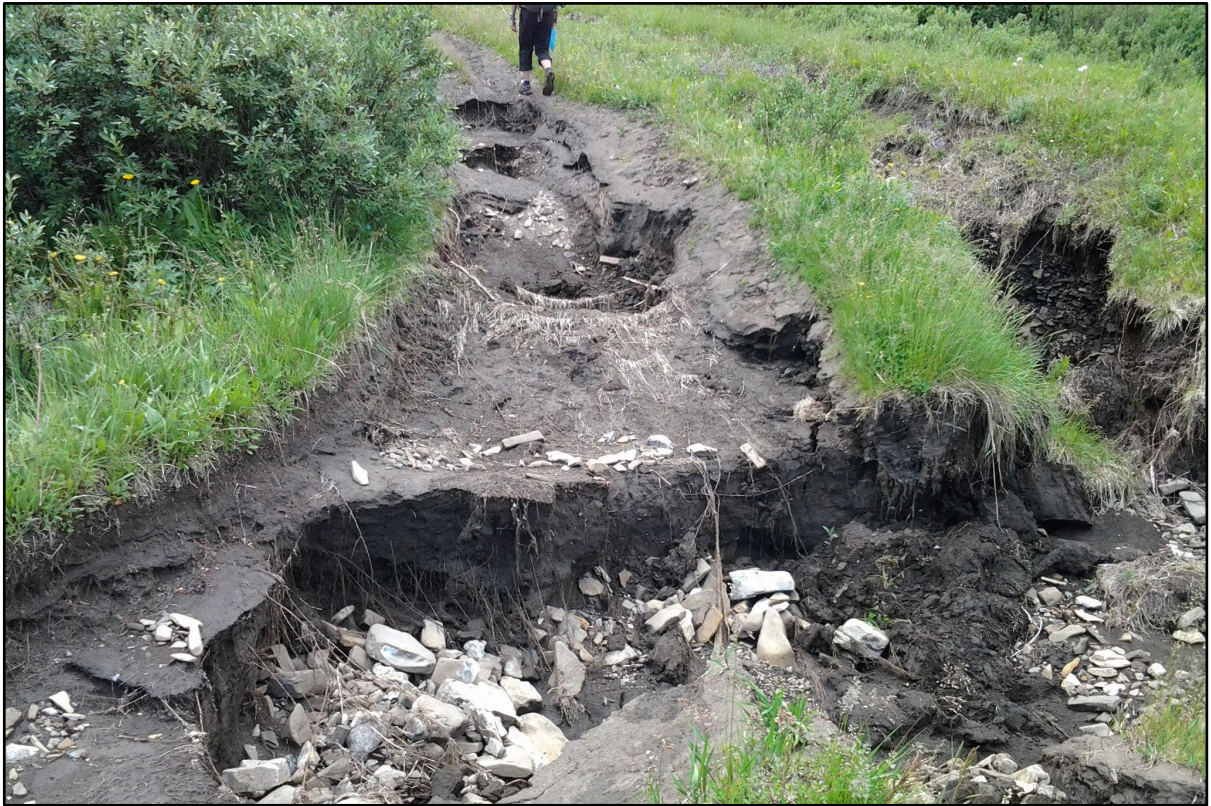
Figure 11

The primary objective of the BWRMP is to provide complementary data and analysis to government agencies responsible for access management decisions in the Bighorn. This is accomplished through assessing recreational impacts from OHV use in the Bighorn by examining trail damage conditions and assessing damage severity over the thirteen-year monitoring period 2003-2017. AWA's monitoring work found that OHV use had severely negative effects on the Hummingbird trail system, as evidenced by observations taken across the trail network. Damage was common, and in many cases extreme (severity 5) or severe (severity 4 & 5 combined), particularly after heavy rainfall and with continued use of trails over time.

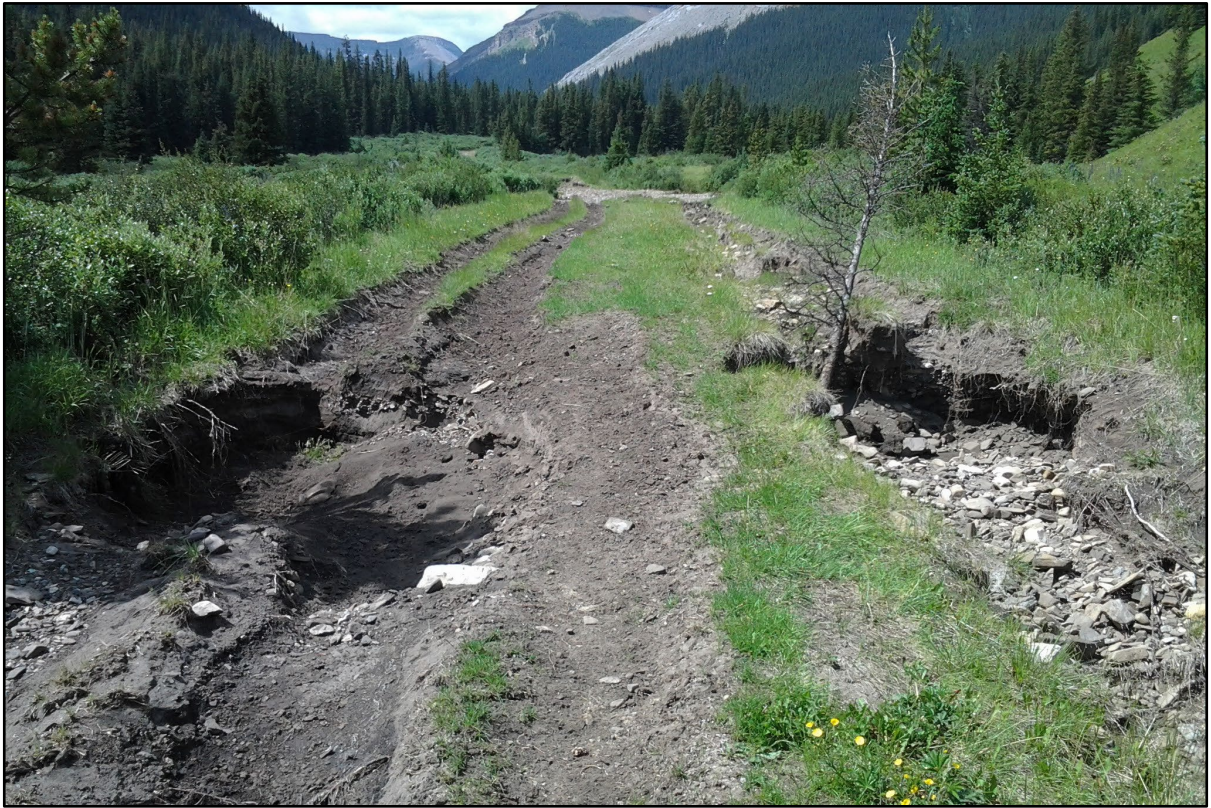
Figure 12

The damage observed across the trail network is significant. Most of the observed damage was visibly attributable to OHV use. Deep, wide rutting at damage sites, braiding, and damage observed at water crossings would likely not occur from equestrian use or foot traffic. It is also important to note that stewardship attempts in many cases contributed to the damage on trails.

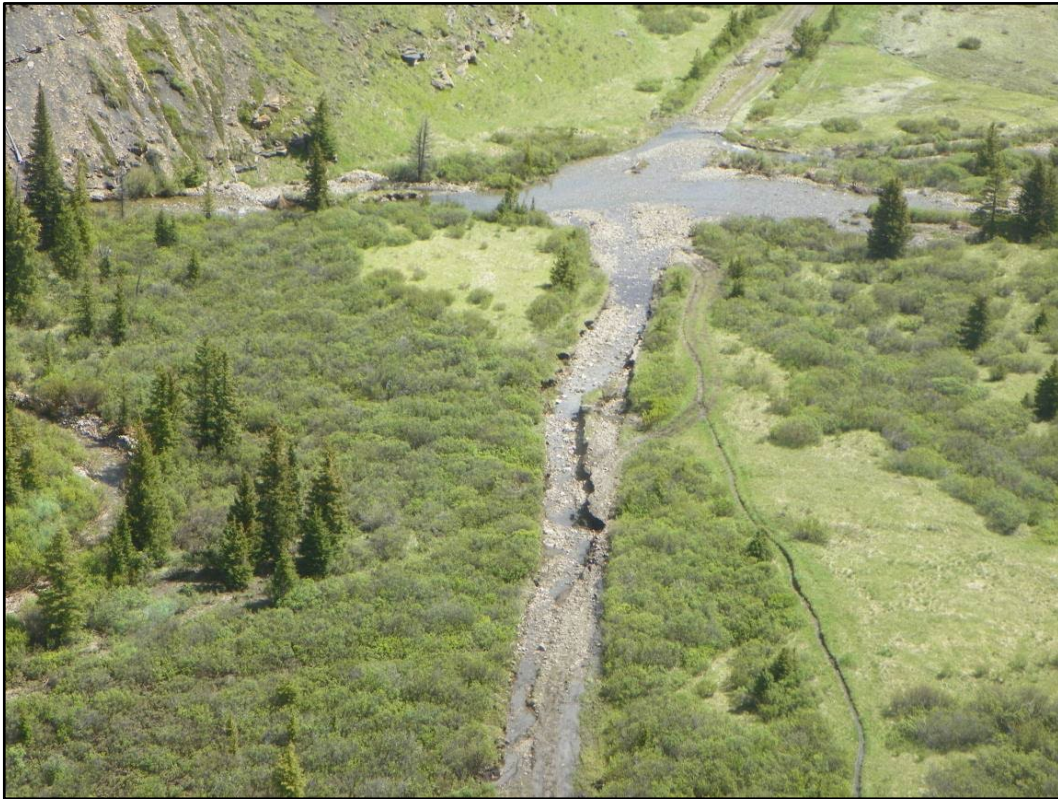
Figure 13

Although BTR had the highest density of damage observations, the greatest density of extreme and severe damage occurred on CAN. The damage on CAN was corroborated by visual evidence of deep rutting, soil erosion and degradation, and a high number of water crossings along the trail (**Figures 11 and 12**). OHV trails can alter watershed processes; ruts intercept the water table and re-route groundwater flow to the surface, particularly in wetlands and at stream crossings (Arp and Simmons 2012). Much of the damage observed on CAN, particularly in 2012 and 2013, could be attributed to this phenomena, as OHV ruts provide a path of least resistance for water flow. When coupled with heavy spring rains and flooding, as was the case in these years, OHV activity may have channeled surface and groundwater water flow, accelerated erosion processes, and contributed to the dramatic, sinkhole-like damage.

Severe damage was also noted on CAN in 2014, which was likely a result of the extreme erosion events from the previous years coupled with damage from re-routed trails, which were often placed immediately adjacent to the original eroded trail (**Figure 12**). Recreational trails located within the floodplain or close to groundwater sources, on steep slopes, or on wet soils are most susceptible to erosion. Trails located on a side-hill that follow the contour and cut into a slope are generally more sustainable because of better drainage (Marion and Olive 2006). At the time, AWA predicted additional slumping and erosion of the re-routed trail segments on CAN, noting they were still located within the floodplain. In addition, stream bank erosion and channel widening were observed at water crossings.

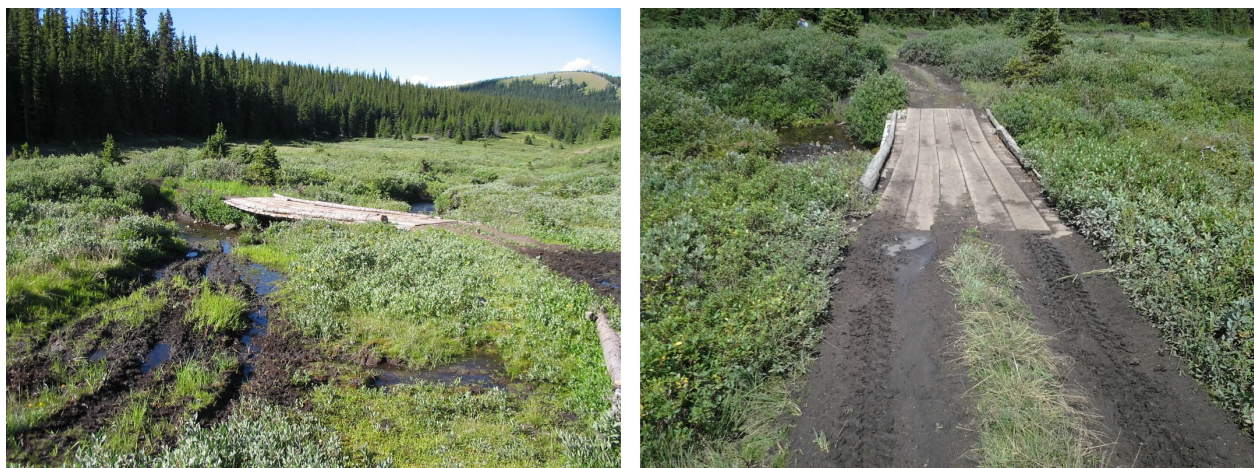
Figure 14

Bridges can help minimize direct impacts to the surrounding bank and riparian vegetation, as one bridge located on BTN demonstrates (**Figure 14**). Recovery of riparian vegetation is important since this recovery increases streambank stability and reduces sediment delivery to streams (Simon and Collison 2002, McKergow et al. 2003). However, all stream crossings can and do deliver sediment regardless of structure; furthermore, bridges can also cause other impacts such as channel constriction and alteration (Kidd et al. 2014, Erdle and Mayhood 2014).

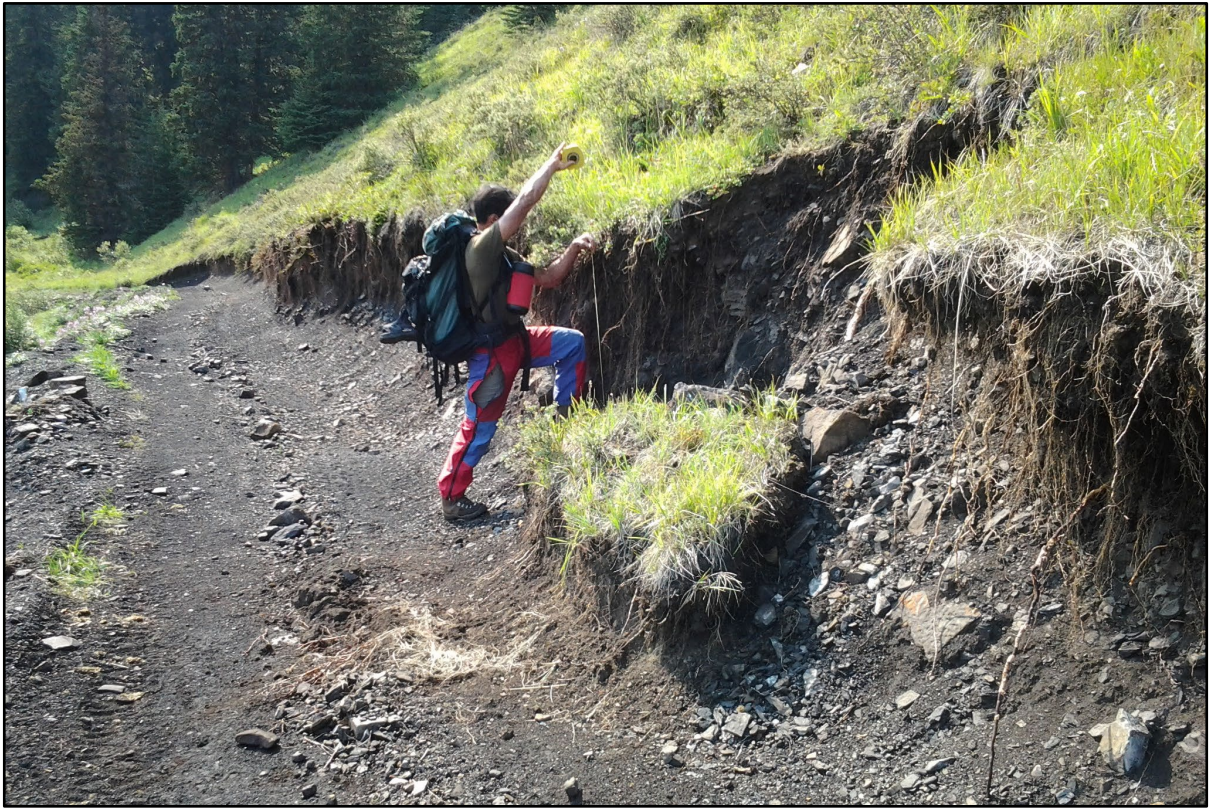
Figure 15

It is thus concerning to note that spikes in trail erosion depth noted along the western half of CAN and the eastern half of HUM both corresponded to re-routed trail sections. This type of reconstruction, much of which was undertaken under the auspices of the Backcountry Trail Flood Rehabilitation Program (2014-2019) has in many cases seen trails re-sited—sometimes at significant cost—to a new location that is nevertheless within the same landscape that caused the damage in the first place. Consequently, the new trails often show the same type of damage within a few years and thus contributed to a doubling of the original damage footprint (**Figure 15**).
