# DIRECT ACTION: AWA's 2012 Bighorn Monitoring Report

BY SEAN NICHOLS, AWA Conservation Specialist

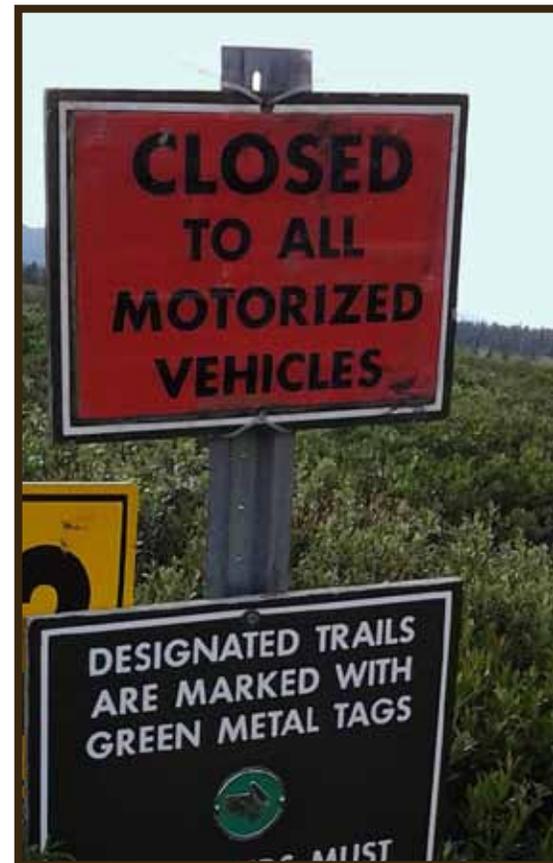
Trail closure signs posted at the Hummingbird Creek trailhead.

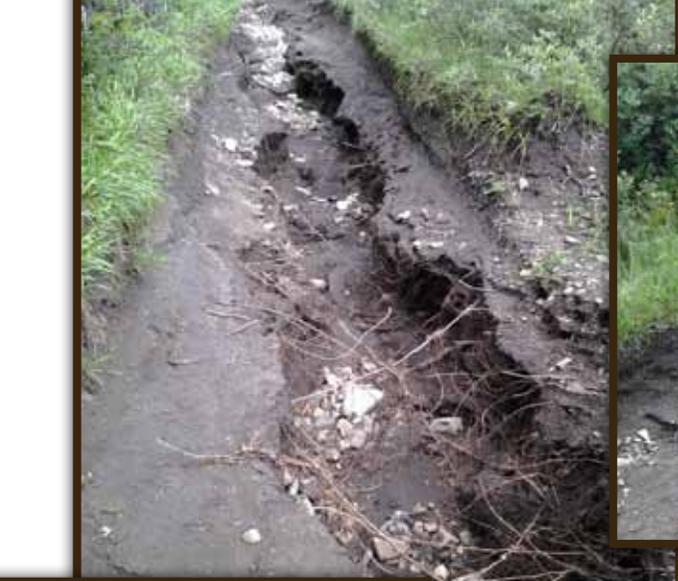
- 1** Many of the damage sites that have not yet completely caved in are on the verge of doing so. In 2005-2006, 144 damage sites were originally recorded on the stretches of trail monitored on this trip. This year, an additional 146 damage sites were added to that tally, showing an increased rate of trail degradation over the last half-decade.

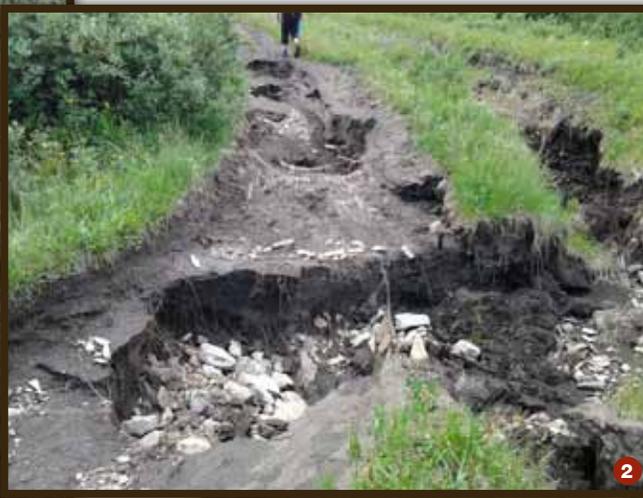
- 2** Large sections of the trail have become so eroded they are now impassable to all but foot traffic. Even the equestrian users we encountered were forced to turn back by these inhospitable sections.

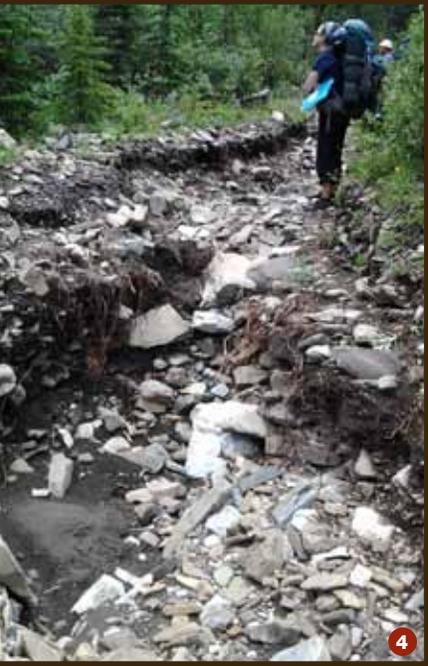
- 3** Attempts at “stewardship” such as dropping this tree in a hole to warn future users do nothing to mitigate the damage caused.
- 4** The erosion at this damage site has created a trench up to 175cm deep.

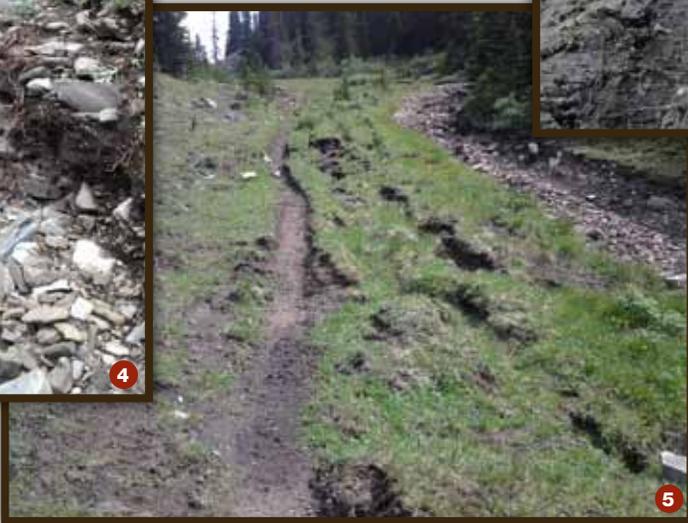
- 5** Trail users often react to damaged sections of trail (such as that on the right) by creating braids and secondary trails to bypass the obstructions, causing further damage to the vegetation.

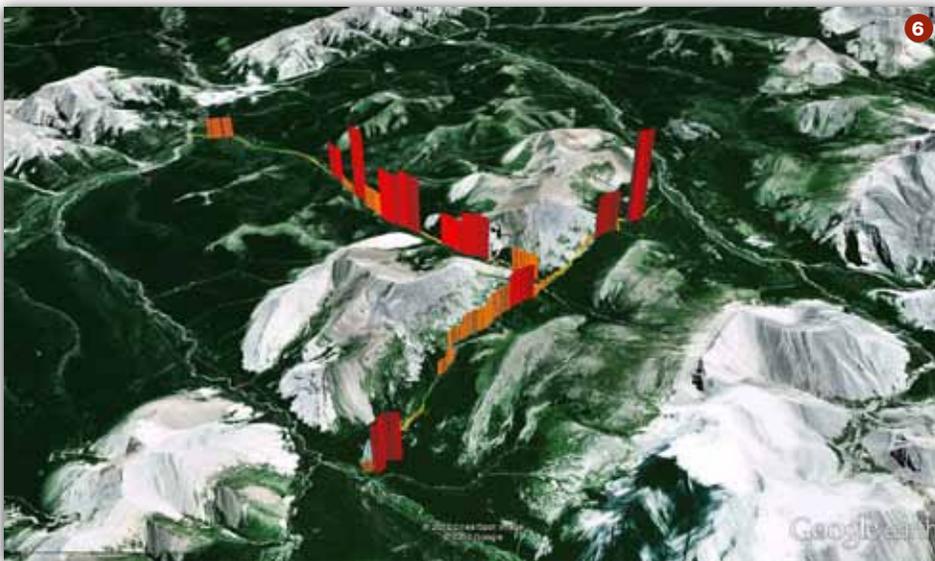
- 6** Erosion Event distribution on OHV trails. Height and colour of 500m trail sections indicates the total length of eroded trail within each section: no eroded trail = green, 1m-10m eroded = yellow, 11m-25m eroded = orange, 26m-100m eroded = dark orange, greater than 100m eroded = red. (Background map courtesy Google Earth)
