**THE BIGHORN WILDLAND
RECREATIONAL TRAIL MONITORING PROJECT**

AN INTERIM RESEARCH SUMMARY FROM 2004 – 2006

Alberta Wilderness Association

March 23, 2007

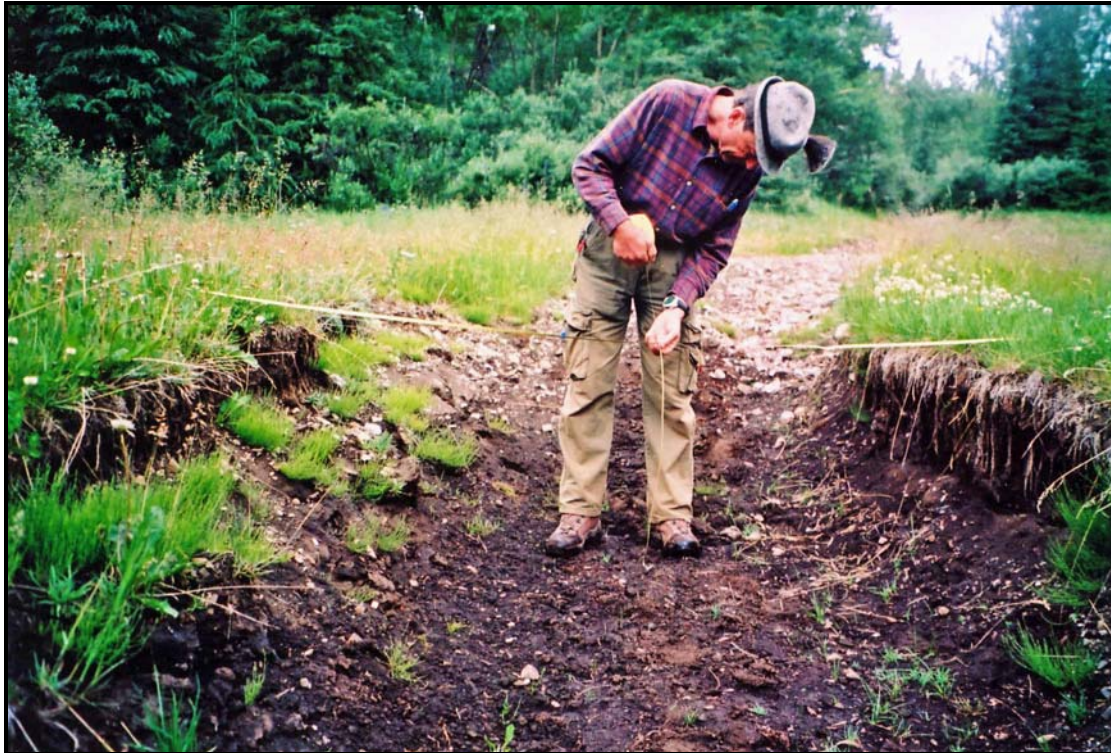
Figure 3. Measuring the depth of an Erosion Event along RNG.

Once a damage site was identified, we 1) geo-referenced the site with a handheld GPS unit (10 m \pm accuracy; Garmin or Magellan), 2) photographed the area, 3) measured the depth of the rut at the deepest point with a tape measure, 4) measured the width of the site at its widest point with a tape measure, and 5) pace-counted the length of the damaged site. When measuring the depth of ruts, we noted when a site was deeper than 25 cm for a distance of 3 m, which qualifies the site as an Erosion Event (EE) (Figure 3). The EE designation is based on LFD standards for trail integrity and, under current objectives, the number of EEs per kilometre of trail is expected to stay the same or decrease over time (SRD 2003). We also classified each damage site and EE by the type of tracks present: motorized, equestrian, or mixed. Motorized vehicle tracks are characterized by two parallel ruts formed by the wheels, approximately 1.0 to 1.6 m wide, with tire tread marks showing in moist soil conditions. Equestrian tracks are characterized by a single track, roughly 45 cm wide, with crescent-shaped marks from horseshoes present in moist soil conditions. Mixed tracks are characterized by the presence of both motorized and equestrian tracks. We also looked for evidence of hikers, mountain bikers, and horse-drawn wagon tracks at all sites. Interpretation of user group association at a site by the presence of tracks is most indicative of recent use rather than total use of that trail. We are most likely underestimating the amount of equestrian use on mixed-used trails since OHV tracks can easily mask horse tracks. This underestimation is perhaps increased because horses may avoid hard-surfaced trails (and wet crossings) and take an alternate route.

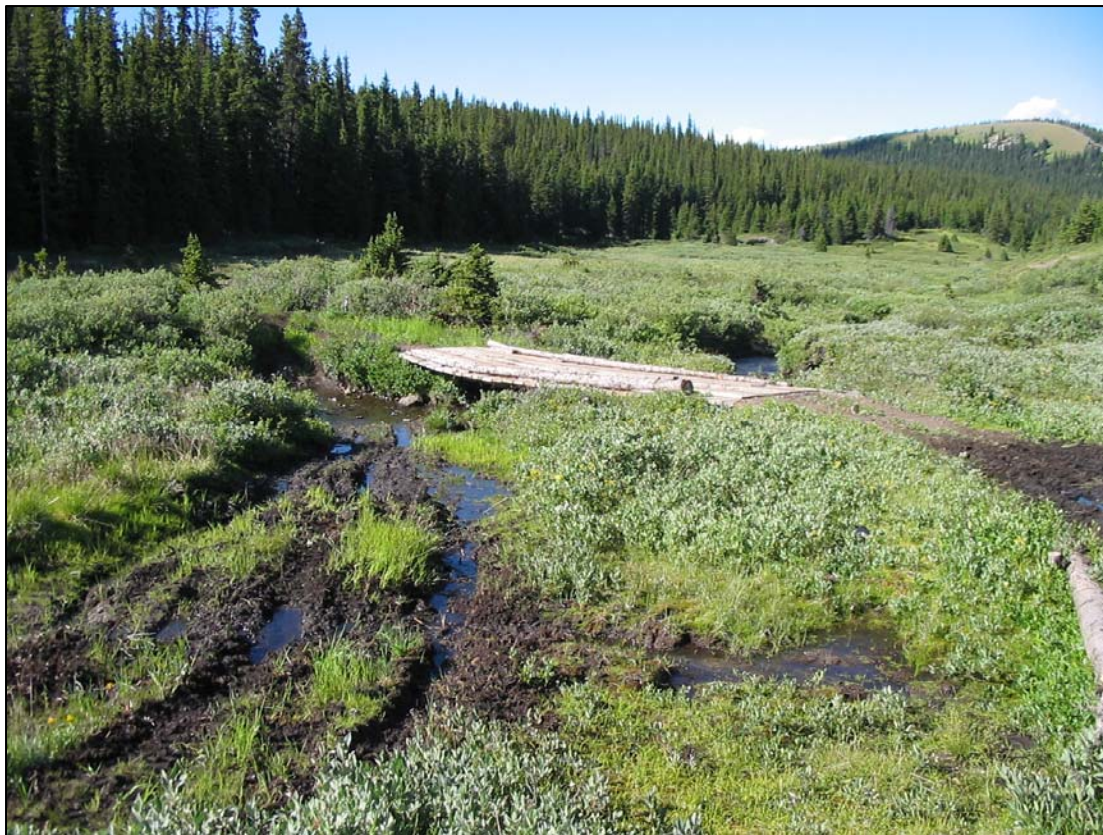
We documented 89 water crossings throughout the network with the highest water crossing densities along CAN, HUM, and BTS (Table 4). Of these 89 water crossings, 7% had formal crossing structures present while 72% had permanent water moving through them. Of the six crossing structures we found, two were on ONI and two were on BTN. In many cases vehicle tracks were found adjacent to crossing structures indicating that some riders are avoiding their use (Figure 7).

Figure 7. A water crossing on BTN. The bridge was placed on the main trail, but users continue to drive OHVs through the creek on the left side of the photo.

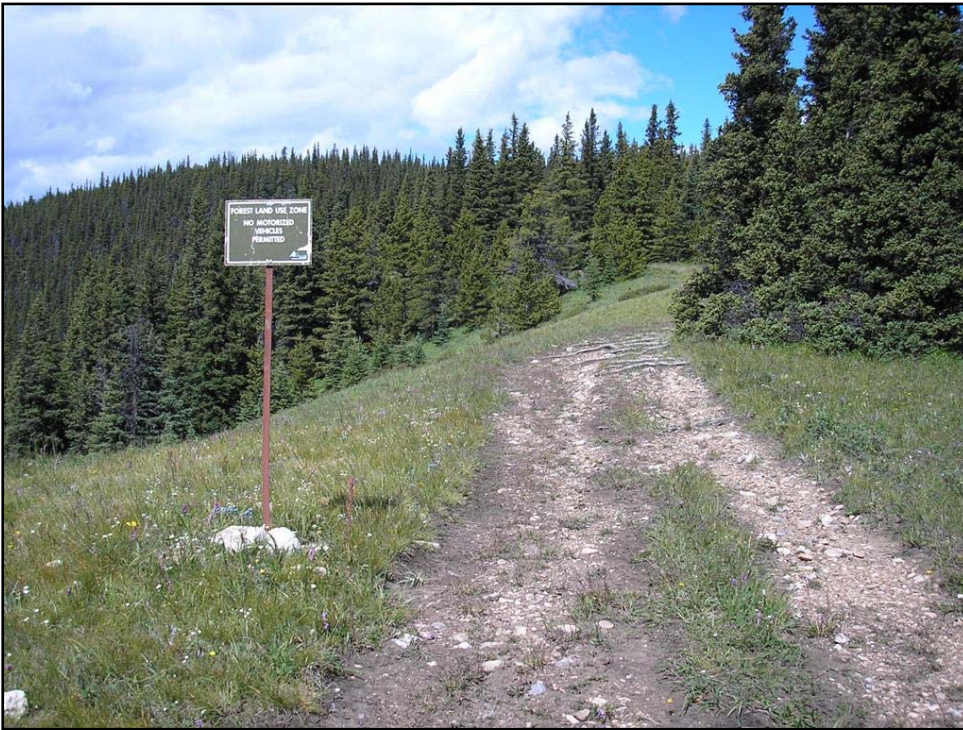
Figure 8. SRD has placed a sign beside the trail stating that no motorized vehicles are permitted. Illegal activity persists but is declining at this site. The sign states: “Forest Land Use Zone. No motorized vehicles permitted.”

2.2) Ensure that all secondary trails are physically blocked and signed at the junction, with language indicating that motorized users proceeding off of the main trail are in violation of FLUZ regulations. We sampled traffic along a small portion of the non-designated trails in the area, and while we found somewhat decreased use on certain trails, others showed a lot of illegal traffic. Well-placed signs appear to reduce the use of non-designated trails. However, signs have often been vandalized (e.g., removed or shot through), which reinforces the need for more enforcement. Such behaviour is an indication of the animosity some users have toward backcountry regulation.

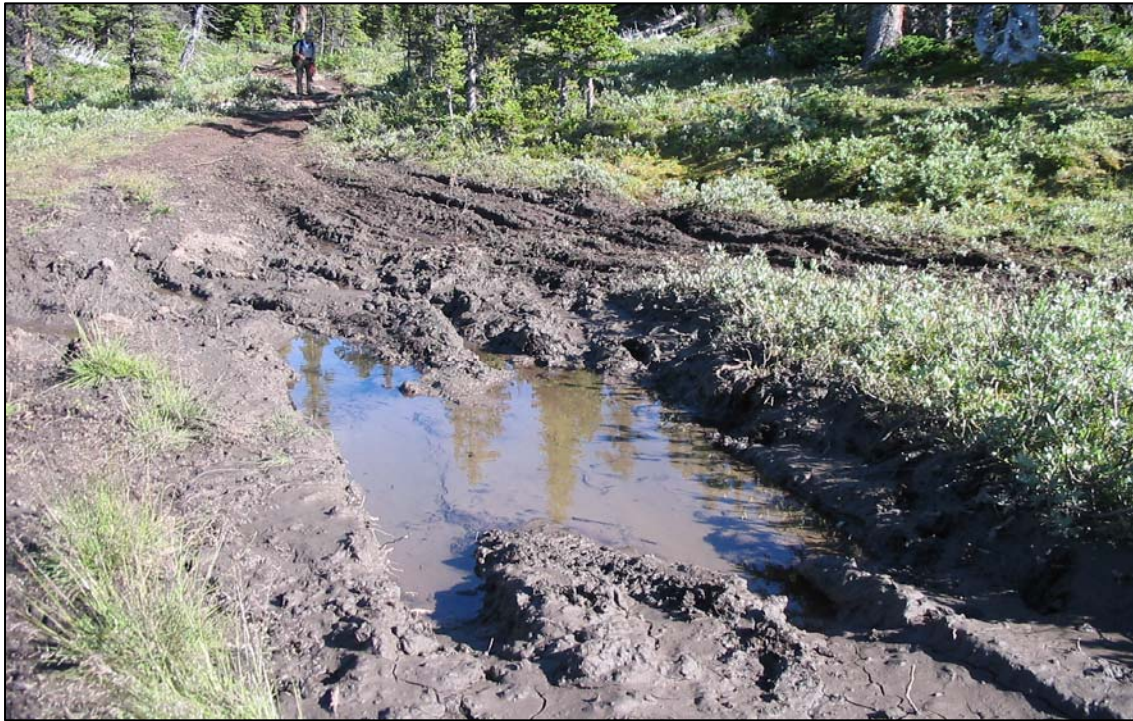
Figure 9. Trail degradation due to a combination of poor water drainage and excessive motorized traffic. Pooling water in one section of the trail leads to trail braiding and exacerbates vegetation loss and soil erosion.

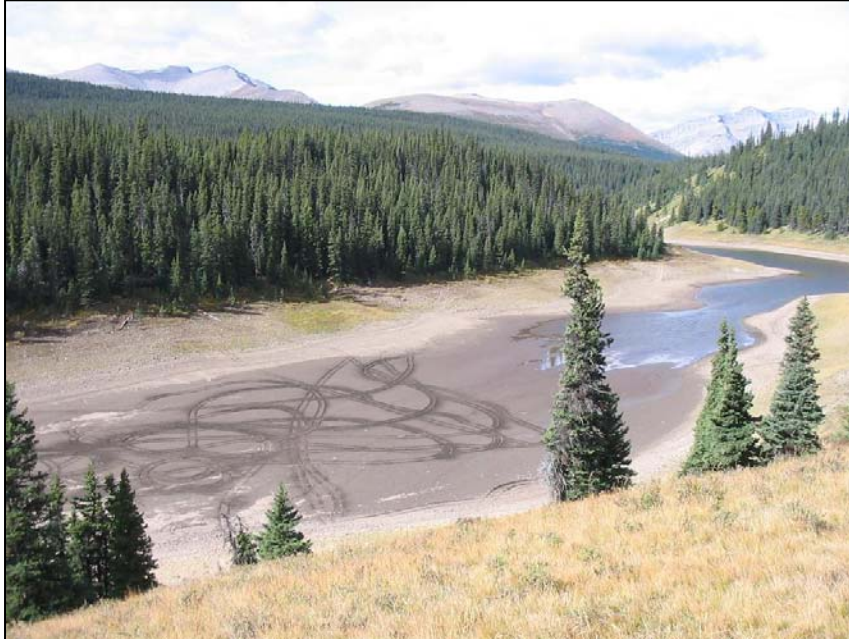
- 1) An undesignated “frolic area” on Onion Lake. The tracks in the lakebed on the left side of the photo are from OHVs and have been found in this location every year since at least 2003.

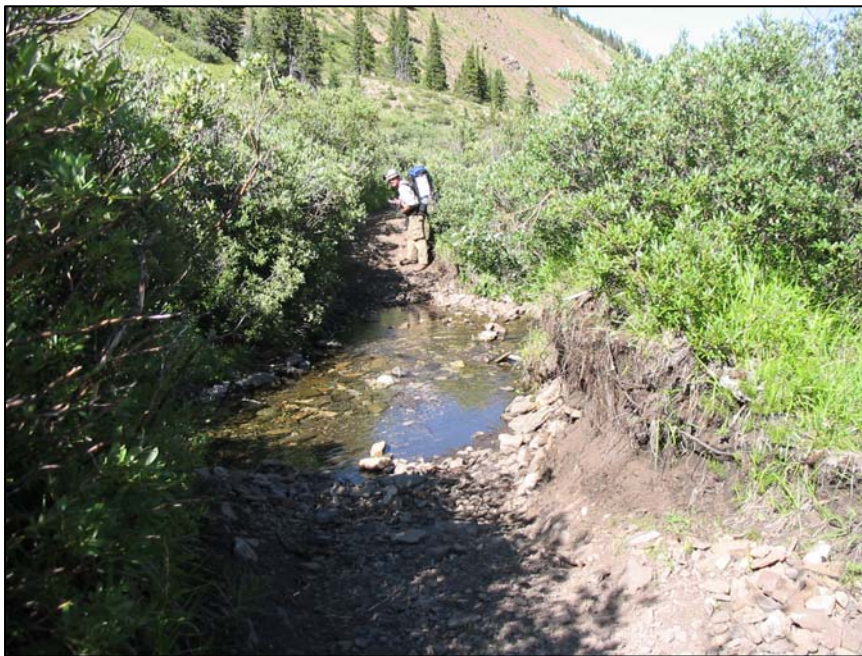
- 2) A poorly designed water crossing along HUM. Sites like these are contributing to water quality degradation and fish habitat loss.

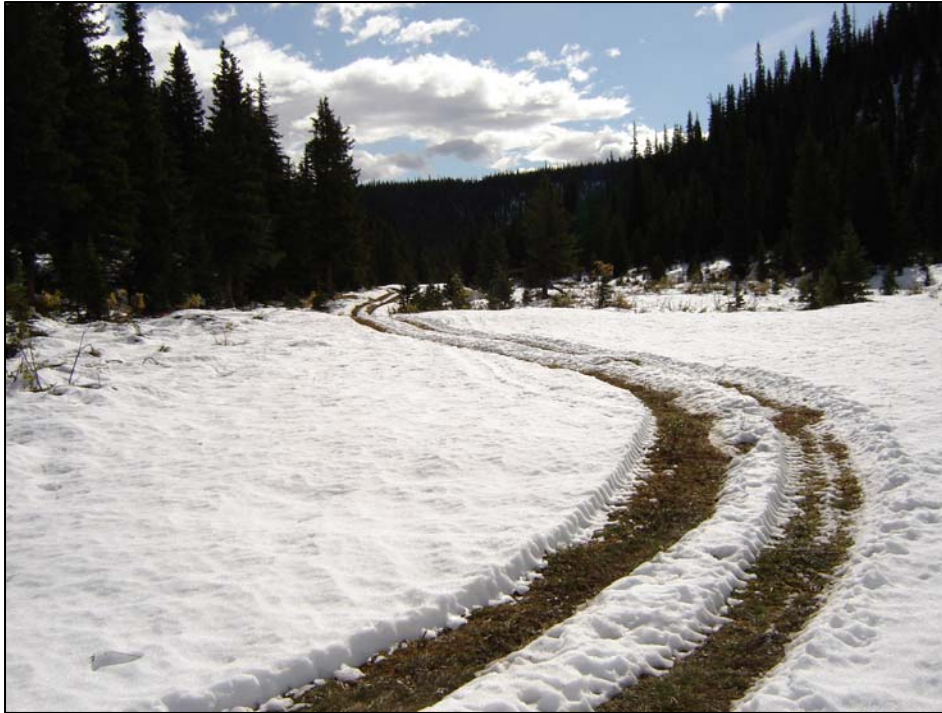
- 3) Use of a non-designated trail by at least one OHV rider near traffic counter 3 in the Onion Lake area.

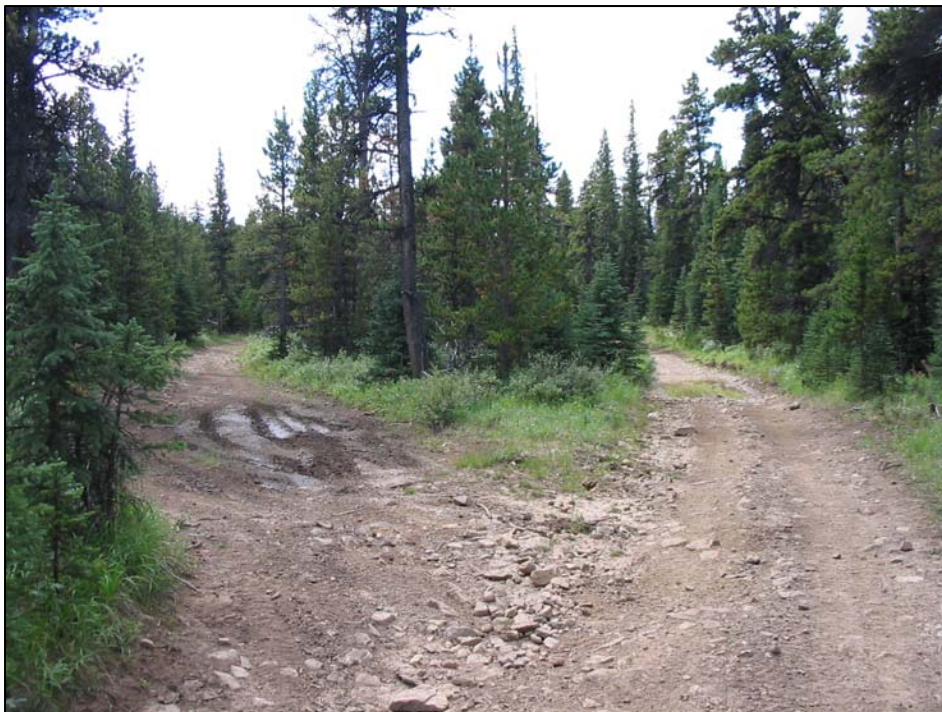
- 4) Trail braiding along the ONI trail. Note the puddling on the left branch.

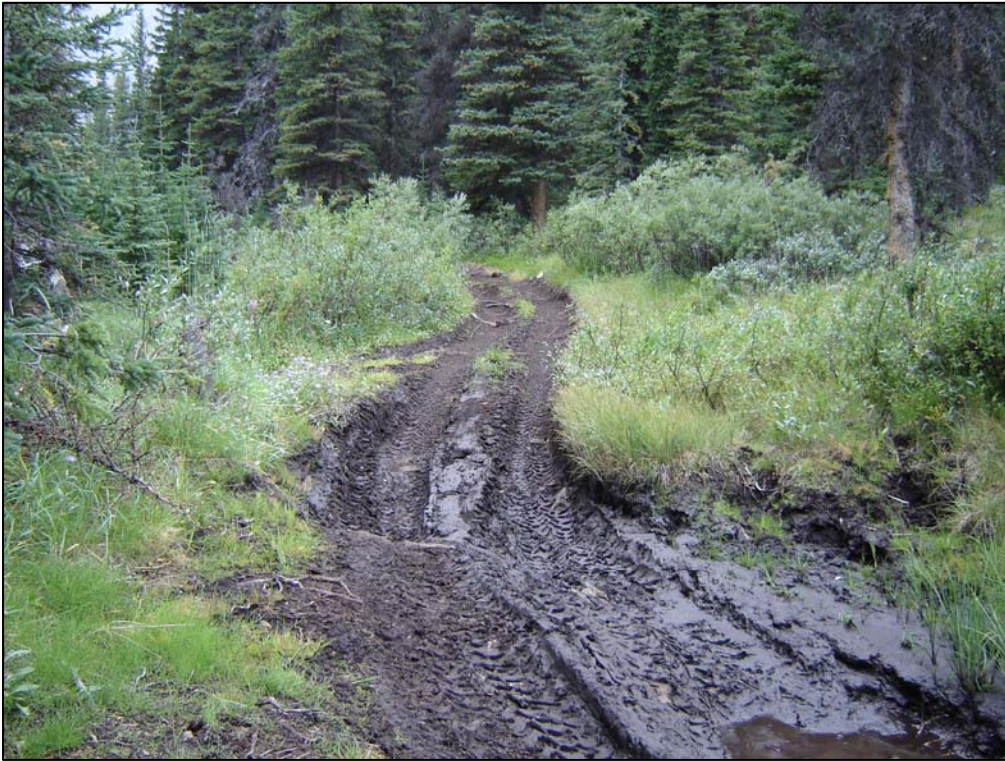
- 5) A section of damaged trail along HUM. Poor trail construction is leading to water pooling and rutting along this OHV track.

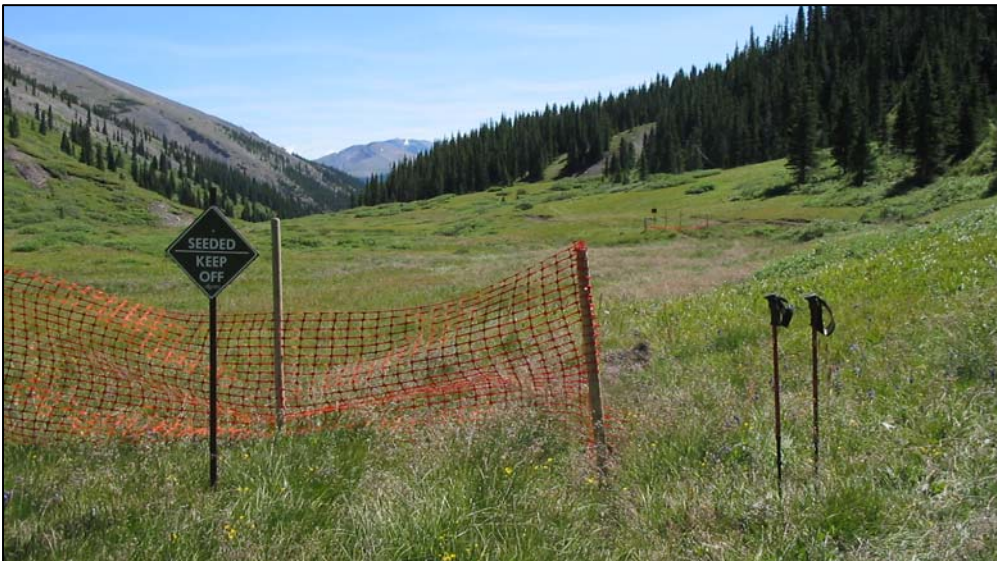
- 6) Reclamation efforts along BTS by SRD. Costs of reclaiming damaged areas, as well as additional enforcement personnel needed for backcountry patrols, need to be included in any cost-benefit evaluation of managing this wilderness resource.

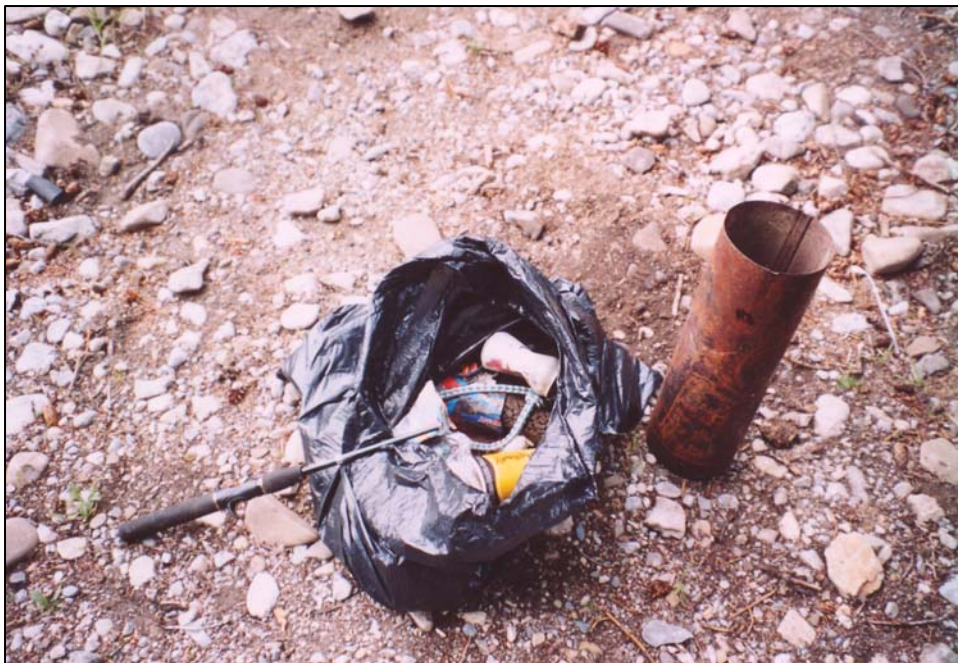
8) Garbage gathered from one backcountry campsite along RNG.
