Is the Access Management Plan Working?

Monitoring Recreational Use in the Bighorn Backcountry

Final Report 2004 - 2008

Alberta Wilderness Association

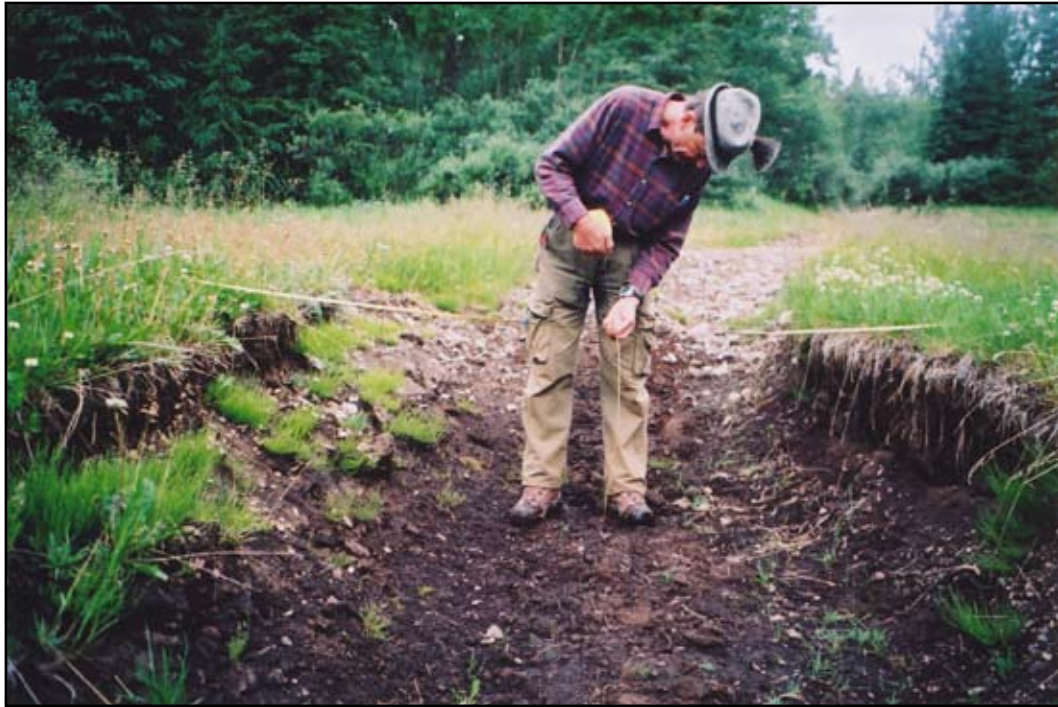
Figure 3. Measuring the depth of an Erosion Event along RNG

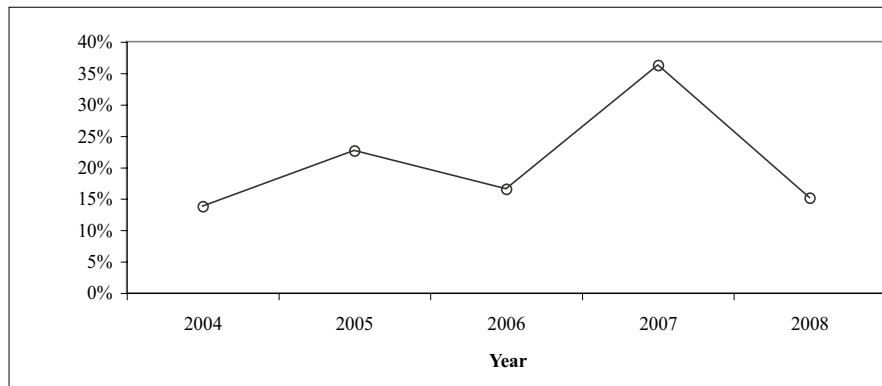
We found that the total number of passes by motorized vehicles during non-designated periods increased from 0.37 Passes Per Day (PPD) in 2004 to 0.73 PPD in 2008, an almost 100% increase. The total number of passes made during non-designated periods, relative to the total amount of traffic recorded on the trail network, fluctuated depending on the year; but, overall, an increasing trend is exhibited from 2004 to 2008 (Figure 4). As of 2008, illegal passes account for 15% of all passes recorded. ONC (1)¹⁵ showed an increase in the proportion of motorized traffic during non-designated periods since 2004, while illegal traffic on CAN and ONC (2) has decreased since 2004 (Table 1). Since 2004, the number of illegal passes made on two non-designated trails has risen and fallen depending on the year. In 2008, there was 33% more illegal passes on the non-designated trails than in 2004.

Figure 4. Percentage of illegal passes per day per year out of the total number of passes. Data from designated trails only

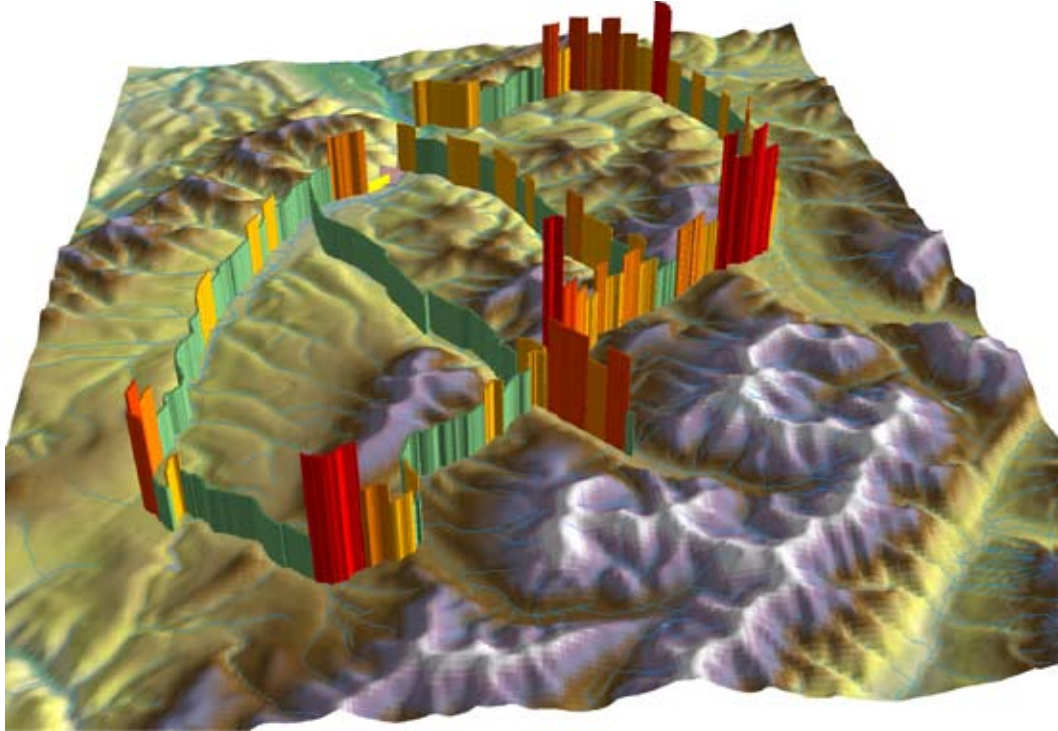
We surveyed more than 76 km of designated trails and found 453 features of concern. These features were not distributed equally among trails (Tables 2, 3 and 4) or sections of trails (Figure 5). The sum length of damaged trail sections varied from 7% of the BTN to 64% of the BTR, for an overall length of 20% of the 76-km trail network. The number of Erosion Events (EEs) was highest on BTR (5.58 EE/km) followed by BTS (3.13 EE/km), while CAN (0.93 EE/km) and HUM (0.91 EE/km) had the lowest density of EEs. Overall, we found roughly one EE for every 600 m of trail in the network. The number of EEs associated with OHV tracks was proportionally higher than the number of EEs associated with equestrian tracks on every trail except for RNG¹⁶. On RNG, equestrian tracks were associated with 86% of the EEs (see Figure 3). The maximum width of damage sites on all trails was an average of 8.87 m (n=223), with the two widest damage sites on ONC (50 m) and RNG (50 m). The mean maximum depth was greatest on BTR (0.45 m) and BTN (0.44 m), and the deepest site we found was 1.6 m on BTR.

Figure 5. Erosion Event (EE) distribution within the trail network; view looking southeast from above the North Ram River headwaters. Height and colour of 500-m trail sections is related to the number of EEs within each section: 0 EEs=green; 1 EE=yellow; 2 EEs=orange; 3 EEs=dark orange; 4-6 EEs=red. Scale is variable on this projection, but the length of individual trail sections is 500 m. See Figure 2 for names of individual trails.

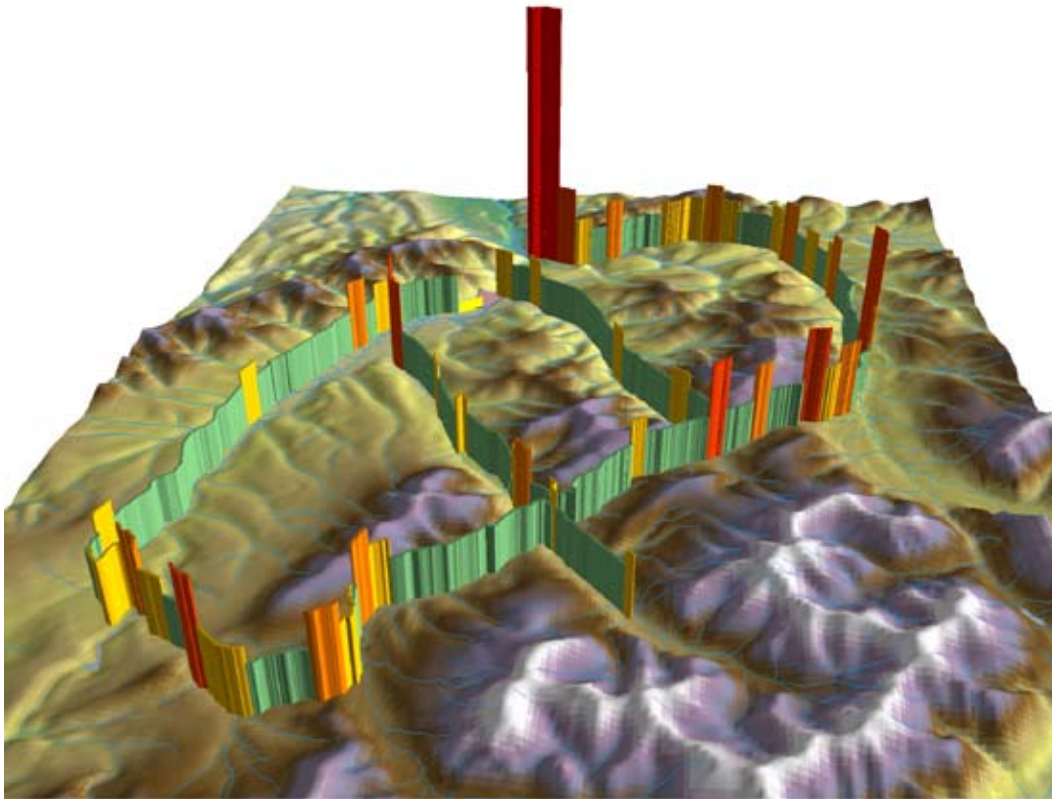
More than one non-designated trail junction was found for every kilometre of designated trail in the trail network, with most of these occurring along RNG and associated with equestrian trail use (Figure 6). Non-designated trails found along BTN, BTR, BTS, and ONC were most often associated with OHV use (Table 5).

Figure 6. Non-designated trail distribution within the trail network; view looking southeast from above the North Ram River headwaters. Height and colour of 500-m trail sections is related to the number of non-designated trail junctions within each section: 0=green; 1=yellow; 2=orange; 3-5=dark orange; 6-9=red. The length of individual trail sections is 500 m, but the scale is variable on this projection. See Figure 2 for names of individual trails.

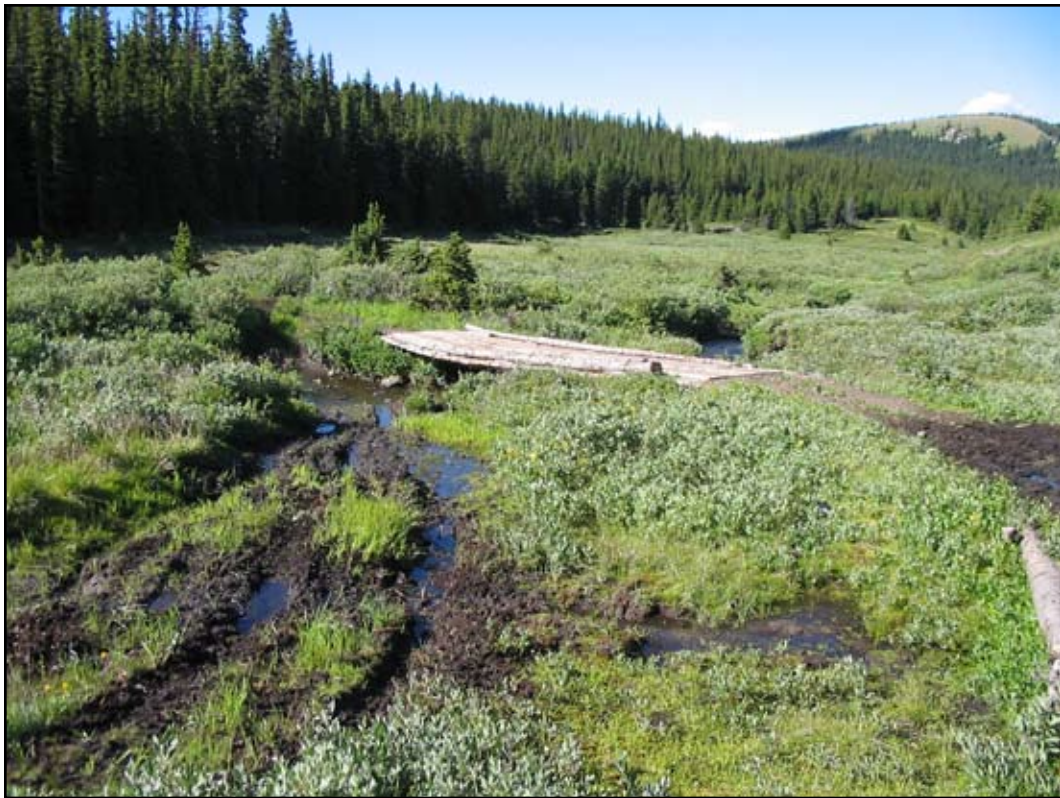
We documented 89 water crossings throughout the network with the highest water crossing densities along CAN, HUM, and BTS (Table 4). Of these 89 water crossings, 7% had formal crossing structures present while 72% had permanent water moving through them. Of the six crossing structures we found, two were on ONC and two were on BTN. In many cases, vehicle tracks were found adjacent to crossing structures indicating that some riders are avoiding their use (Figure 7).

Figure 7. A water crossing on BTN. The bridge was placed on the main trail, but users continue to drive OHVs through the creek on the left side of the photo.

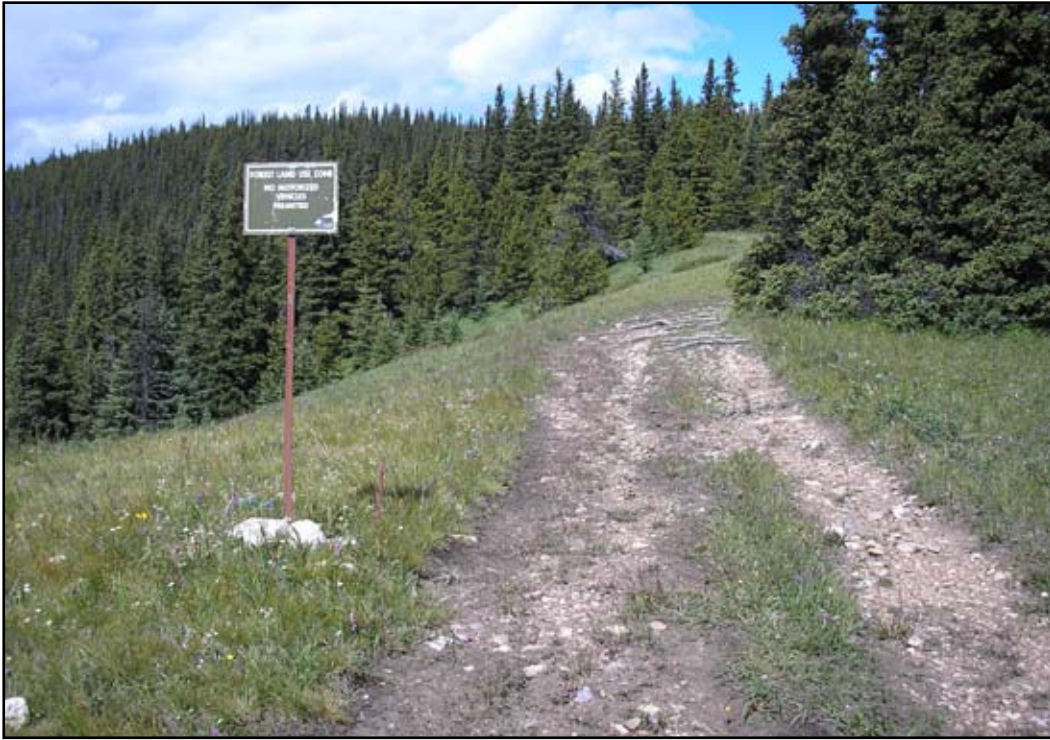
Illegal activity on two non-designated trails has also fluctuated over the study period with alternate years showing an increase and then a decrease in illegal use. In 2008, illegal passes on these two trails have increased 33% percent since 2004. It is important to remember that these two trails represent only 5% of the non-designated trails we found that had evidence of use by motorized vehicles. Further research is warranted to determine the extent of non-designated trail use. Presently the trend is unclear and our sample size is limited in this regard. Anecdotal evidence documented during this study suggests that signs or barriers placed at the junction of non-designated and designated trails may reduce the frequency of illegal use (Figure 8).

Figure 8. SRD has placed a sign beside the trail stating that no motorized vehicles are permitted. Illegal activity persists but is declining at this site. The sign states: "Forest Land Use Zone. No motorized vehicles permitted."

3. Ensure that all non-designated (i.e., illegal) trails are physically blocked and signed at the junction, with language indicating that motorized users proceeding off of the main trail are in violation of FLUZ regulations.

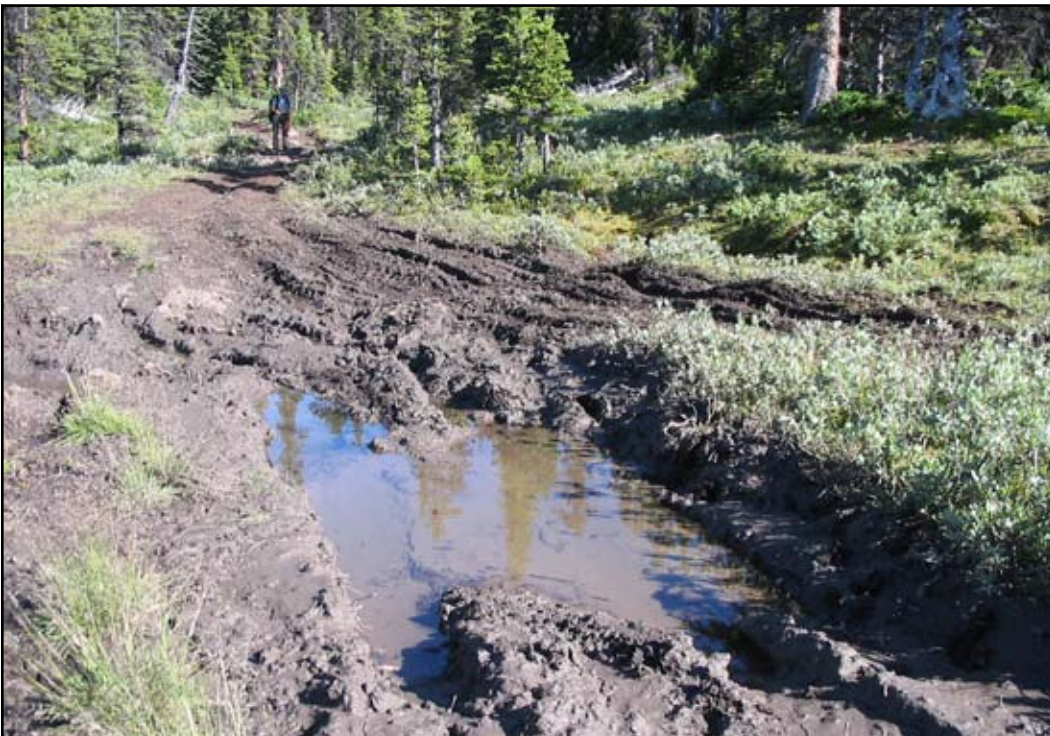
We found extensive damage (~20% of all trails) and intensive erosion (1 EE for every 600 m of trail) throughout the trail network. There were particularly high levels of damage on BTS and BTR (Figure 9). In most cases, this damage was associated with OHV use, except on RNG, where 93% of the 41 EEs were associated with equestrian use. Both equestrian and motorized users appear capable of causing similar levels of trail damage in the area; however, we do not have data on the relationship between equestrian-user density and associated levels of trail damage. Anecdotal evidence suggests that the hardened conditions of the eastern portion of the ONC trail are at least partly responsible for the relative absence of OHV and equestrian-related damage here. The relatively flat slope along some sections of ONC, CAN, and HUM may also contribute to the durability of these sites to trail activities (Coleman 1981). Visual evidence clearly suggested that a large percentage of the trail damage observed and recorded is due to inadequate storm and stream water drainage; the mostly amateurish stewardship efforts at controlling and managing runoff on the trails had little effect.

Figure 9. Trail degradation due to a combination of poor water drainage and excessive motorized traffic. Pooling water in one section of the trail leads to trail braiding and exacerbates vegetation loss and soil erosion.

We found evidence of trail stewardship by local clubs, as encouraged by SRD, but in some situations these efforts will only temporarily address the problem. In many cases, water movement near or across the trail is not adequately addressed by the drainage methods used (H. Unger, P.Eng, pers. comm.). Attempts by some groups to reduce the impact of their own activities within the Bighorn Backcountry are commendable; however, additional expertise is needed in these endeavours and a more systematic approach to trail improvement must be implemented.

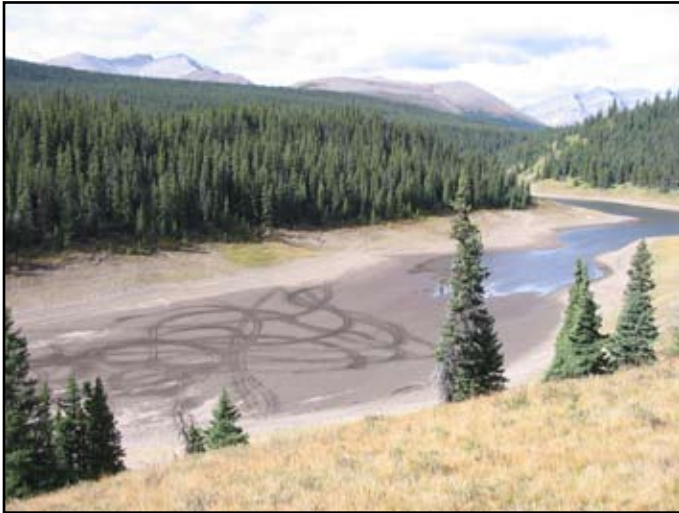
1) A non-designated "frolic area" on Onion Lake. The tracks in the lakebed on the left side of the photo are from OHVs and have been found in this location every year since at least 2003.

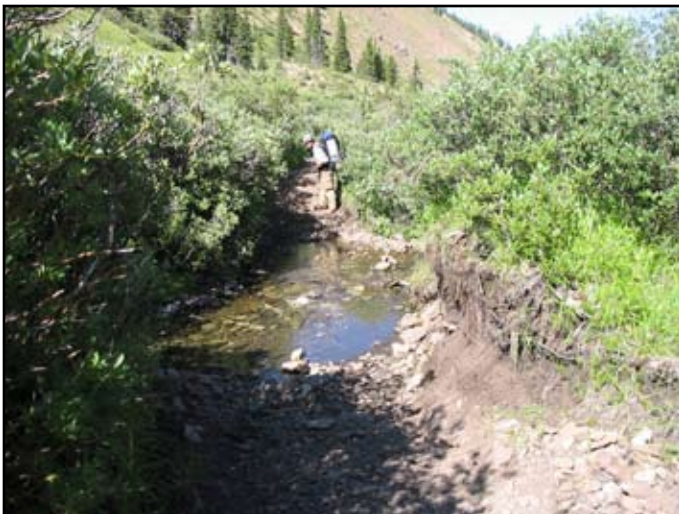
2) A poorly-designed water crossing along HUM. Sites like these are contributing to water quality degradation and fish habitat loss.

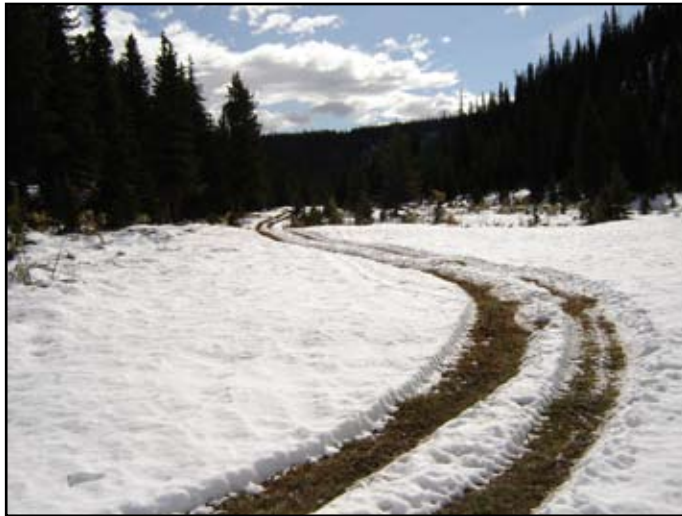
3) Use of a non-designated trail by at least one OHV rider near traffic counter 3 in the Onion Lake area.

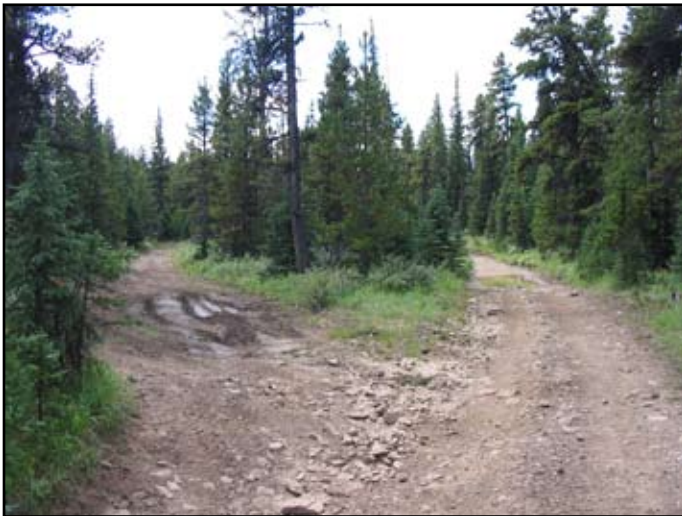
4) Trail braiding along the ONC trail. Note the puddling on the left branch.

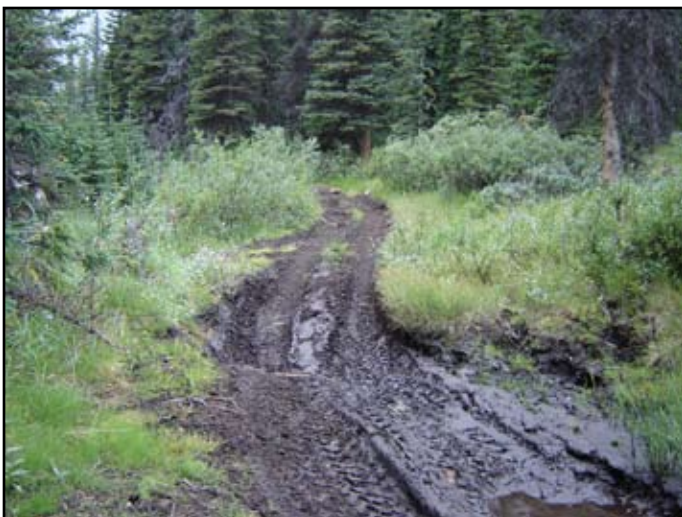
5) A section of damaged trail along HUM. Poor trail construction is leading to water pooling and rutting along this OHV track.

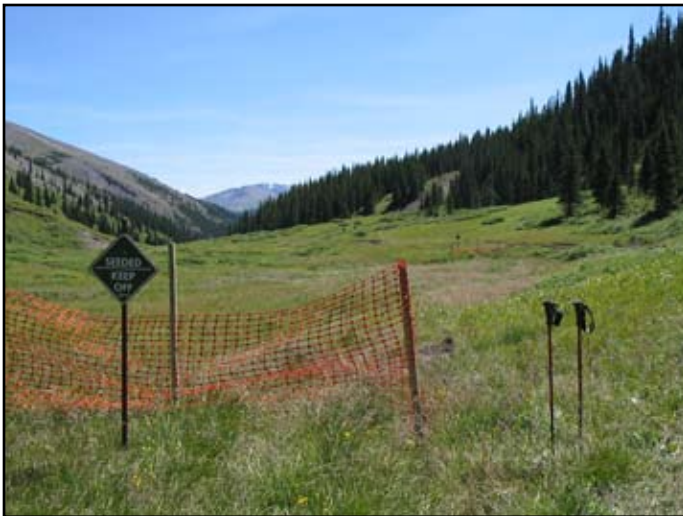
6) Reclamation efforts along BTS by SRD. Costs of reclaiming damaged areas, as well as additional enforcement personnel needed for backcountry patrols, need to be included in any cost-benefit evaluation of managing this wilderness resource.

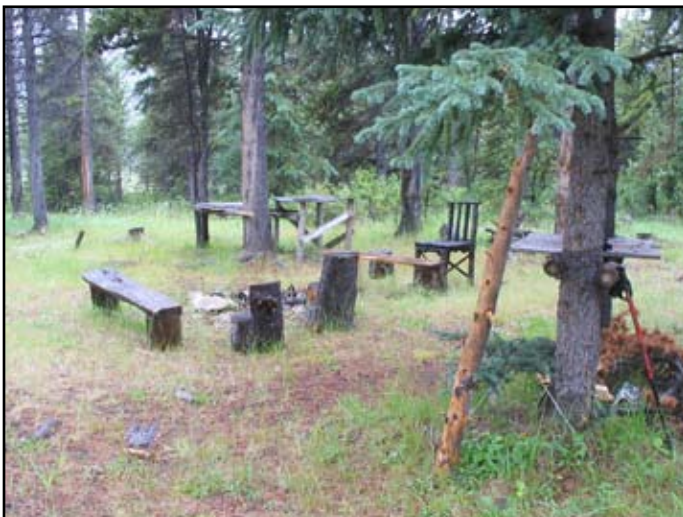
7) Backcountry campsite along RNG

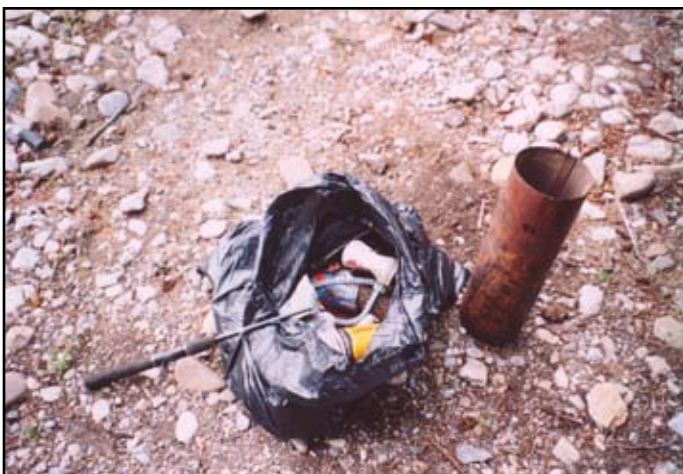
8) Garbage gathered from one backcountry campsite along RNG

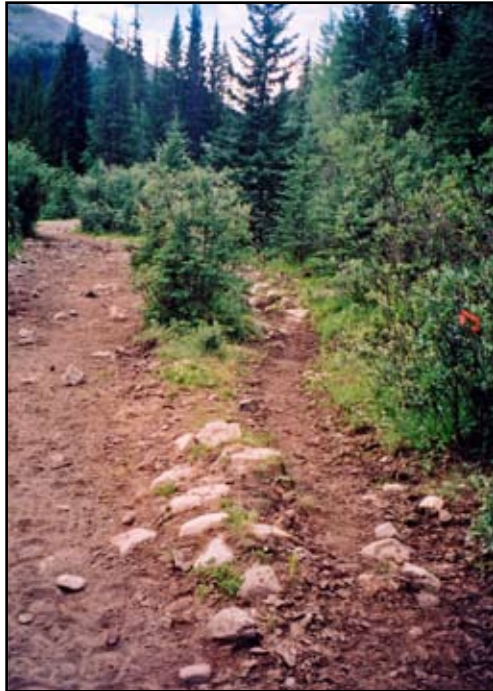
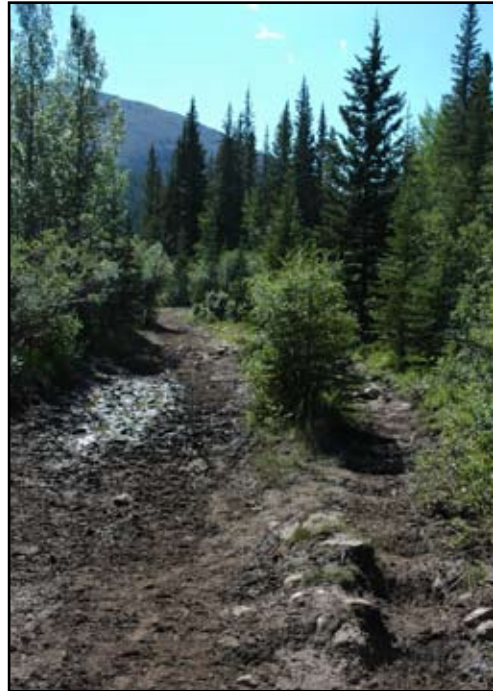
Comments: Illegal OHV trail up ridge. Since first observation, a sign has been installed indicating that the trail is not to be used. However, tracks indicate that sign is being ignored and there is now a new braid 14m long.

Observed July 21, 2004

Observed August 17, 2008

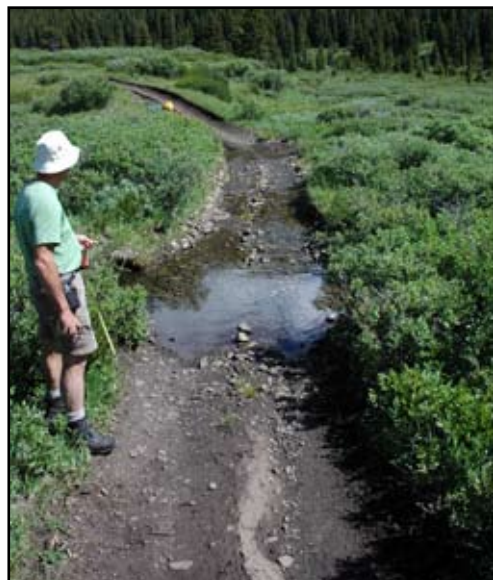
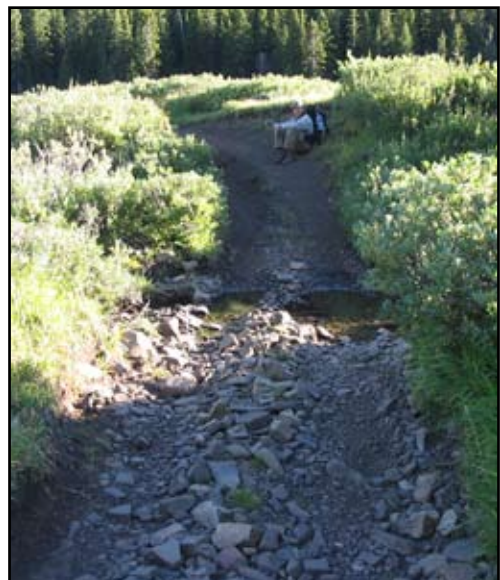
Observed July 14, 2004

Observed August 2, 2008

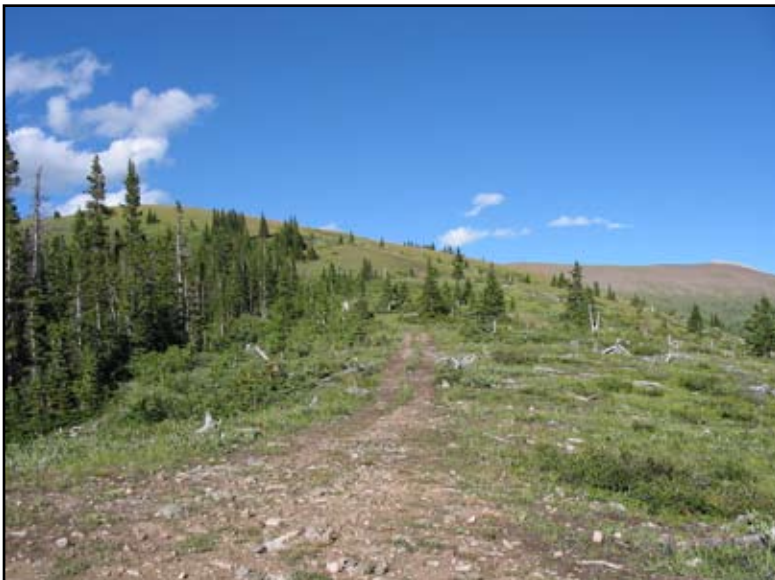
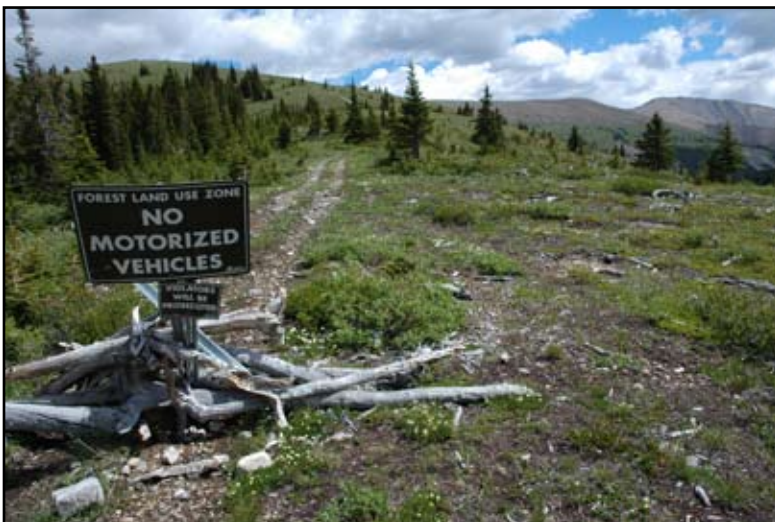
Observed August 2, 2005

Observed July 14, 2008
