ALBERTA WILDERNESS ASSOCIATION BIGHORN WILDLAND RECREATION MONITORING PROJECT

2012 REPORT

Monitoring of Recreation Uses and Impacts in Bighorn Wildland, Alberta
Study Location: Hummingbird Forest Recreation Area

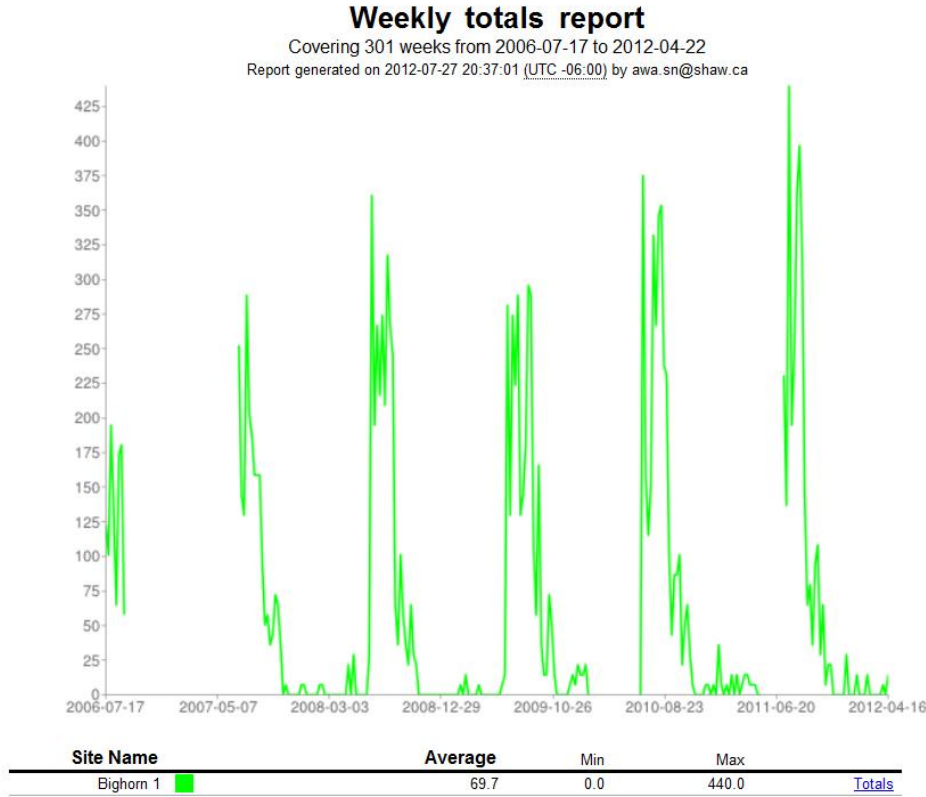
Figure 3. A graph from the TRAFx website showing recorded OHV passes at the ONI/HUM trailhead. A clear trend of increasing use from 2006 to present is visible, despite data gaps. This data also evidences vehicle passes during the trail closure period from February 1 (previously March 15) to June 30 every year, which has been corroborated with visual observations. Similar patterns of use are observable in the data collected from the other vehicle counters.

1. OHV use in the Bighorn is increasing every year
2. OHV use in the Bighorn does occur during trail closure periods

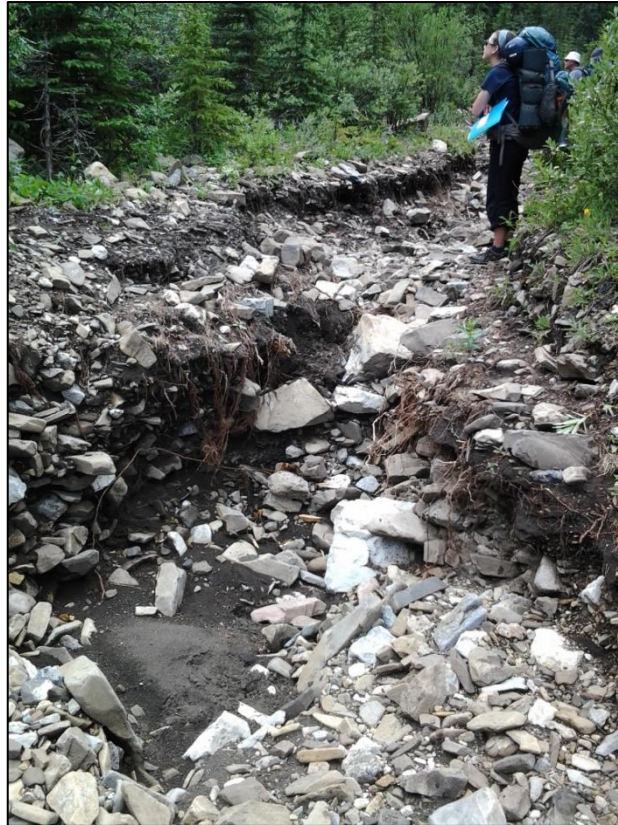
Figure 4. A section along CAN trail showing a damaged site of approximately 1.75 m in depth.

exceeded “normal” rutting depth due to either excessive use or erosion, site depth was measured (i.e. ruts were observed throughout the entire trail network, but were only measured when the depth was of concern). Of these damaged sites, the average depth was 0.62 m and the maximum observed depth was 1.75 m.

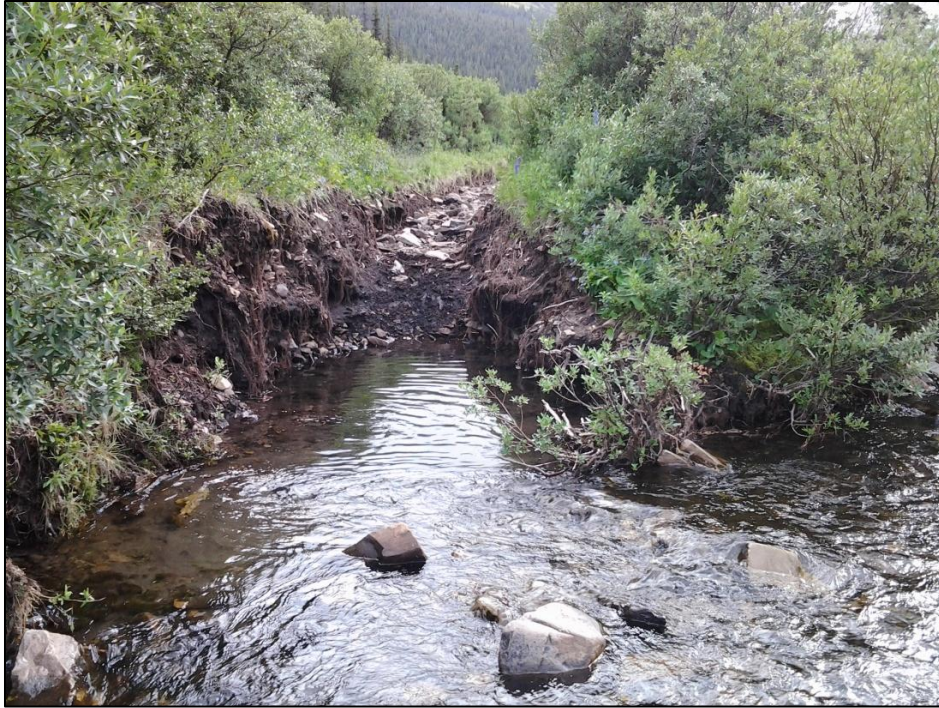
Figure 5. A water crossing located along CAN trail. As no permanent structures are present, users must travel directly through the stream.

6. **Address water quality and fisheries objectives by improving water crossings along designated trails through the construction of bridges for permanent streams and hardened fords for ephemeral streams.** Approaches to streams should be hardened with gravel to reduce bank erosion and fenced to encourage their use. AWA was pleased

We documented 8 water crossings throughout the network with the highest water crossing densities along CAN. Of these water crossings, only 1 had a formal crossing structure present.

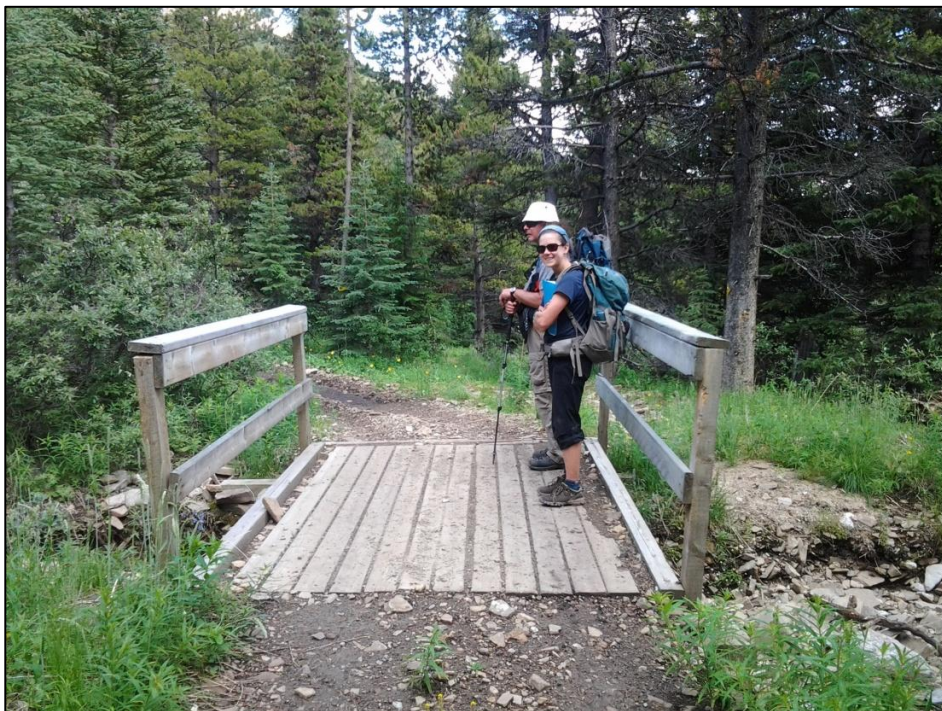
Figure 6. Permanent water crossing constructed on BTR.

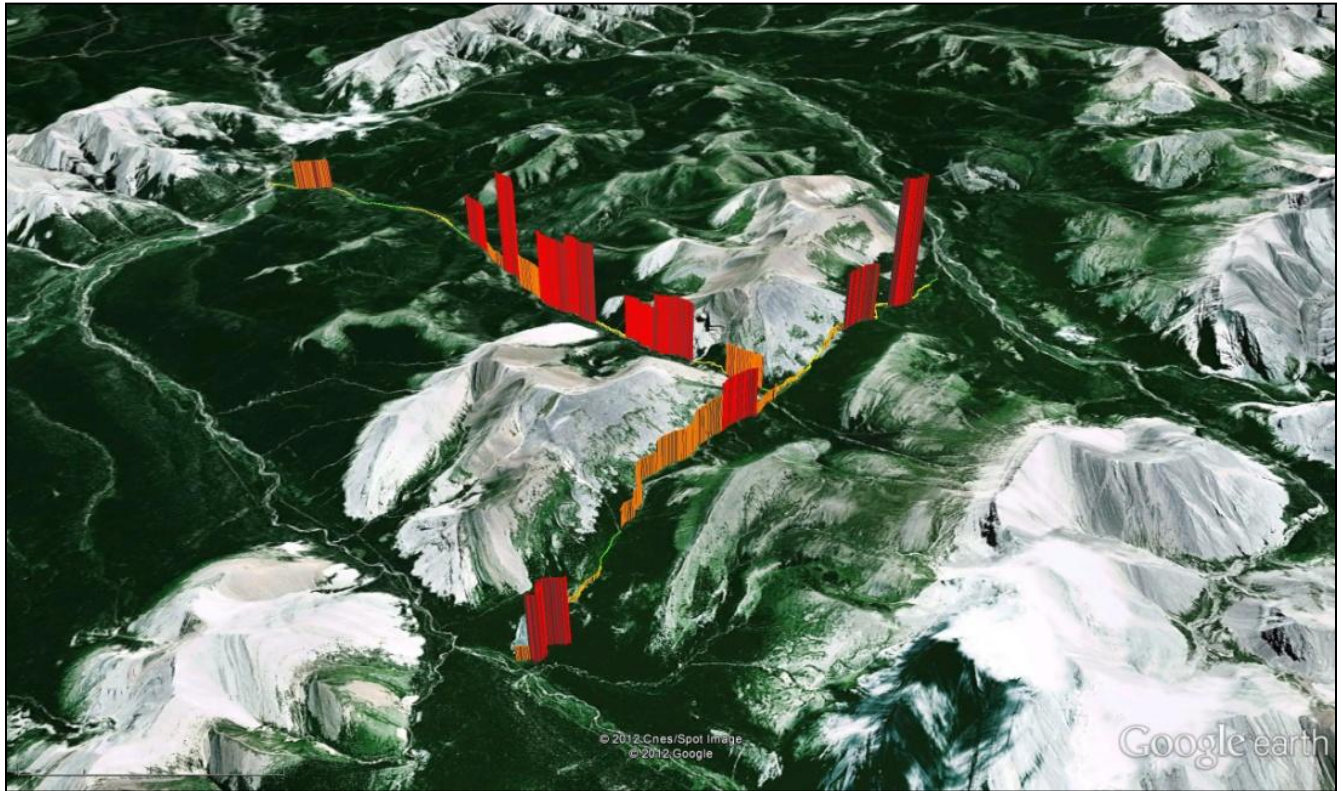
Erosion events were observed at a total of 98 sites (Figure 7). Trail erosion was most severe on CAN, where large sections were essentially impassable.

Figure 7. Erosion Event distribution on CAN, BTS and BTR; view looking southeast from above the North Ram River headwaters. Height and colour of 500m trail sections is related to the total length of eroded trail within each section: no eroded trail = green, 1m-10m eroded = yellow, 11m-25m eroded = orange, 26m-100m eroded = dark orange, greater than 100m eroded = red. Scale is variable on this projection, but the length of individual trail sections is 500m. (Background map courtesy Google Earth.)

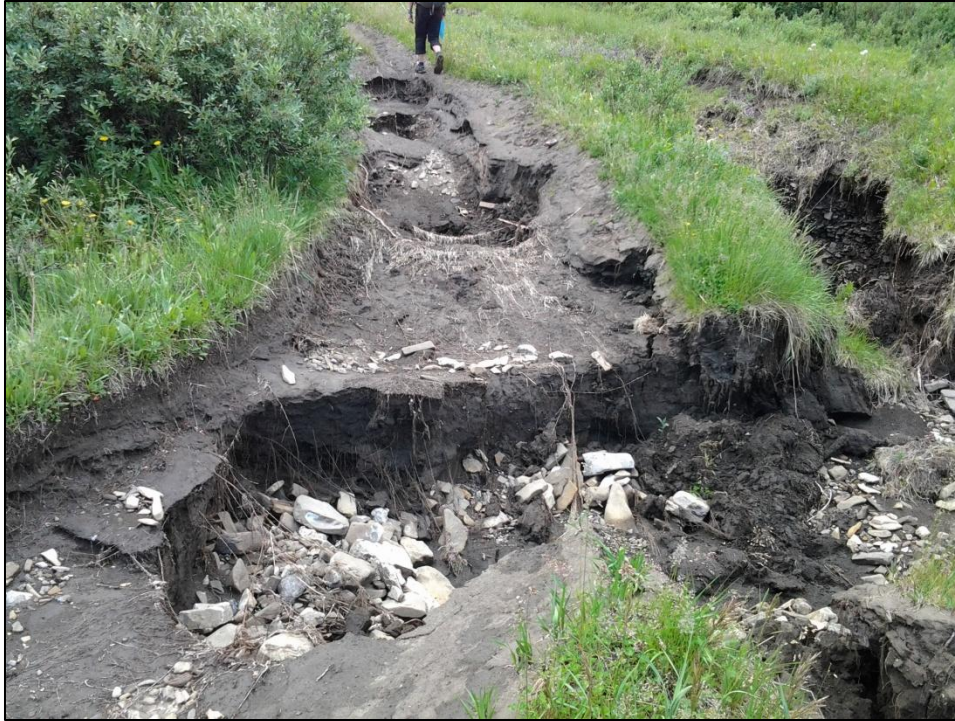
Figure 8. A section on CAN trail made impassable due to extreme erosion.

During our July 2012 field study, severe trail damage and intensive erosion were observed throughout the Hummingbird Recreation Area trail network. Overall, 146 sites were recorded, in addition to the 453 features of concern documented between 2004- 2008. There were particularly high levels of damage on CAN. In most cases, this damage was associated with OHV use, although impacts inflicted by equestrian use were also documented. Due to extreme trail erosion and deep rutting, several sections of the CAN trail were practically impassable to foot traffic, let alone to equestrian or OHV users.

Visual evidence indicated that a large percentage of the trail damage observed was due to inadequate storm and stream water drainage. It should be noted that high winter snow pack and heavy spring rains created higher-than-average water levels in 2012, which likely contributed to the extreme trail erosion observed. These wet conditions emphasized the natural topographical, soil and vegetative profile that make the Bighorn Backcountry unable to sustain motorized activity. The low river valleys are easily saturated, and the unstable stream banks quickly lose their structural integrity when subjected to long-term motorized activity. It is our fear that if current levels of use are either maintained or increased, temporary trail closures and stewardship efforts will be unable to repair the severe environmental damage. The extreme trail erosion observed throughout the 2012 field season confirmed AWAs position that motorized recreation is incompatible with the protection of the pristine wilderness values of the Bighorn Backcountry.
