*Isn't this Where We Came In?*

SLAPPING A BAND-AID OVER  
THE BIGHORN'S CANARY CREEK

by SEAN NICHOLS, AWA Conservation Specialist

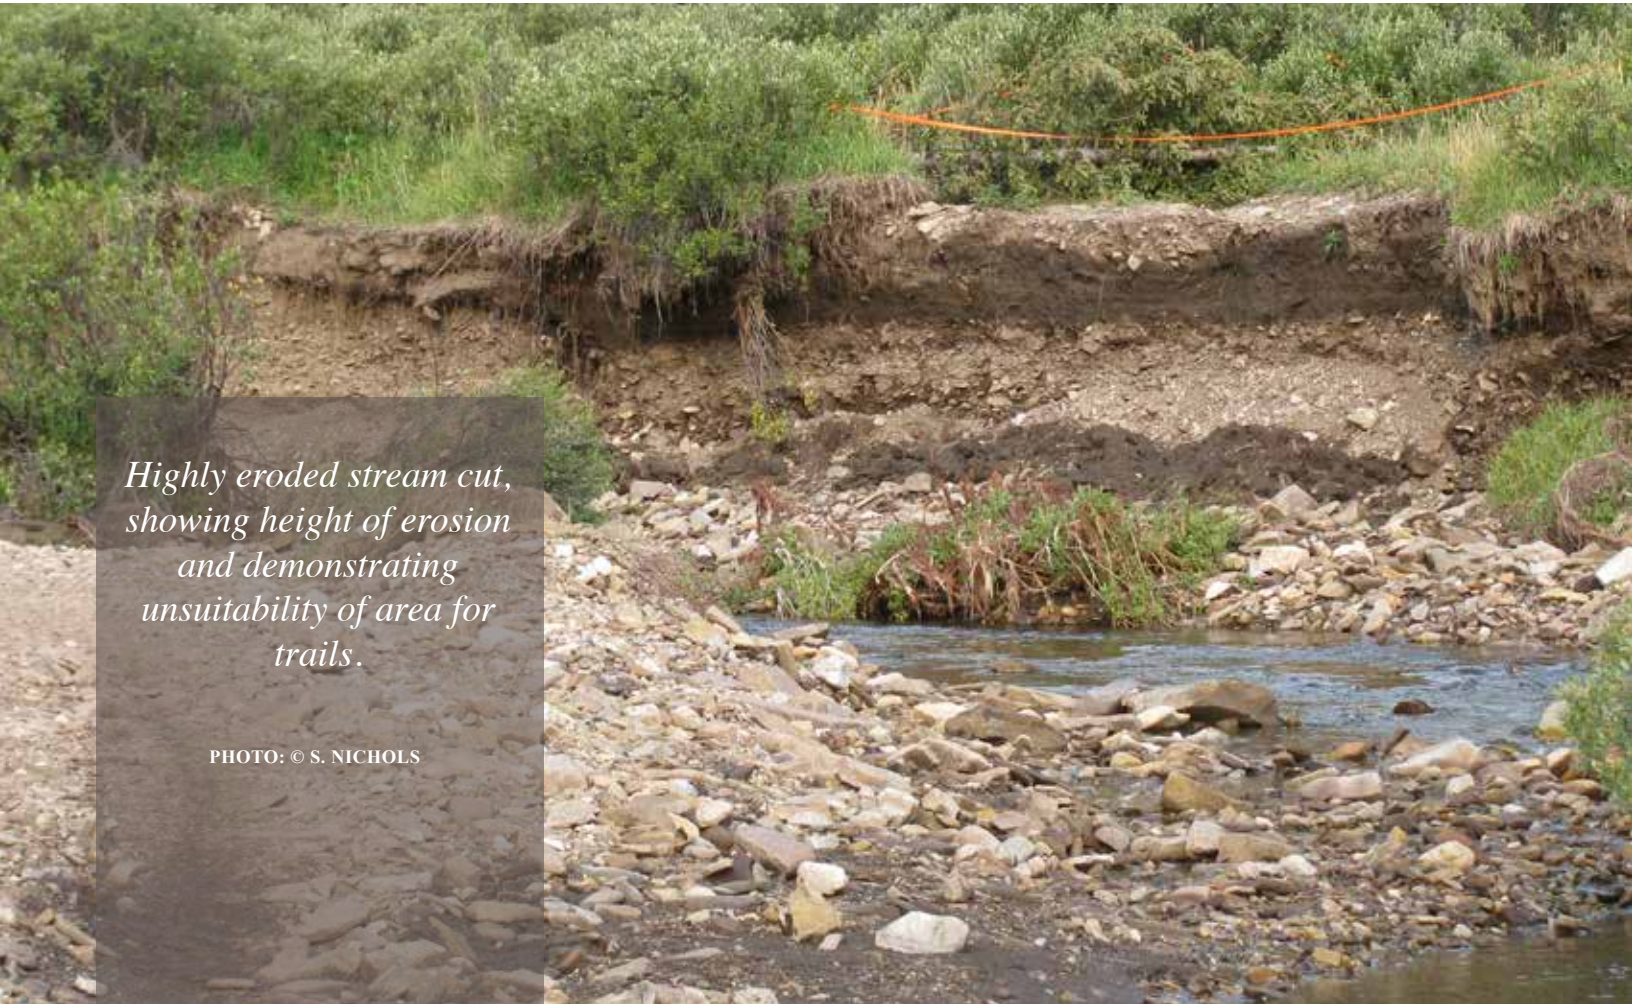
*Highly eroded stream cut, showing height of erosion and demonstrating unsuitability of area for trails.*

AWA's position was then and still is now that the terrain in these valleys cannot support this type of use. The ground in the river valley bottoms is boggy and porous, easily eroded, and prone to washouts. Attempt-

ing to put OHV trails through these systems aggravates the situation by channeling waters and creating paths for intense erosion.

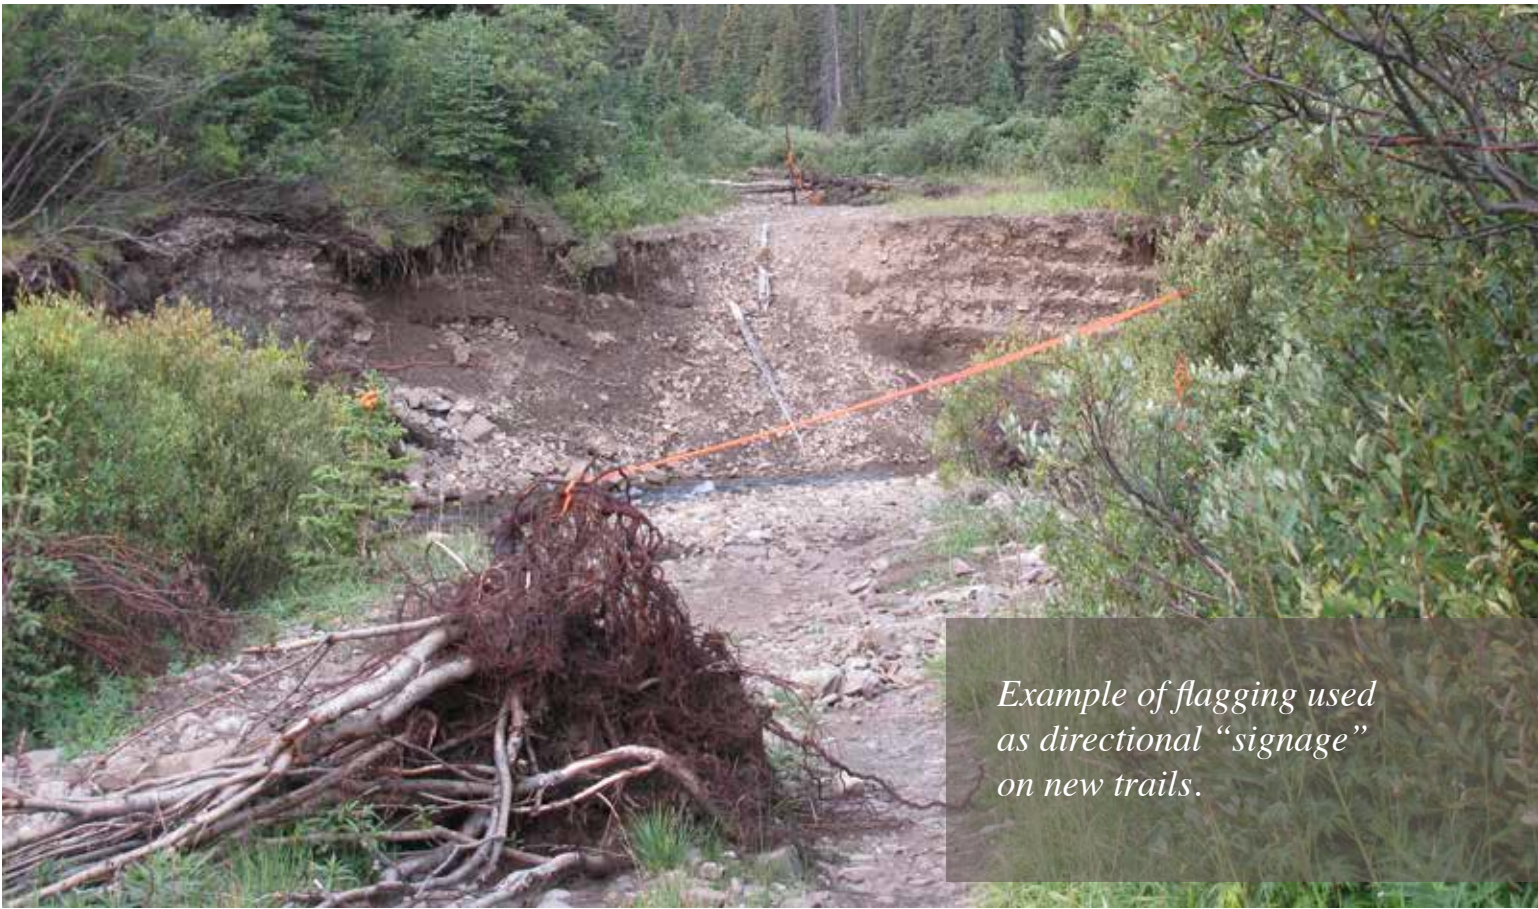
*Example of flagging used as directional “signage” on new trails.*

Little pieces of fluorescent pink flagging tape are everywhere. They

mark the new routes, however, there is no signage from the government or anyone else directing people to stay on the trail or out of sensitive areas. Indeed there is no longer any clarity, any indication, where sensitive areas might be and whether a new trail might not simply run straight through them in the first place. As a Land Management officer observed last year: “without signage, there is a green light to go.”

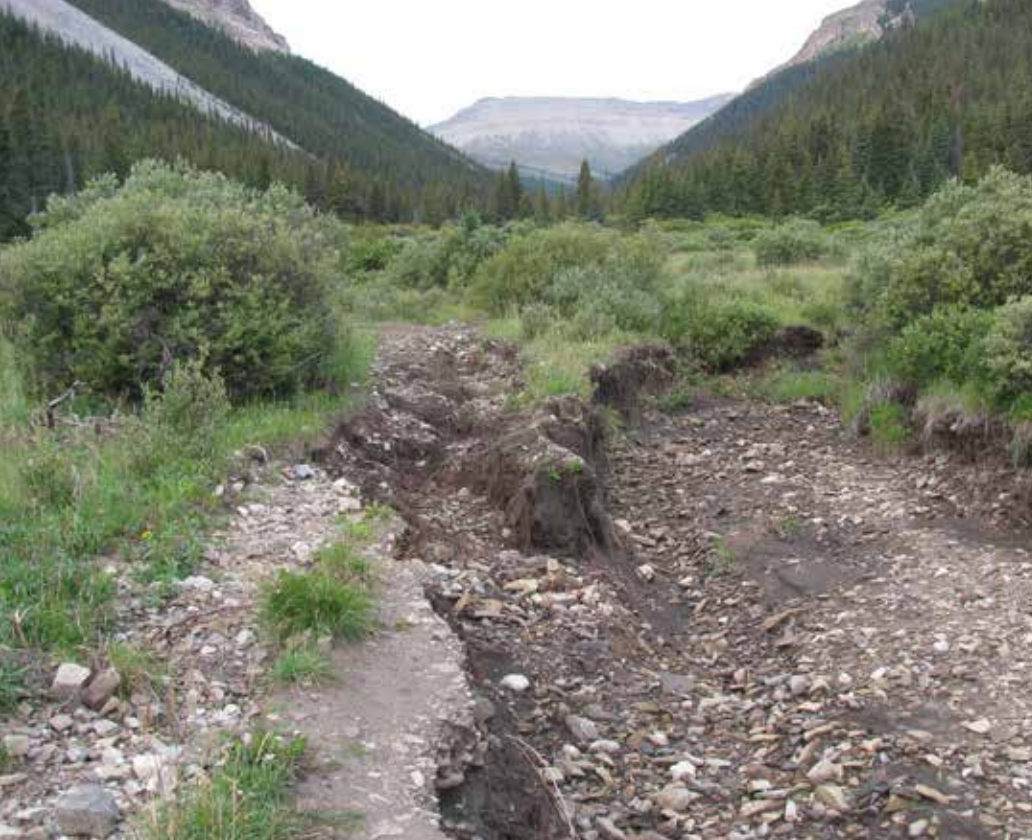
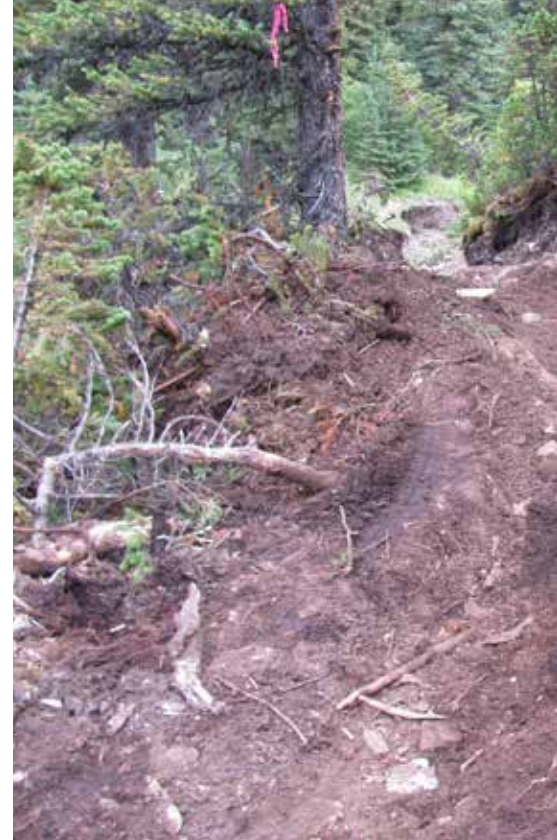
*The cumulative effects of the floods, the erosion, and trails reconstruction have devastated the Canary Creek valley.*

the valley floor. New and redirected watercourses have altered the lie of the land to the point where the existing OHV trails have become not so much impassable, as completely erased. Nature has obliterated them. New channels are up to three metres or more deep; the widths of some of these channels is in the tens of metres. The valley has been reconfigured, re-sculpted.

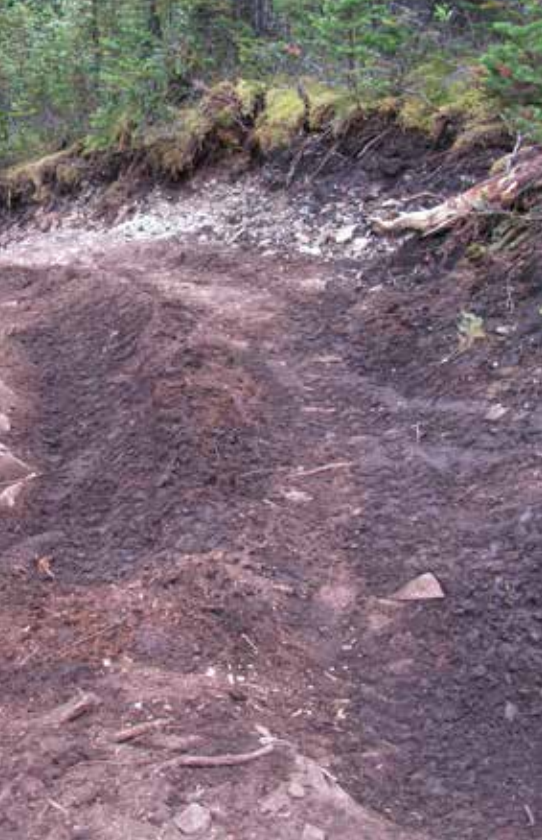
*Example of what happens to trails without adequate protection against erosion.*

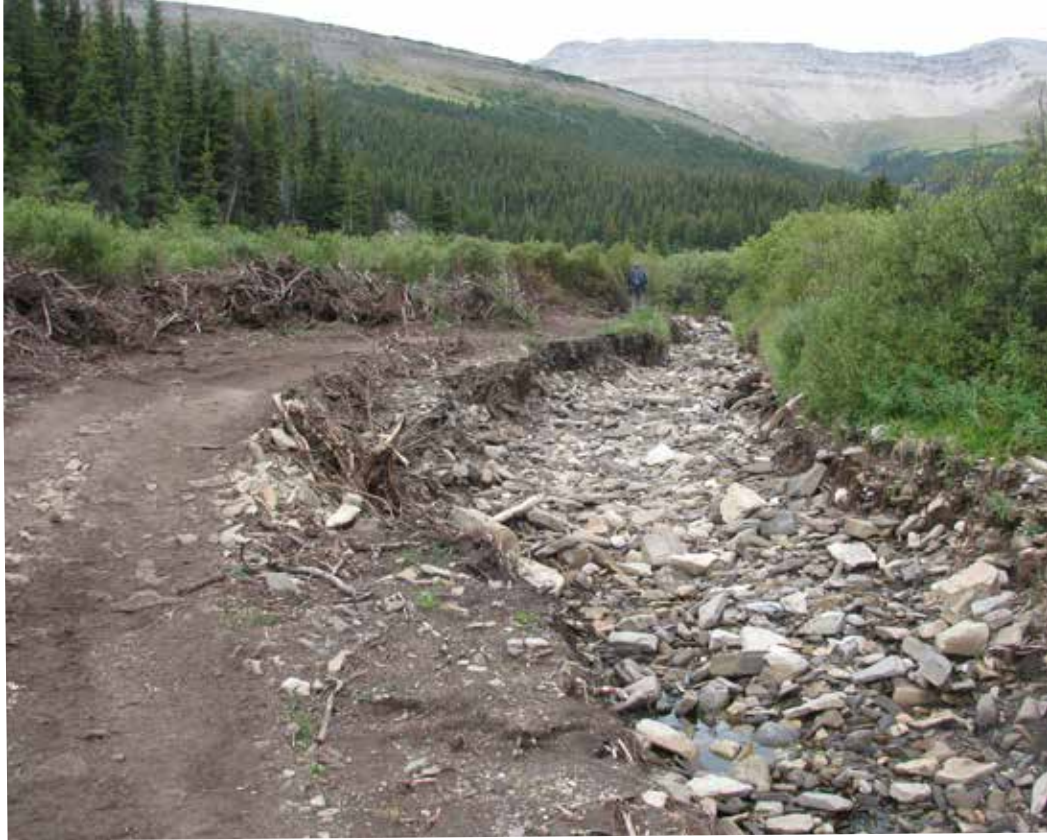
*Example of trail-building practices employed on Canary Creek.*

*New trail beside old. Without protection from erosion, there is no reason to believe it will not end up in the same state.*

In other areas where such fissures have rendered the old trail impassable, the new one is built immediately alongside it, on the same type of ground and subject to the same kinds of pressures and effects. It takes no great insight to see that the same fate will befall the new trail before long. We will be right back where we started and Canary Creek will be the worse for it.
