# ***Emergency Report: Alberta Native Cutthroat Trout Populations & Critical Habitat at Risk***

*Prepared for*

*Timberwolf Wilderness Society  
Pincher Creek, Alberta*

*FWR Technical Note No. 2017/08-1  
August 2017*

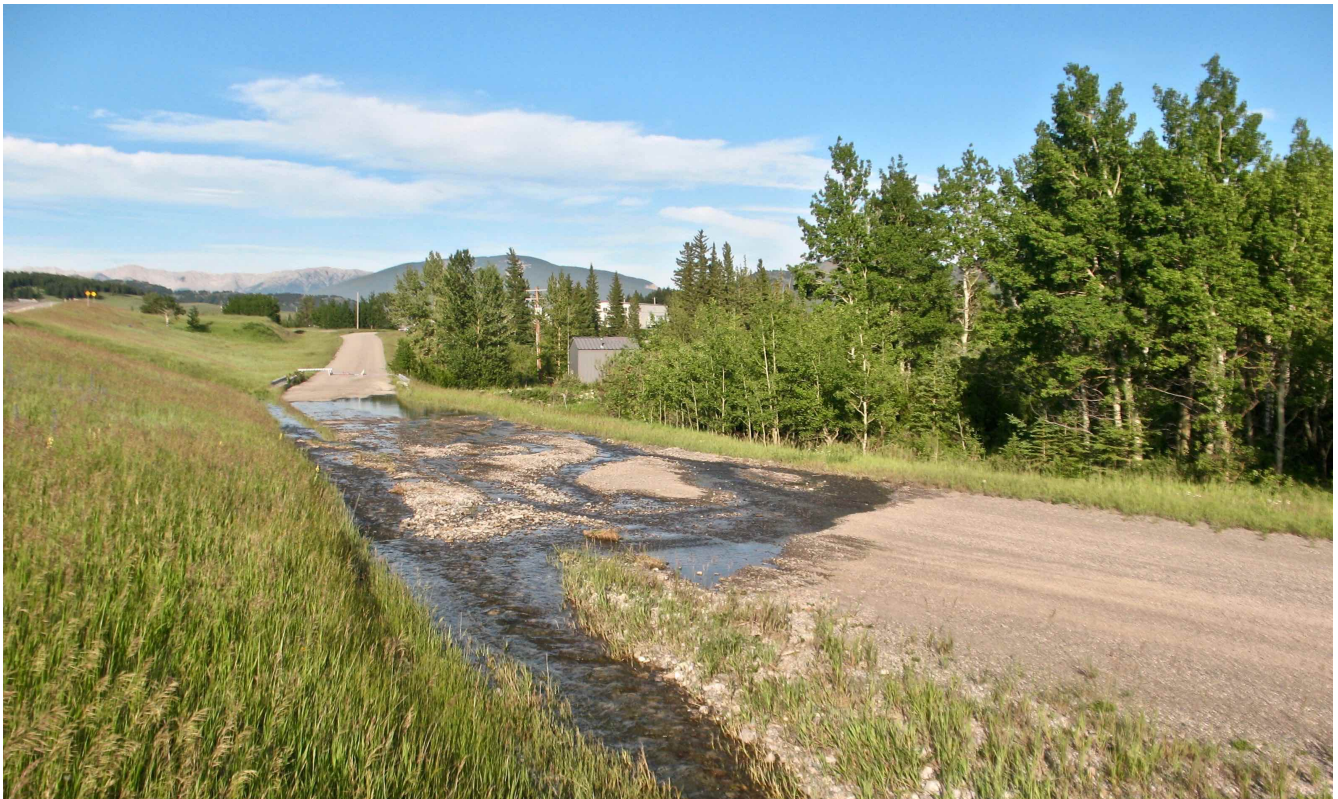
**Cover photo:** Girardi Creek, designated critical habitat for threatened native Alberta westslope cutthroat trout under Canada's Species At Risk Act (SARA), has been diverted by a plugged culvert down the ditch and former roadway of Highway 3, the Crowsnest Highway, in southern Alberta, 25 June 2017. Critical habitat downstream from the blockage was substantially dewatered, apparently for days. Destroying any part of critical habitat is contrary to section 58(1) of SARA.

The Girardi Creek population of cutthroats is rare among Alberta remnant stocks in showing no trace of the rainbow trout genome that is widespread in the Crowsnest River and all other drainages in the Alberta native cutthroat range, so is of extremely high value for conservation.

<b>Girardi Creek</b>	11U 0672726E 5500432N	from 2014 to 2017	Stream was recently diverted by blocked culvert, stopping water flow to critical habitat and blocking fish movement. Ongoing blockages are inevitable due to inadequate repair work and a highway culvert that is inadequate to pass high loads of coarse sediment.
<b>Jumpingpound Creek tributary</b>	11U 0643619E 5648138N	2017/08/25	Population at severe risk of being lost; critical habitat is virtually dry, with subsurface flow blocks upstream and downstream movement to overwintering habitat

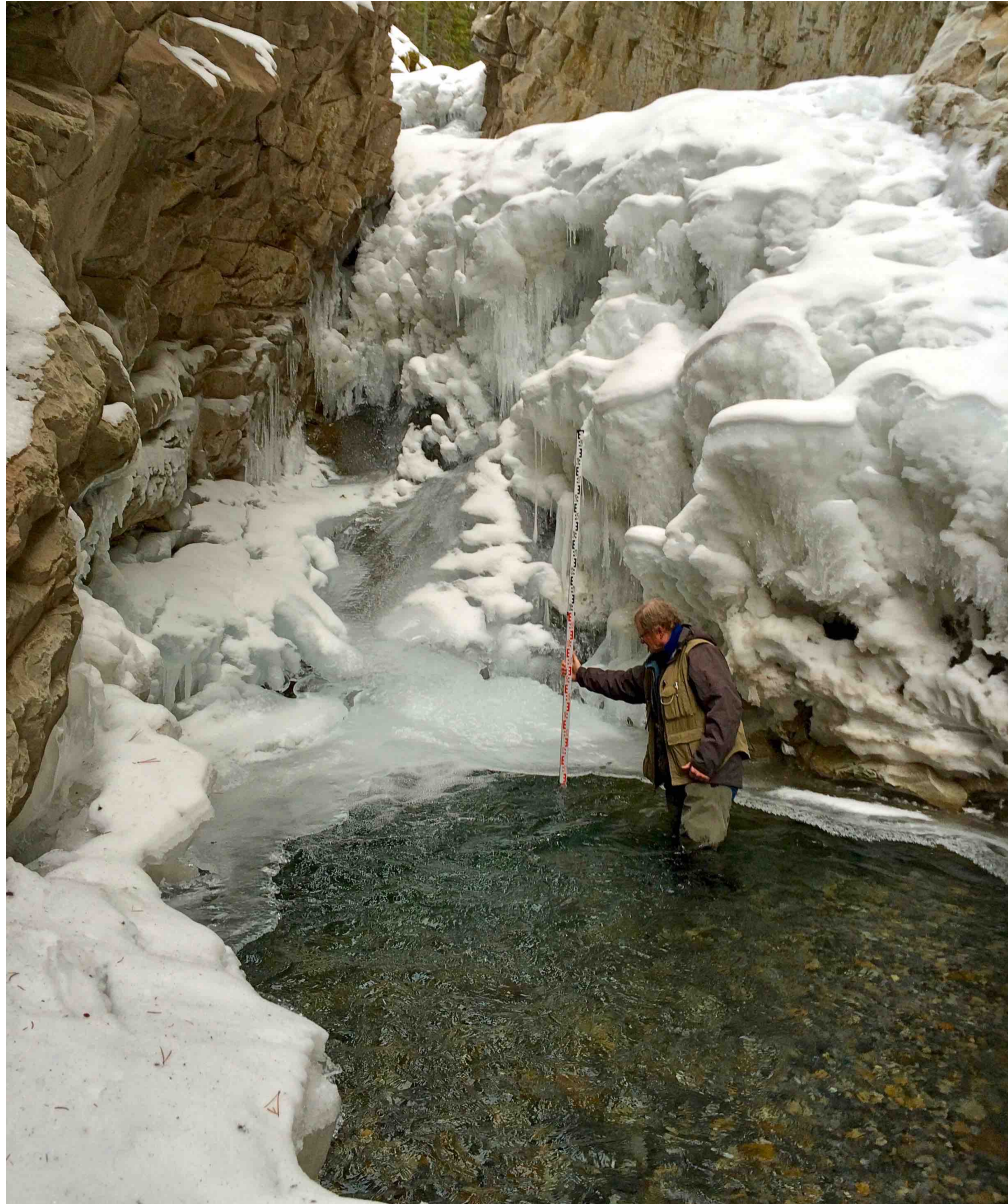
## ***Evan-Thomas Creek***

13 January 2015: This plunge pool below the barrier falls is at the upstream end of the SARA-designated critical habitat. It was used by nearly half of the native cutthroat trout population for overwintering in 2010-2011 (Gifford 2011). At that time it was much deeper and more capacious. After the flood of 2013, the pool was largely filled in by gravel and cobbles: note the large deposit of gravel in the foreground. Underwater video in the plunge pool on this date found only a single trout, which could not be identified to species. We have found no cutthroat trout in this stream since October 2013 (Table 1).

I believe this population likely has gone extinct. Immediate steps are needed to determine if there are any remnants of this small stock. If it is shown that some fish still survive, immediate work is required to salvage what remains, and to restore the population to a viable size.

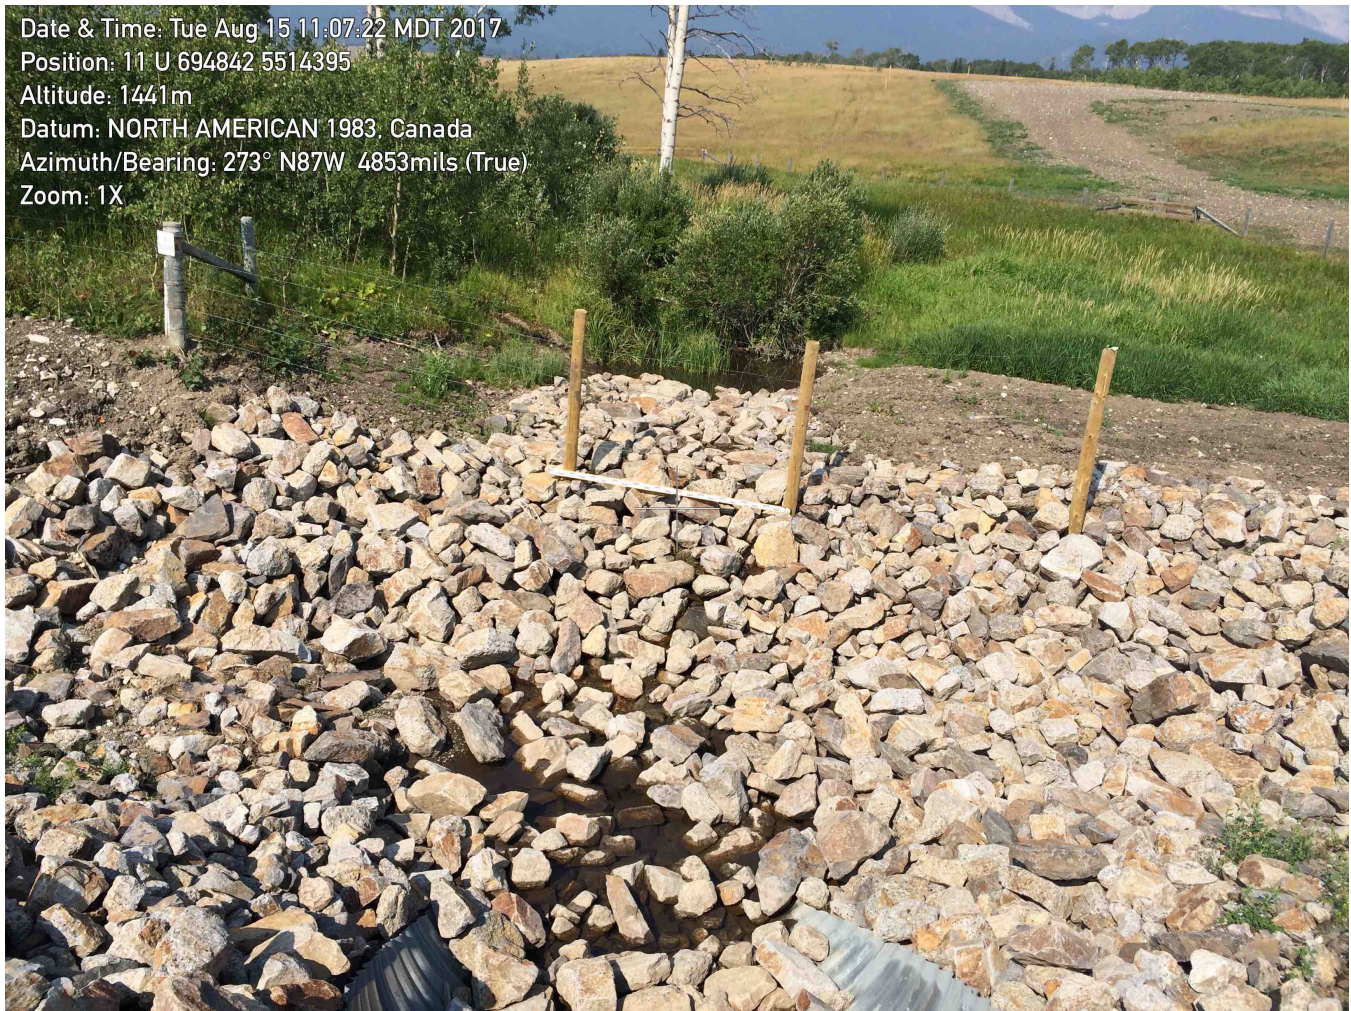
## ***South Todd Creek tributary***

This tributary to South Todd Creek designated critical habitat is blocked by a badly-designed culvert replacement. The tributary is now impassable to trout from upstream (background). Unless this is rectified before freeze-up, trout above the barrier will be unable to reach overwintering habitat in the South Todd Creek mainstem (behind the photographer), and could perish. The tributary will be unusable as habitat for the listed population in the mainstem. Designation of the tributary as critical habitat awaits a legally-required action plan, now more that two years overdue, from Canada's Minister of Fisheries, Oceans and the Coast Guard.

Free movement of westslope cutthroat trout is blocked by a faulty culvert replacement. At present flows and less, fish are unable to reach overwintering habitat, or to access spawning habitat next spring. This problem must be rectified prior to freeze-up of fall 2017, or part of the South Todd Creek population could be lost, and the only identified spawning location could be isolated from the remaining population.

I believe that this construction blockage constitutes destruction of a part of critical habitat, which is illegal under section 58(1) of Canada's Species At Risk Act. Free movement of trout through the culvert, coupled with erosion protection, need to be restored before freeze-up in fall 2017 to permit trout to move to safe overwintering habitat, and to allow passage in the spring to the only identified spawning site above the road.

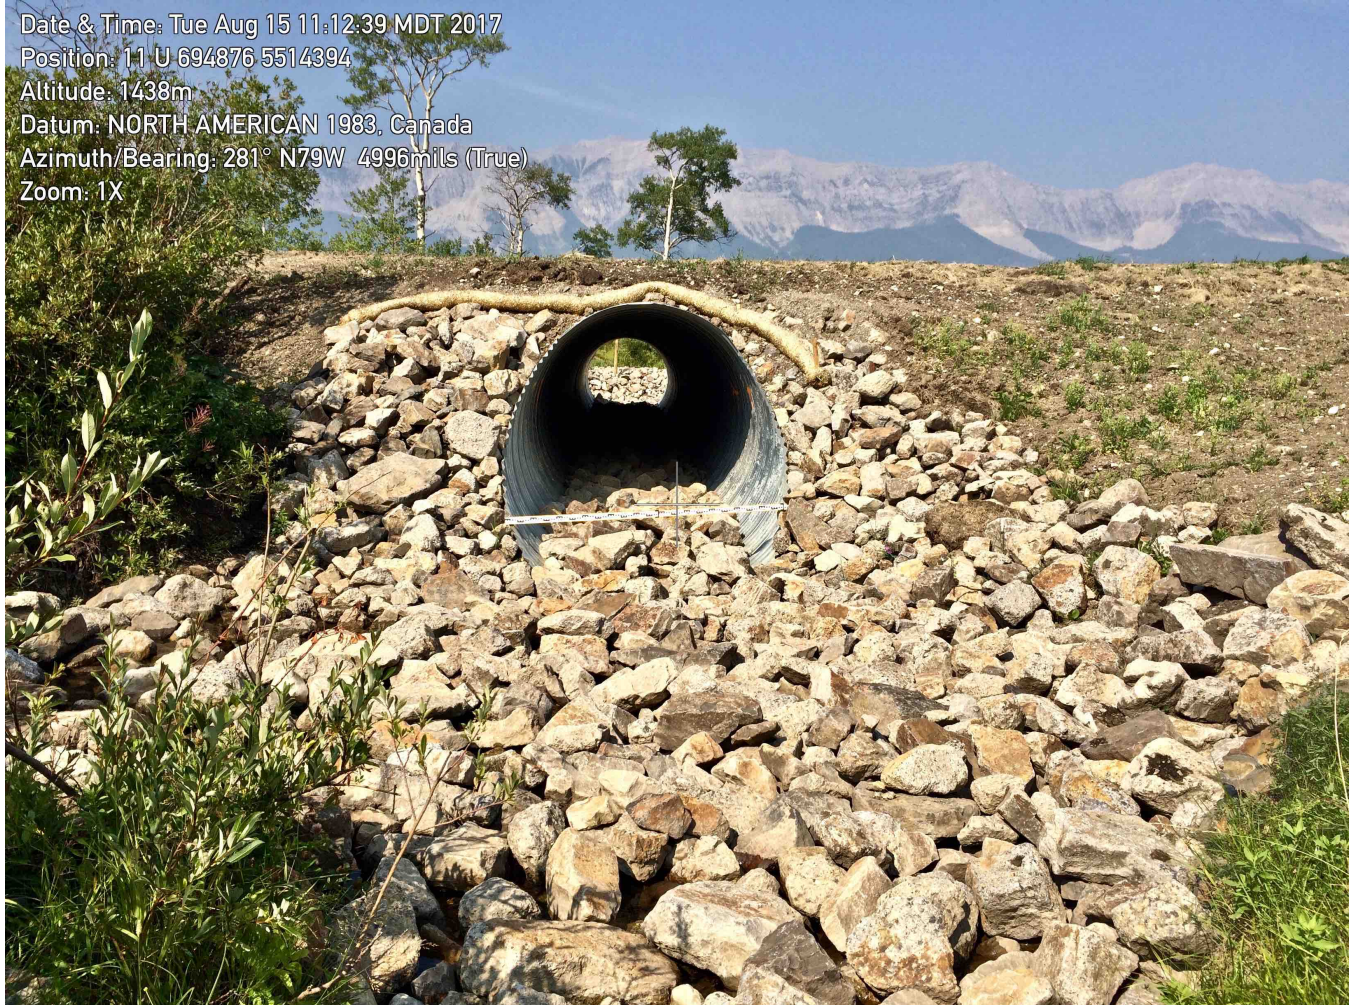
This is the same culvert on South Todd Creek tributary as in the previous photograph, but looking into the outlet from the downstream side. The culvert is impassable to trout at present flows.

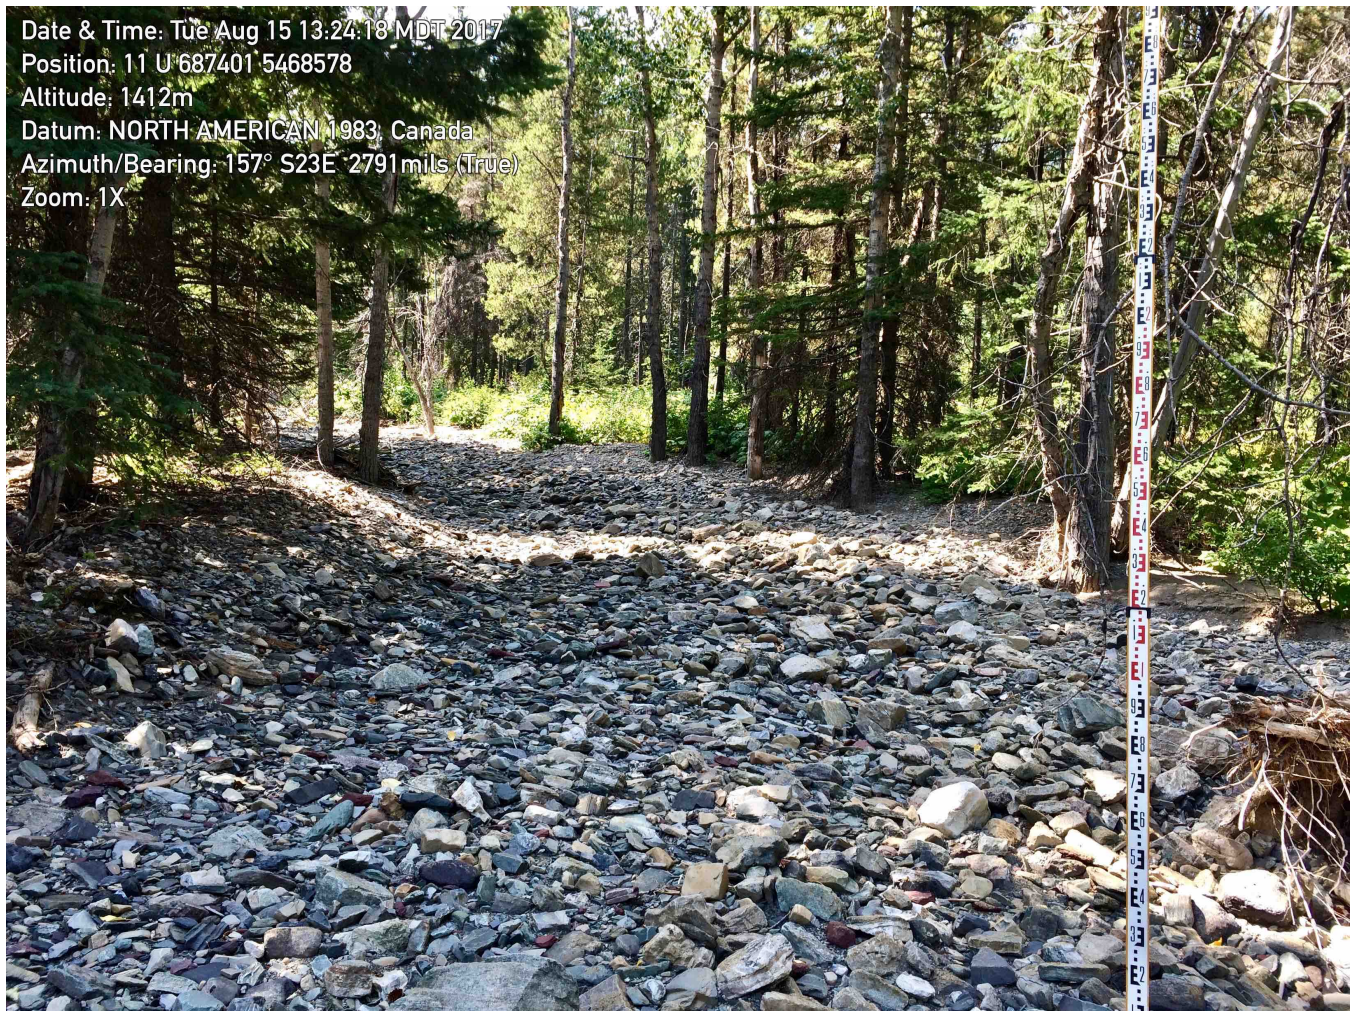
## **Syncline Brook**

This photograph was taken looking upstream into the critical habitat reach from the lower boundary of the reach at 11U 0687325E 5468464N. The camera GPS reading may be incorrect as it had not had time to stabilize. The reach is dry and unavailable as surface habitat, although it may still support small trout deeper in the hyporheic zone.

This population has high demonstrated value for restoration and recovery, but is at continuing very high risk of extinction due to its small size and unusually challenging habitat. Steps need to be taken as soon as possible to salvage and redistribute the genetic resources represented by the Syncline Brook stock before they are lost completely.

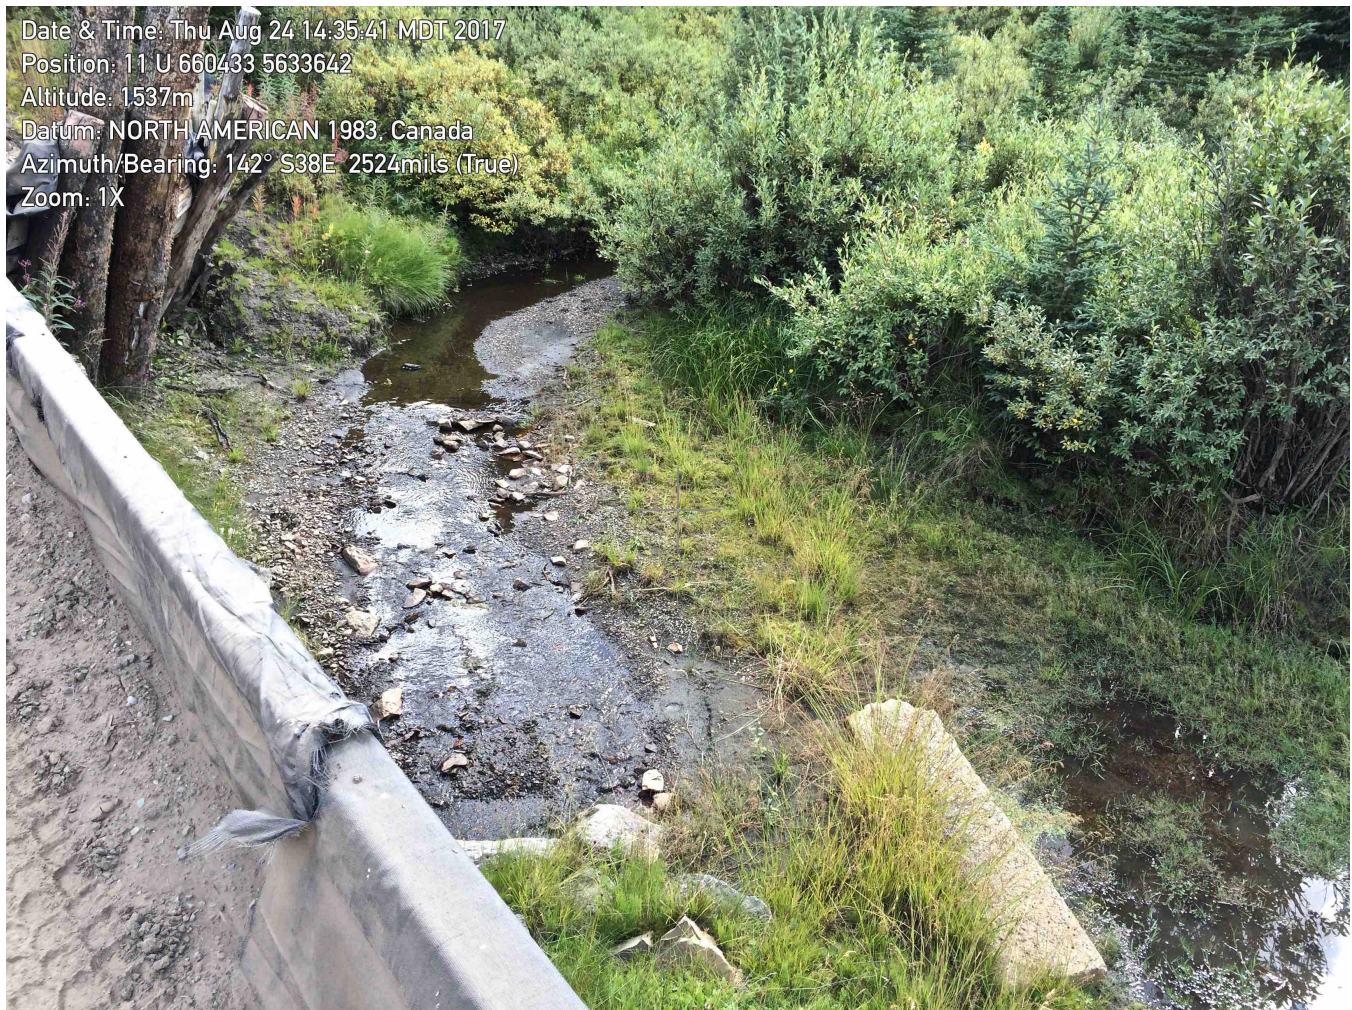
## ***Silvester Creek***

Flow conditions are very low in upper Silvester Creek (24 August 2017), and are likely to continue to decline in the face of projected lower than normal rainfall and higher than normal temperatures for August through October (Environment Canada 2017). This site is more than 250 m above the upper boundary of designated critical habitat, but several hundred metres downstream from a site at which I observed cutthroats preparing to spawn in June. The upper reaches of the creek therefore are *de facto* critical habitat for this population. The upper reaches need to be afforded protection of critical habitat designation, which I have been assured will occur once the long overdue action plan is released. In the meantime they are unprotected under SARA. Silty runoff from this bridge and its road approaches continue to contaminate the creek at this point. The installed silt fences are inadequately maintained and ineffective. Enforcement is non-existent.

All of these issues are likely to lead to a reduction in population size, rendering the population at greater risk of extinction. Immediate action is needed to locate those parts of the population at most risk and salvage them, minimizing the likely effects of lost critical habitat by at least temporarily moving a small part of the population to secure habitat elsewhere. The trail system needs to be disconnected from the stream network or reclaimed entirely, and further development in this watershed (e.g., logging) needs to be disallowed until the security of this stock can be assured.

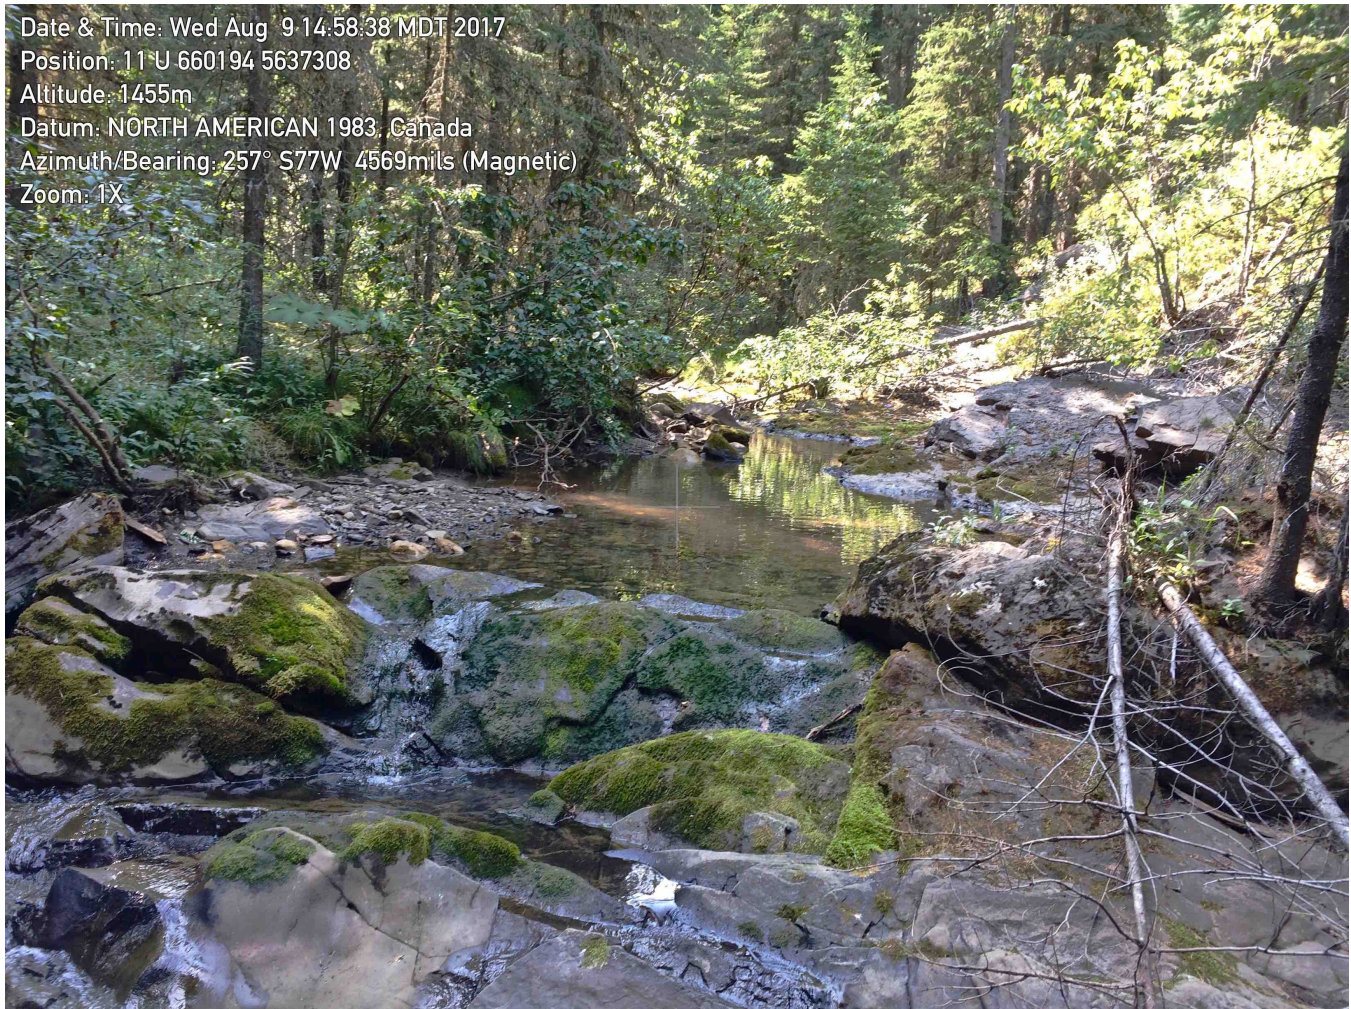
Silvester Creek SARA-designated critical habitat for threatened Alberta native westslope cutthroat trout nears surface zero-flow conditions in early August 2017. At normal flows, water spills over the entire sill in the foreground; now the sill is barely wetted. Flows are likely to continue to decline for reasons described above. Trout may become isolated in stagnant reaches and be trapped in waters that are too warm for them, resulting in mortalities, or they may be unable to seek suitable overwintering sites in late fall due to being isolated in the disconnected stagnant pools separated by lengths of dry streambed. An emergency rescue plan is needed.

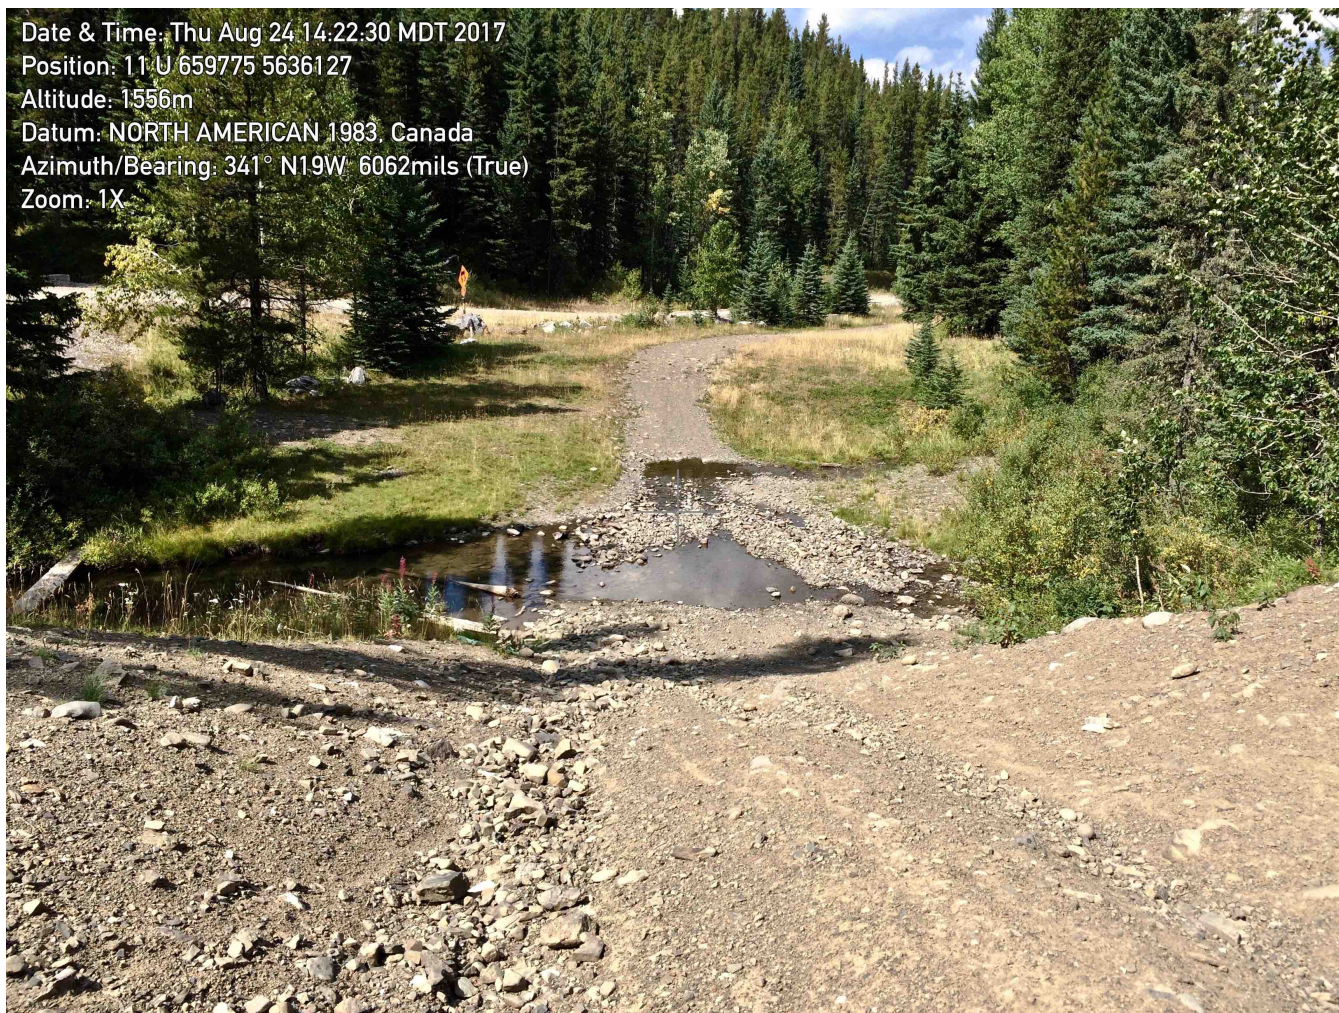
This tributary of Silvester Creek provides overwintering habitat for substantial numbers of large cutthroats from Silvester Creek (Paul and Dormer 2005). If flows continue to decline as expected, this location could dry and become a barrier to upstream movement. Waters downstream would also become unsuitable overwinter habitat. A contingency plan is needed to ensure that adequate overwinter habitat is available through the 2017-2018 winter season, or to provide for rescue of some part of the population.

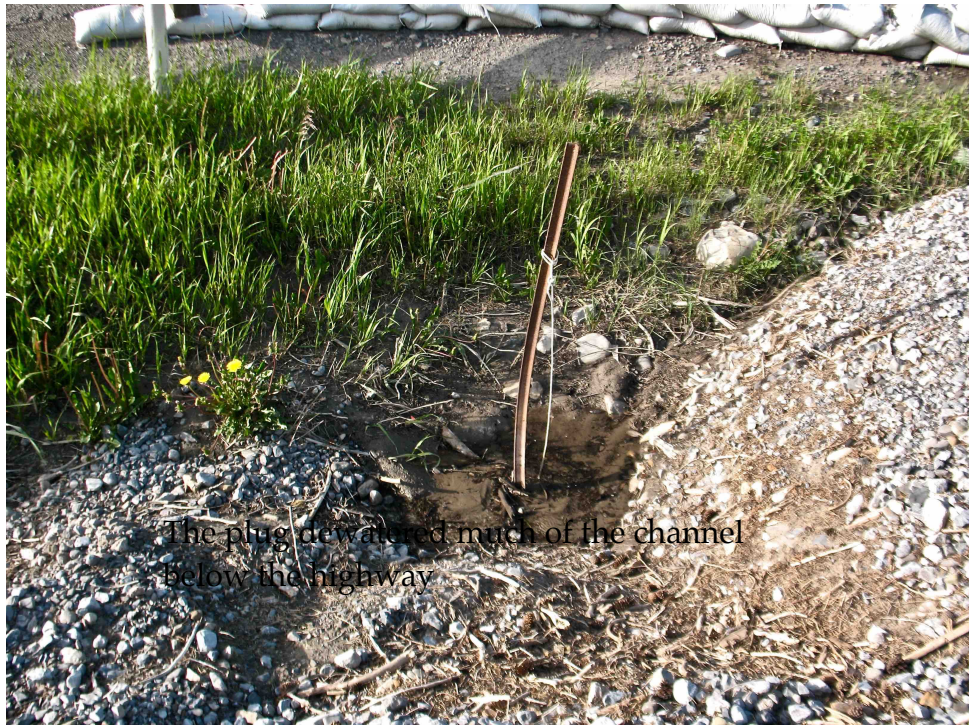
## ***Girardi Creek***

On 25 June 2017 the Highway 3 culvert was plugged with gravel, being completely buried on the entrance side, and almost completely full of gravel on the downstream side. The upstream side showed many recent OHV tracks crossing the creek. Girardi Creek had been diverted down the south ditch of Highway 3 eastward toward the Crowsnest River about 350 m distant. The diverted creek was eroding and headcutting a channel into the ditch. About halfway to the river, the creek had left the ditch and had spread thinly over an abandoned piece of the old highway, entered its south ditch, then apparently spilled over a high, steep bank into the river. The entire reach was impassable to trout.

25 June 2017: The angle iron post (top photo) marks the buried inlet of an undersized culvert intended to pass Girardi Creek under the Crowsnest highway (Highway 3). The entire culvert was plugged with gravel on this date, and appeared to have been for some time, perhaps days, based on the degree of erosion of the overflow channel. The plug dewatered much of the channel below the highway (bottom photo), while Girardi Creek was diverted down the highway ditch. (next page).

In my opinion these repairs recently made to Girardi Creek critical habitat at the Highway 3 crossing are temporary, and do not solve the underlying problem at this site. The culvert is not large enough to pass the creek and its heavy load of gravel-sized sediment. This culvert will continue to plug up with gravel intermittently, with the results just described. It needs to be replaced by a bridge of sufficient span to pass the creek and its load of gravel downstream. In the meantime, every time the culvert plugs, some part of critical habitat will be destroyed, contrary to section 58(1) of the Species At Risk Act.

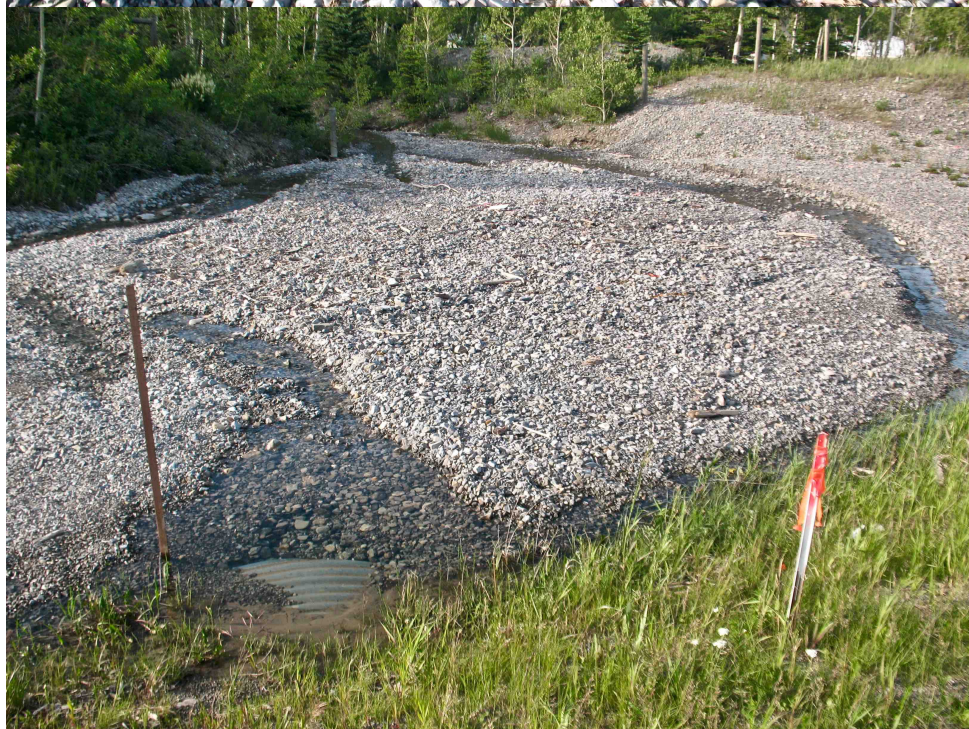
The flow of what was left of Girardi Creek downstream from the highway was much attenuated relative to the flow above the highway. The habitat below the highway was very shallow and divided into several channels, rejoining at the fence line.

The plug dewatered much of the channel below the highway

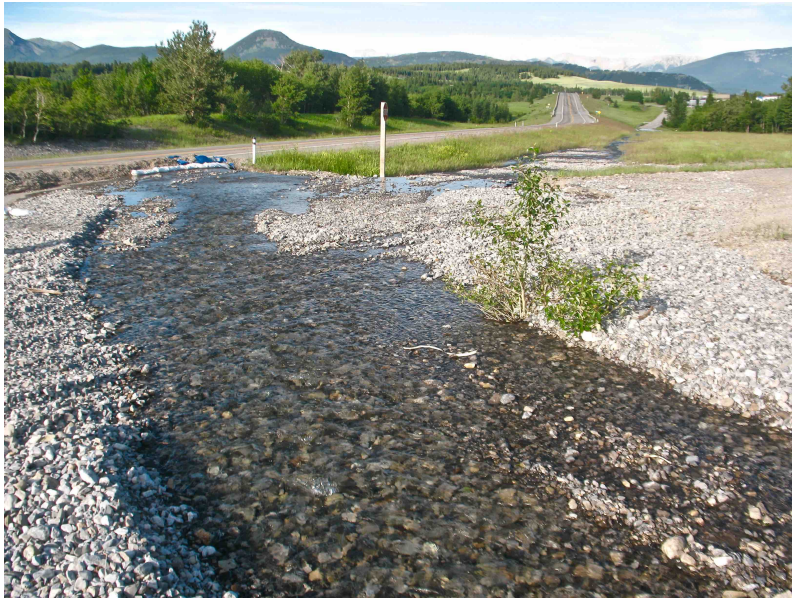
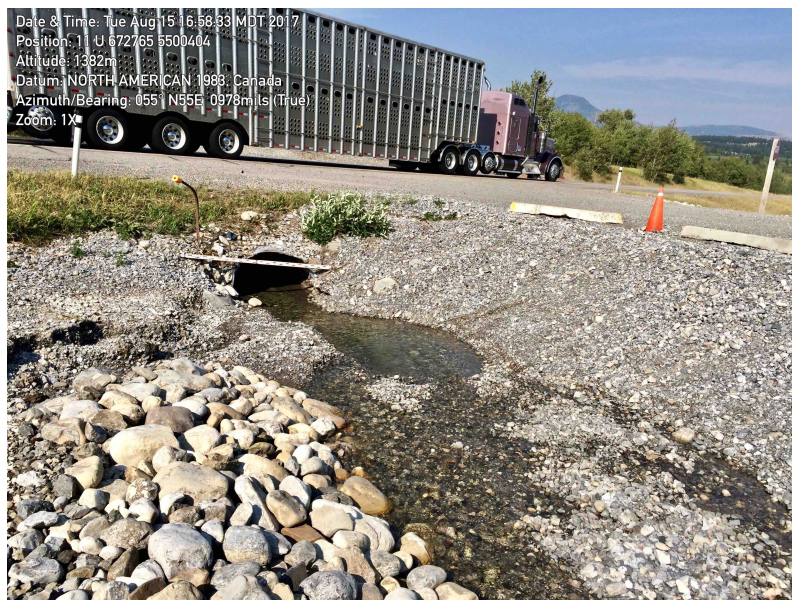
On 15 August 2017, the Highway 3 culvert on Girardi Creek had been cleaned of much of the gravel, the entrance being 60-70% open. Girardi Creek had been placed back in its channel. The gravel on the upstream side had been pulled back out of the channel onto the banks, and some small concrete curbs had been placed across the place OHVs had used to ford the creek. I saw no evidence of OHVs crossing recently. New cobbles and boulders had been placed along the left bank above the culvert, apparently in an attempt to contain the stream within a single, deeper channel. The channel below the culvert had likewise been reshaped to make it deeper, by drawing gravel out of the channel and onto the banks. Flow below the culvert had been restored.

25 June 2017: Girardi Creek is diverted eastward down the Highway 3 ditch (top photo), eroding a new channel and eventually spreading over an abandoned piece of highway (cover photo). This event destroyed a part of critical habitat and appears to be a clear violation of section 58(1) of the Species At Risk Act.

By 15 August 2017, the culvert had been unplugged and much of the channel damage had been repaired (bottom photo), but it is evident that this culvert will continue to plug up and destroy critical habitat again. This site poses complicated problems in that it requires a fix that passes water and a high sediment load under the highway, but that sediment could quickly fill in the channel below a barrier downstream, making it passable. That barrier is probably the reason that the cutthroat population in this creek shows no sign of introgression with rainbow trout, common in the Crowsnest River. Work by a good fluvial geomorphologist is required on this problem very soon before serious damage is done to the population.

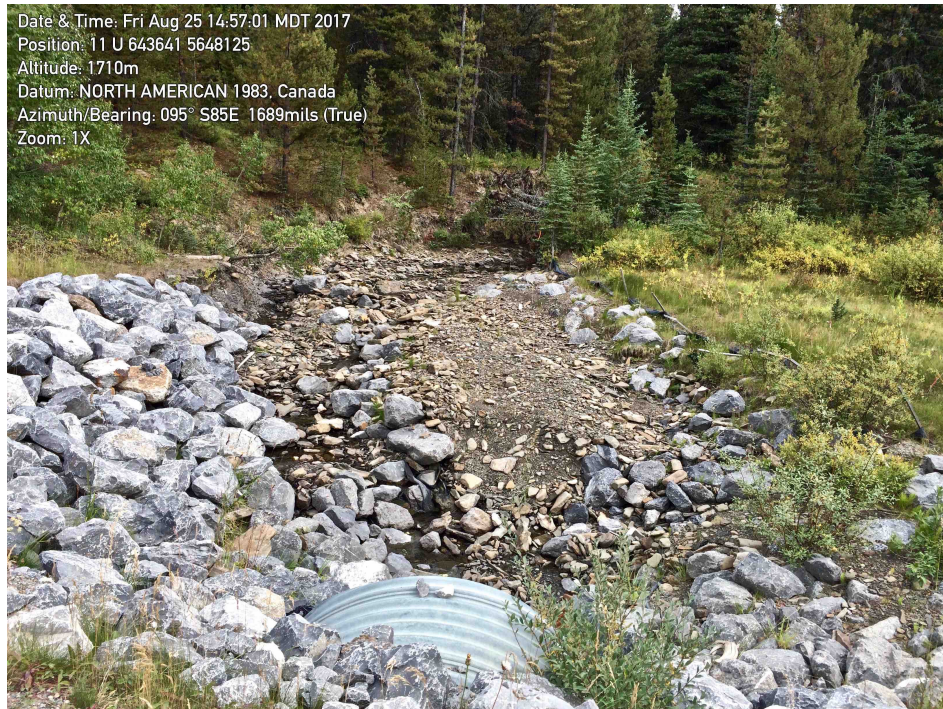
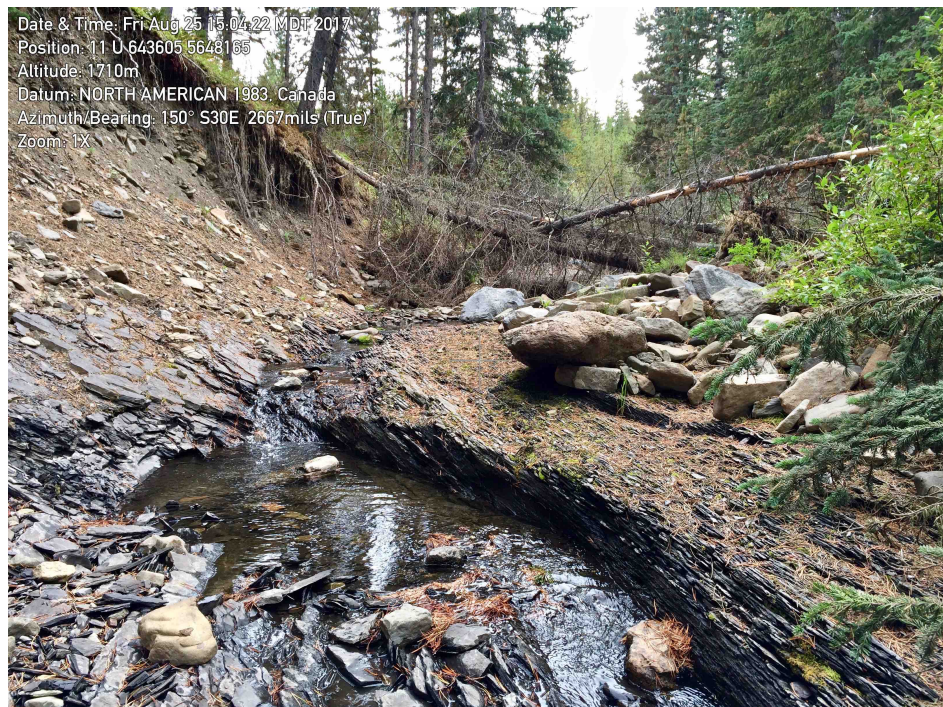
## ***Jumpingpound Creek tributary***

This small tributary was once a narrow channel. It was severely eroded and reshaped by the June 2013 flood. On 25 August 2017 it had very low flow which went subgravel for a short distance above the Powderface Trail, blocking fish movements past that point (top photo). Below the road, what exists of the flow spills thinly down sloped bedrock, forming another difficult impediment to fish movements (bottom photo). Flow is likely to continue to decrease through October. If a populations still exists in this creek it needs to be located and rescued.

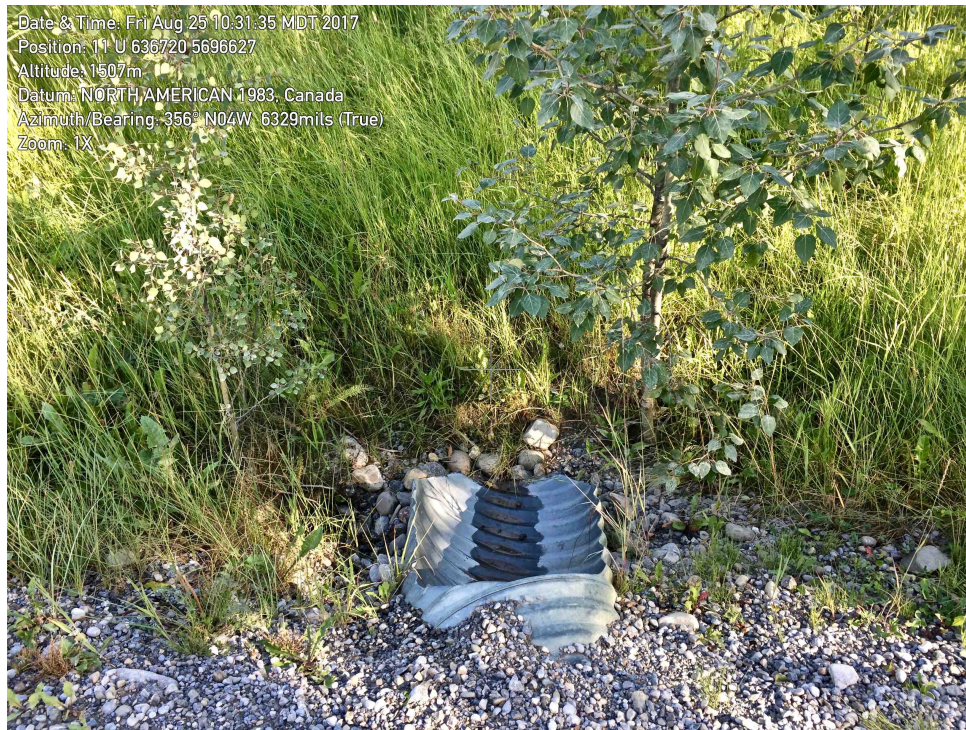
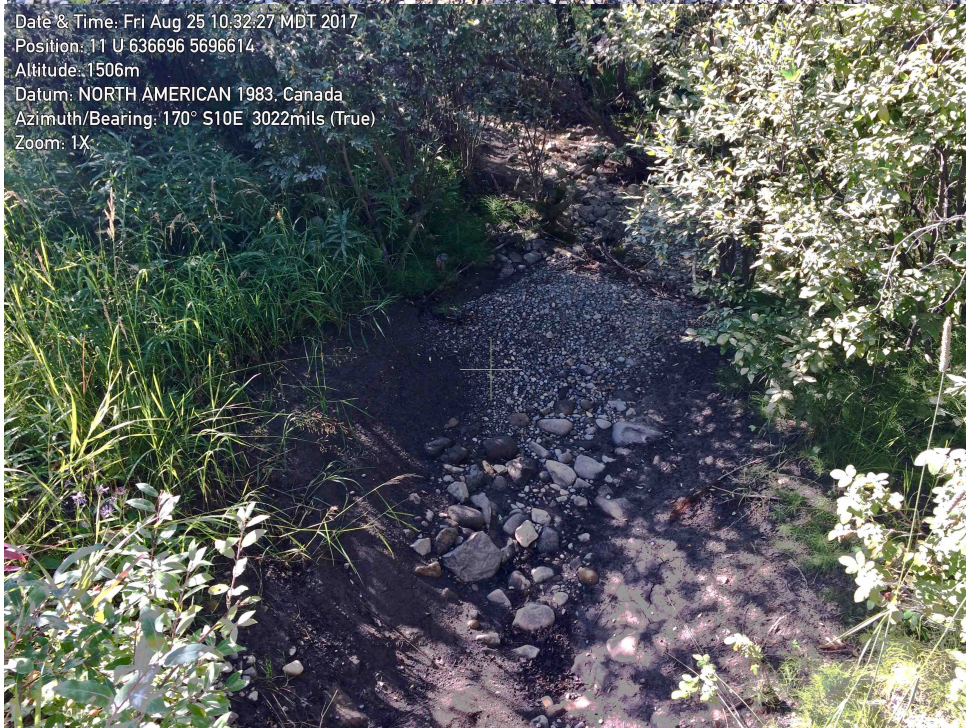
## **Mockingbird Creek**

Both channels of Mockingbird Creek were dry at the Waiparous Road culverts on 25 August 2017 (top and bottom photos). In the headwaters the channel had a puddle on a cutline that drained as a trickle beneath a small pile of sticks (next page). An immediate search of this stream needs to be made to discover and, if necessary, rescue any cutthroat trout that may be surviving in isolated wet habitat.

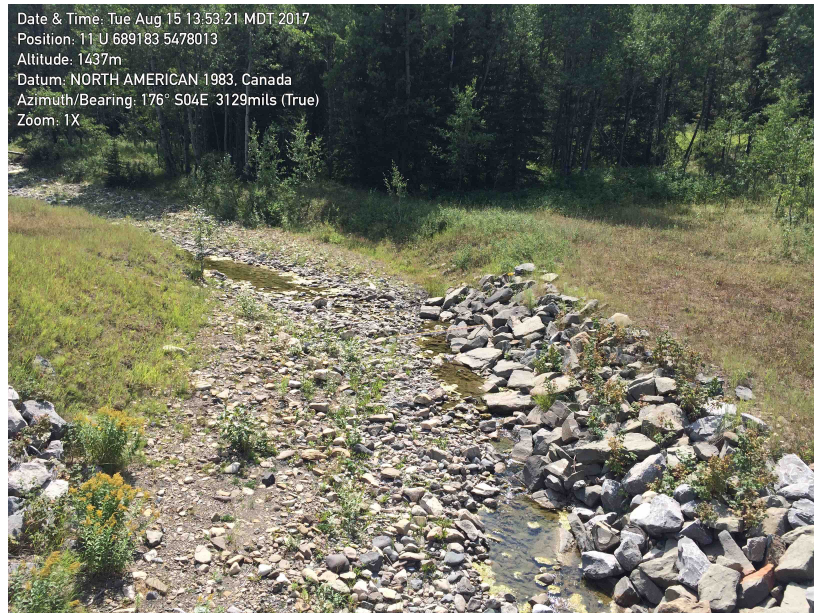
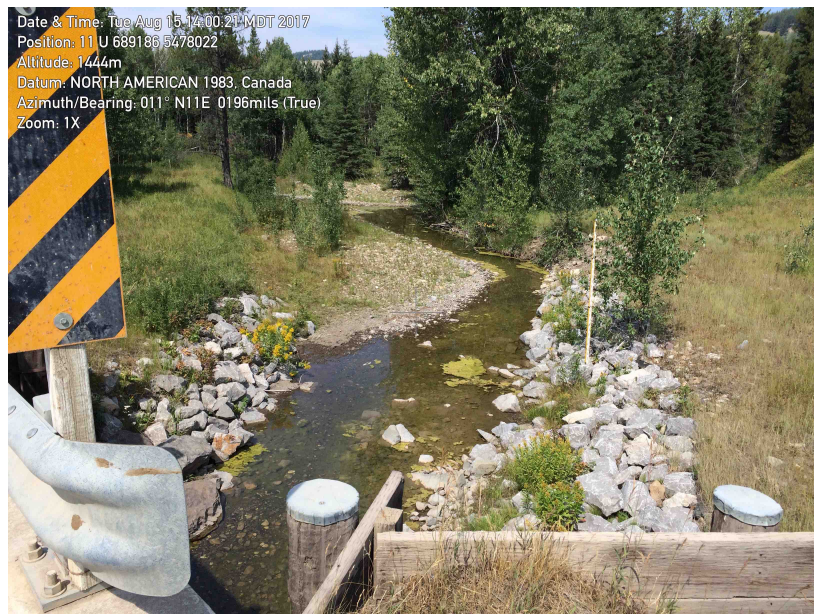
## O'Haggen Creek

On 15 August 2017, O'Haggen Creek above the road crossing was barely flowing. At the first corner above the bridge, it was nearly sub-gravel, making movement past that location nearly impossible. Below the bridge the creek looked more substantial, but was really a near-stagnant elongated pond with a prominent growth of filamentous green algae. We can expect flows to decrease due to continuing abnormally low precipitation, while temperatures are likely to increase (Environment Canada 2017), putting the trout population at additional risk, especially of thermal stress.
