Trails, Sediment, and Aquatic Habitat:

McLean Creek

By Logan Boyer

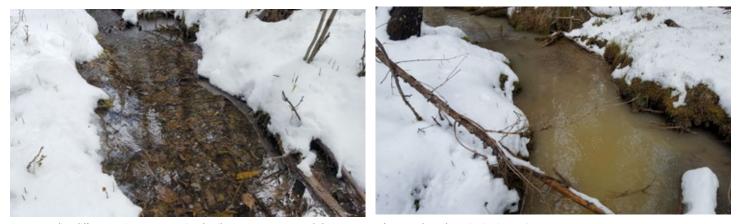
Water quality differences in a McLean Creek tributary upstream and downstream of a gravel road. PHOTO: © L. BOYER

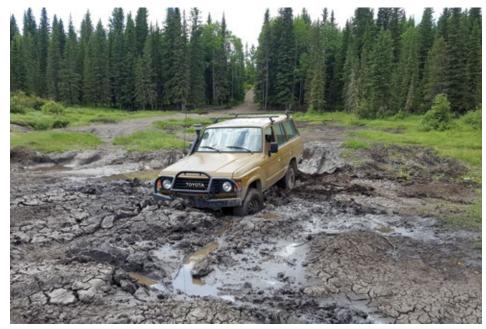
Trucks and OHV's frequent McLean headwaters for mudding PHOTO: © L. BOYER

Throughout the early months of sampling McLean Creek ran with a colour akin to a creamy coffee, as snowmelt and rainfall eroded the various dirt trails. We observed significant increases in TSS during precipitation events, with an average threefold increase of TSS concentrations downstream of sampled sediment sources. A striking example of sediment delivery was at a trail crossing near the headwaters of McLean Creek, where I could observe crystal clear waters meeting muddy trail runoff, increasing the TSS concentrations a hundredfold. The clear, unaffected waters only flowed for a quarter-kilometre, with the entirety of the creek downstream looking an opaque brown. This crossing is also a popular spot for mudding, as I witnessed multiple vehicles stuck in the mud there. This further exacerbates the sediment loading problem.
