Native Trout Critical Habitat Trip

By Phillip Meintzer, *AWA Conservation Specialist*

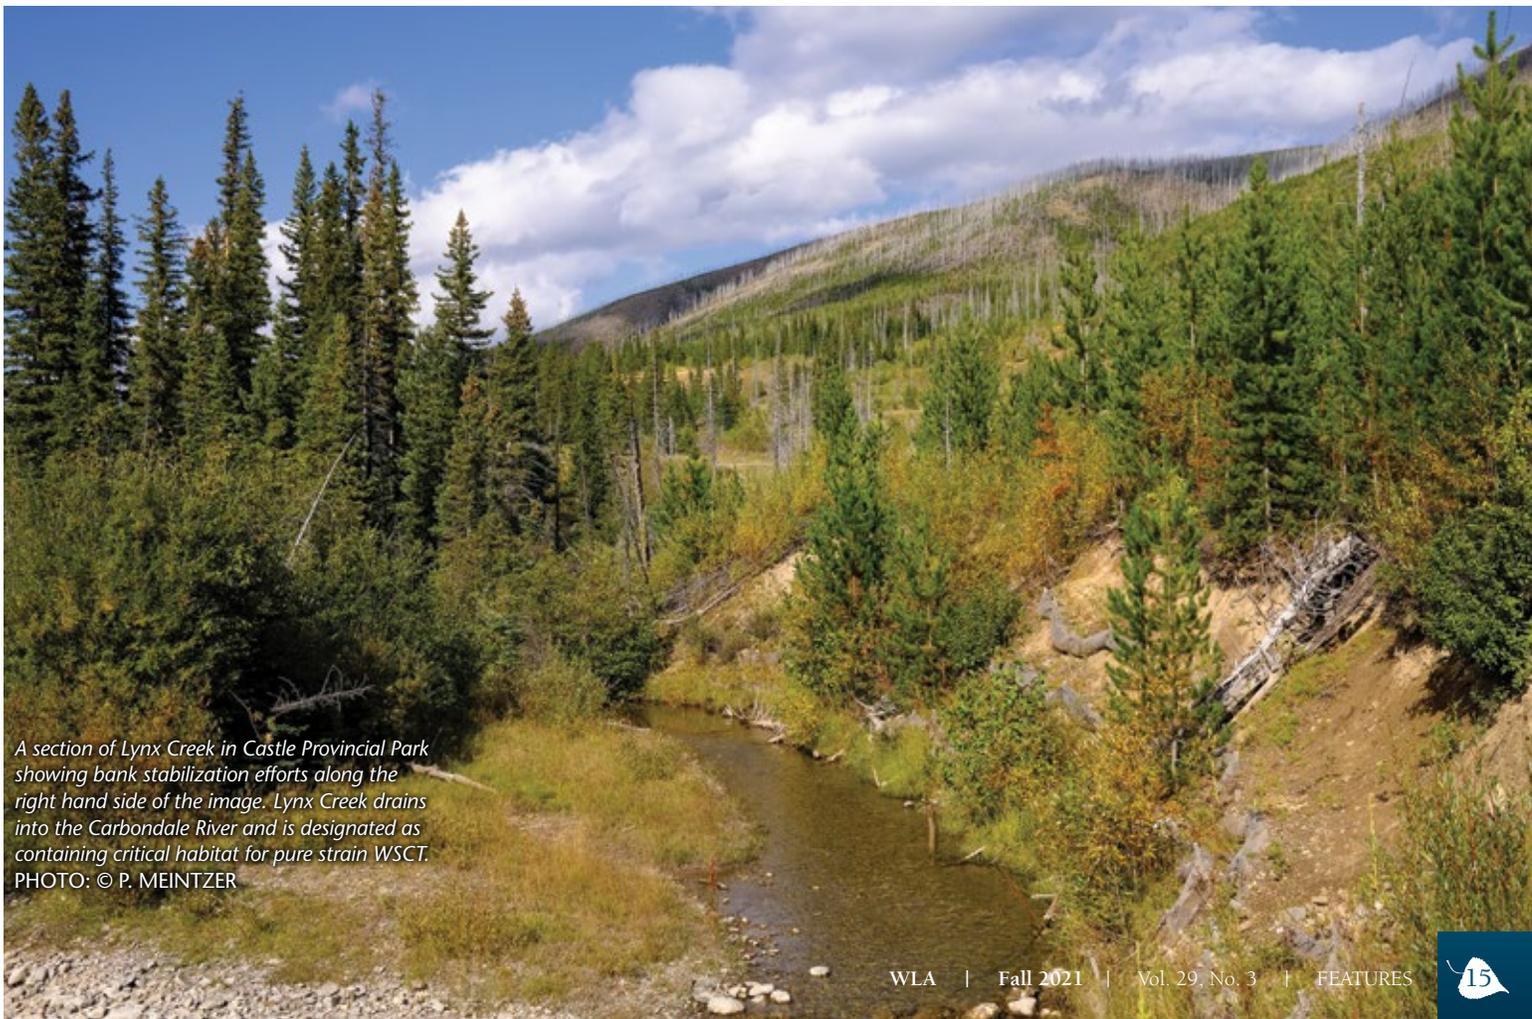
A section of Lynx Creek in Castle Provincial Park showing bank stabilization efforts along the right hand side of the image. Lynx Creek drains into the Carbondale River and is designated as containing critical habitat for pure strain WSCT.
PHOTO: © P. MEINTZER

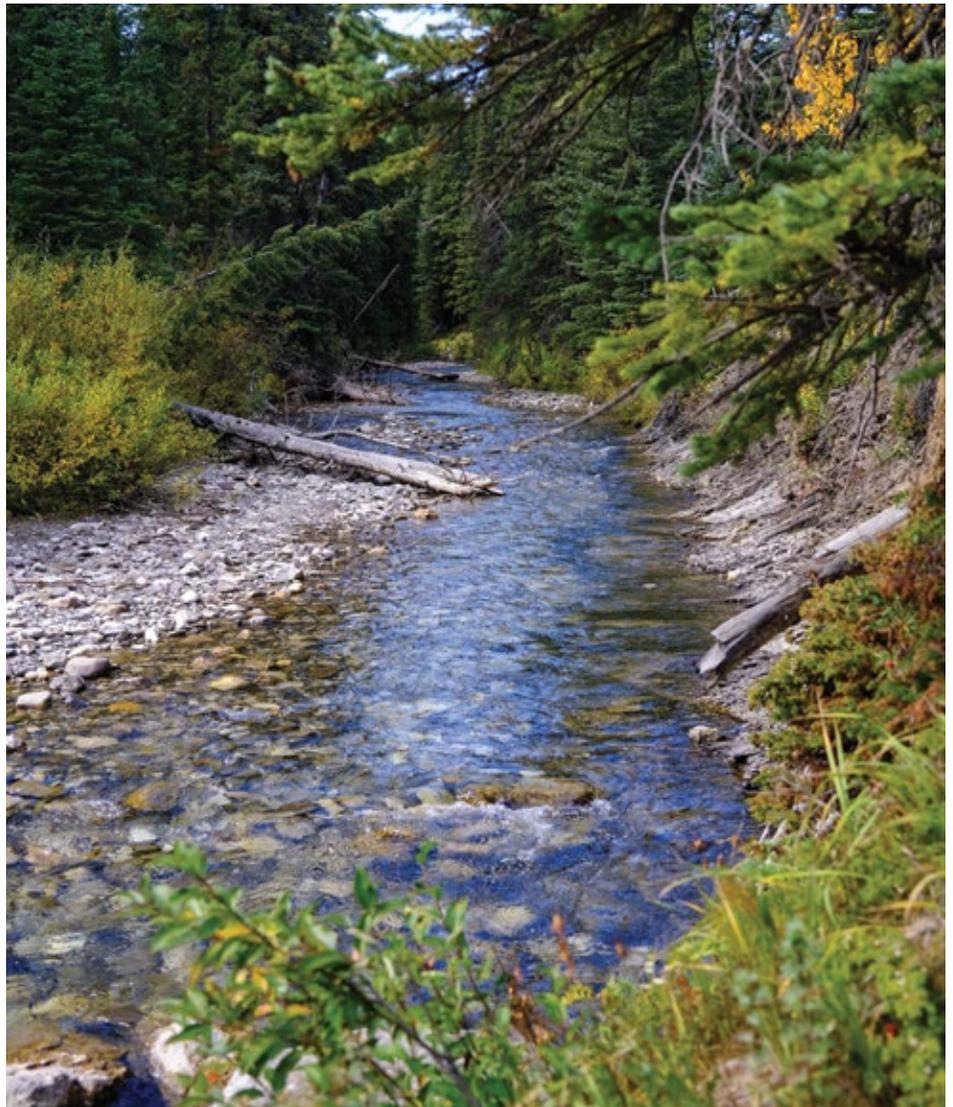
One of many tributaries containing WSCT critical habitat along the Atlas Road which passes west of Crowsnest Mountain connecting Coleman to Highway 40. The Atlas road is primarily used for logging and offroad vehicles and crosses numerous creeks along its length. PHOTO: © P. MEINTZER
