Wilderness Watch

Restoration Efforts at Apetowun Creek

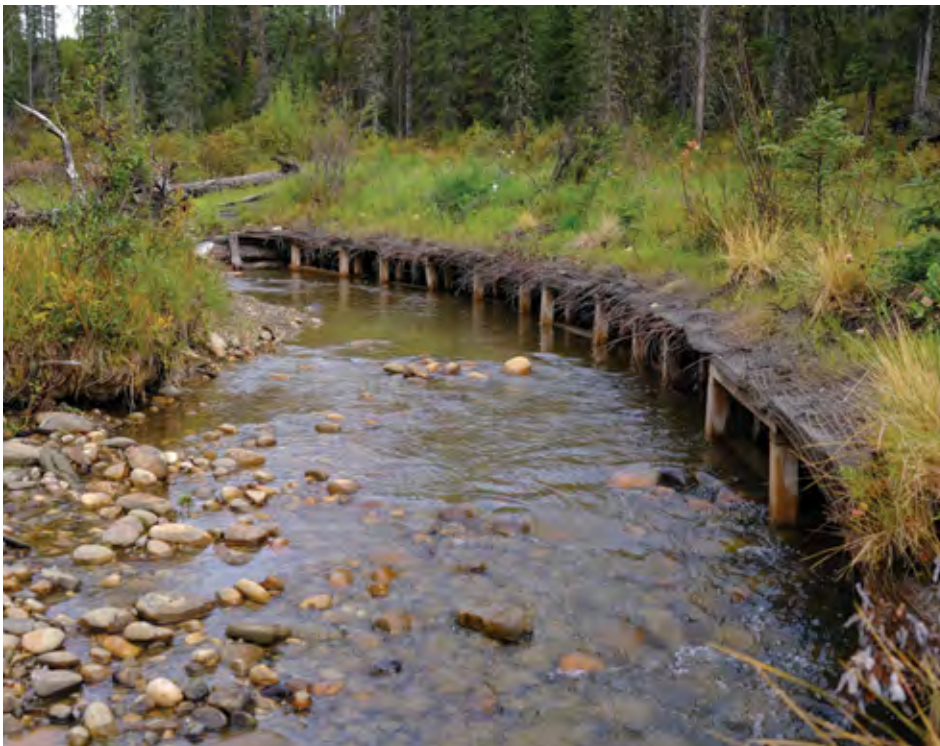
During AWA's site visit in September 2021, we were given a tour of the reconstruction efforts at various sections of Apetowun Creek that had been washed out by the coal mine spill, including the creation of artificial stream banks (pictured). Reconstruction efforts are now complete. Photo © P. Meintzer
