Fifteen Years of OHV Damage in the Bighorn Backcountry

By Sean Nichols and Phillip Meintzer

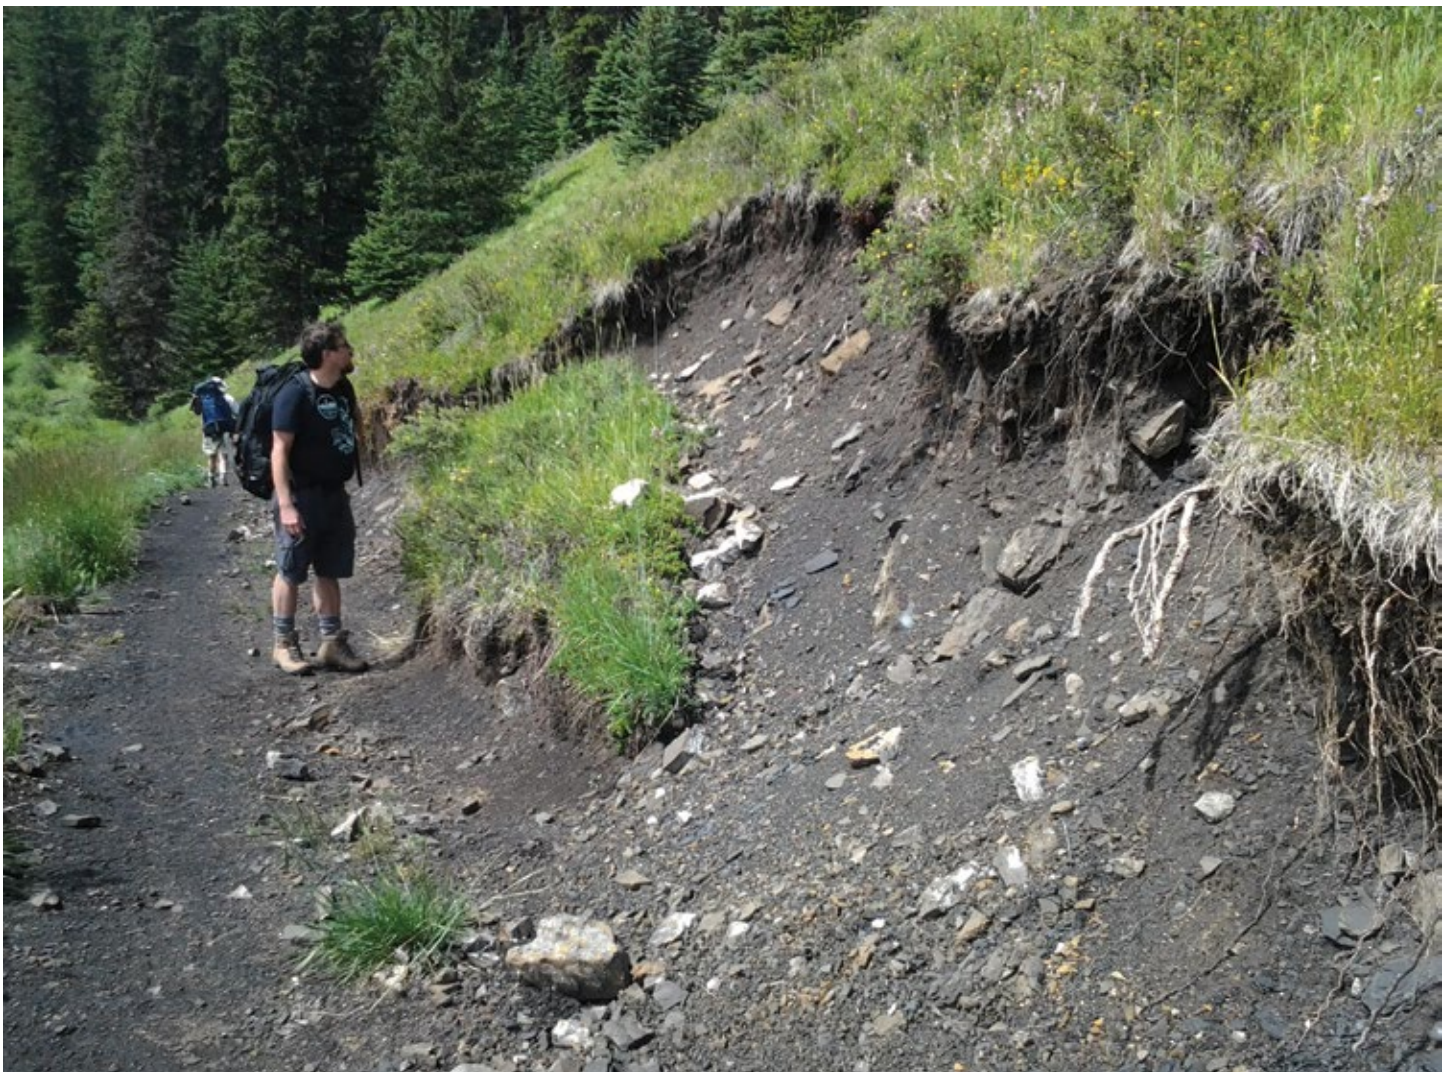
Slumping is a form of trail damage that occurs when a mass of land (i.e., dirt, clay, rocks, mud etc.) slides down a slope. This photo depicts an incident of slumping that was noticed during a trail survey in 2017. Photo © Alberta Wilderness Association.
