Alberta Wilderness Association

BIGHORN BACKCOUNTRY REPORT

OHV use in the Bighorn

Results of the 15 years of research and monitoring of trails in the Bighorn.

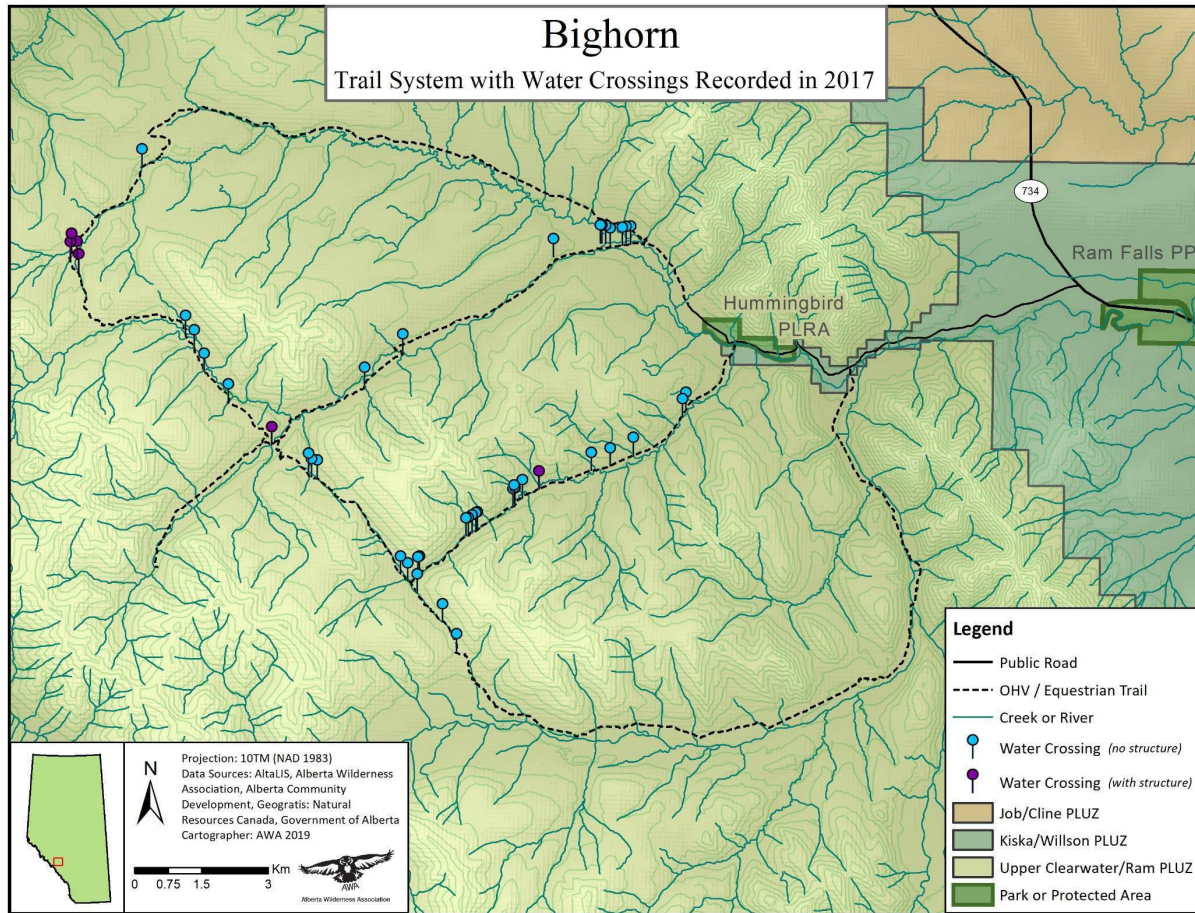
Figure 9

In 2017, 46 water crossings were encountered along the monitored trail system, six of which had formal bridge structures in place. There were nine water crossings on BTN (four of them bridged), three on BTR, five on BTS, 18 along CAN (one bridged) and 11 along HUM (one bridged) (**Figure 9**). With 40.28 kilometres monitored in 2017, this averaged 1.14 water crossings per kilometre of trail monitored. The highest density of water crossings was encountered on CAN (1.82/km) and BTR (1.30/km), followed by HUM (1.01/km), BTS (0.94/km) and BTN (0.75/km).

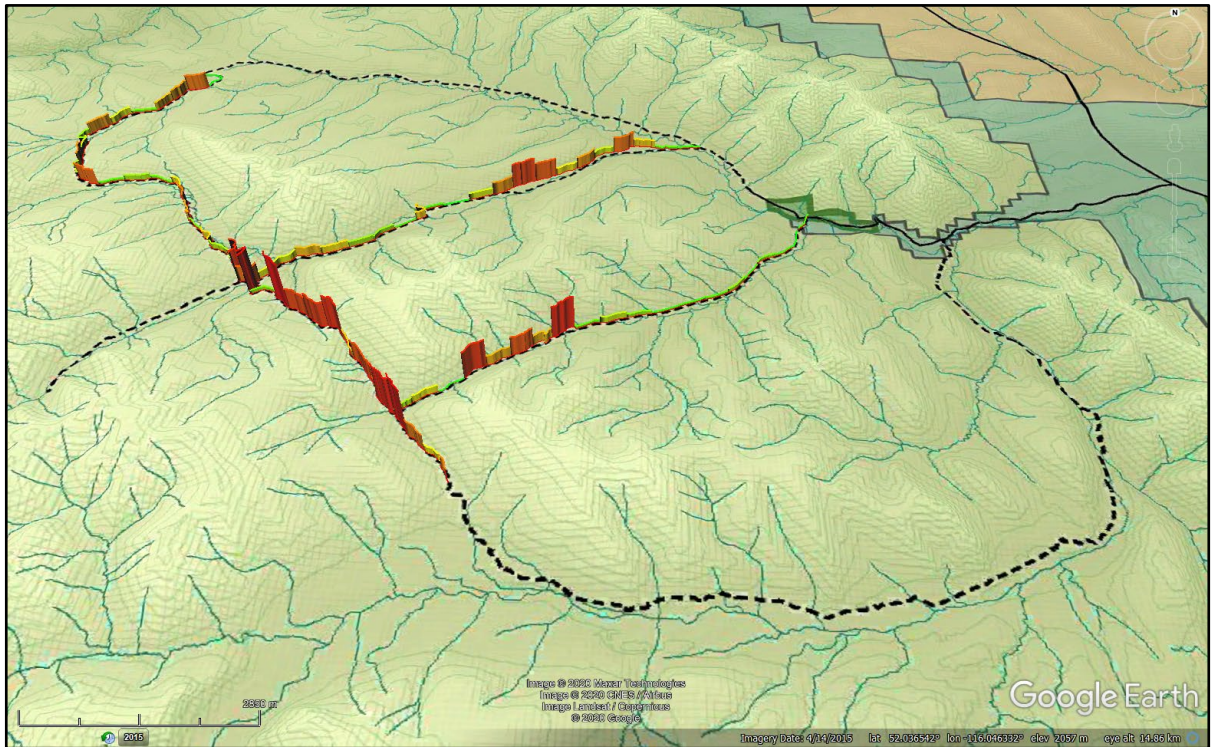
Figure 10

Google Earth was then used to generate a visualization of these average erosion depths for 2016, which we determined to be a representative year (**Figure 10**).

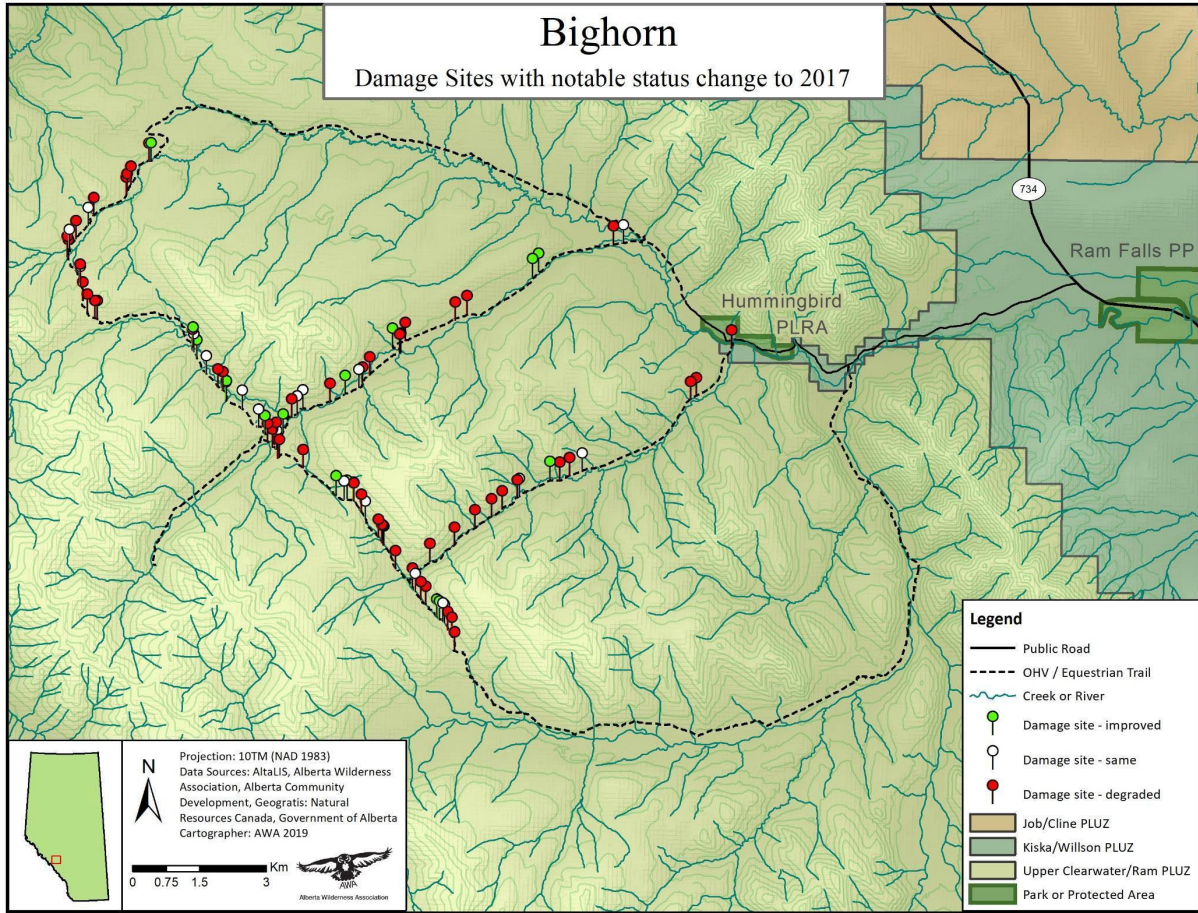
Figure 16

Comparison of the same sites over time indicates that the majority of sites have deteriorated (**Figure 16**). There were 127 matches between observed locations in 2017 and locations from previous years. Of these, 17 sites improved in condition over time (“Better”), 20 were classified as having stayed the same (“Same”), and 58 sites were classified as having deteriorated over time (“Worse”). Thirty-two sites had insufficient information or conflicting results (“No Answer”).

Of the 98 sites where a definitive assessment on site condition could be made, 59 percent of the sites deteriorated over time (“Worse”). Of the sites that were considered “Worse,” eight were located along CAN, six on BTS, 16 on HUM, two on BTR, and 23 on BTN.

The high number of “Worse” sites observed at BTN and HUM suggests that these trails are worth close monitoring in the future. Several patterns emerged upon visual examination. Water crossings with no formal structure, trail segments that contained standing water and/or were located within poorly draining areas, and trails located within soft meadows were more likely to degrade over time. In addition, trails on wet and organic soils that receive high use, contain a low slope alignment angle, or that are in close proximity to water (such as wetlands and floodplains) are more susceptible to erosion processes and surrounding environmental damage. Conversely, many of the sites that improved or remained the same over time tended to be situated on compact, dry soil that had good drainage.

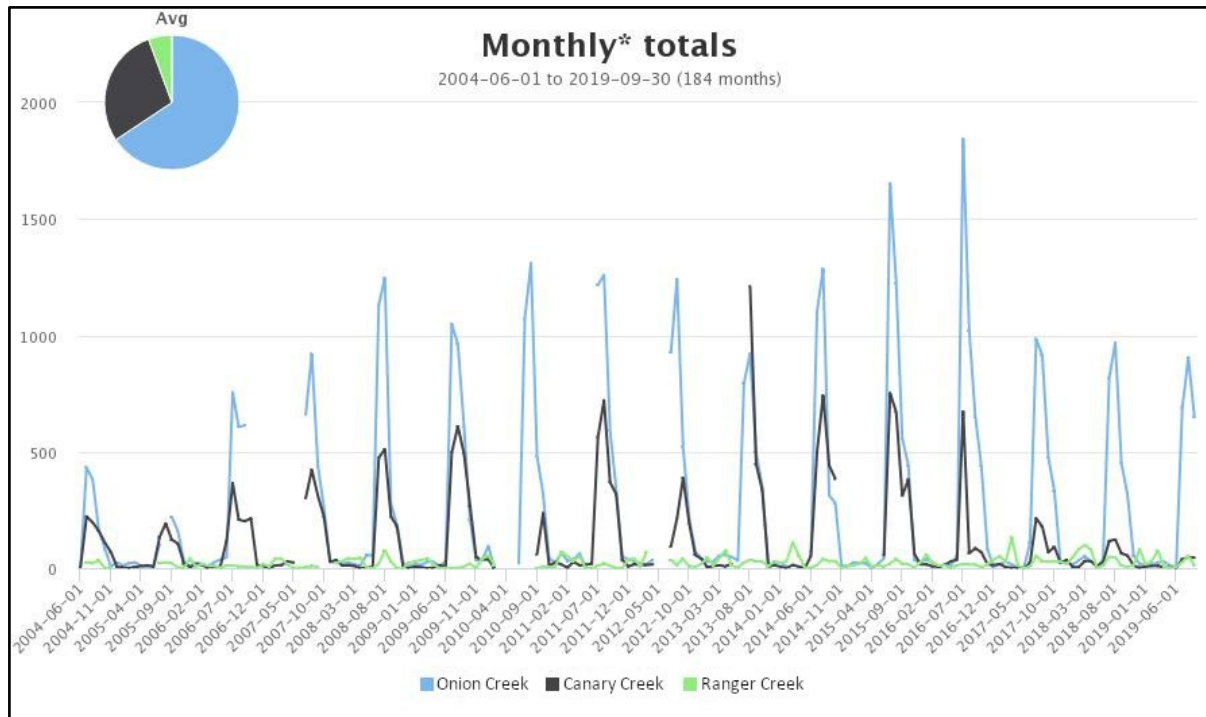
Figure 17

First, motorized use of the Hummingbird trail network continued and has increased significantly over time from when the trail system was first opened until the TRAFx units were withdrawn (**Figure 17**) in 2019.

Second, use has dropped off during periods of heavy rainfall when site conditions made trails impassable and dropped off much more steeply starting in 2017 when CAN was permanently closed to non-winter use (**Figure 17**). This fact confirms that trail closures are an effective measure to address damage caused by inappropriate OHV use.

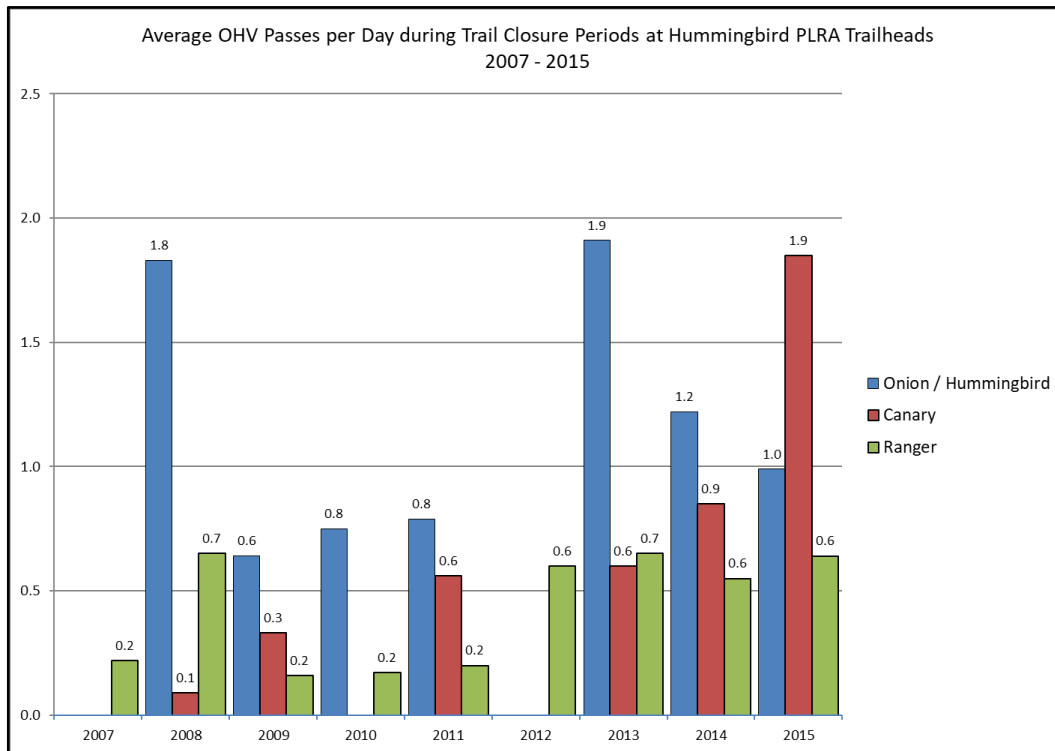
Figure 18

Finally, while traffic during closure periods does decrease, illegal use of the trail network (defined as vehicle passes during closure periods) continues and is significant, especially on the now-closed CAN trail (**Figure 18**). Clearly, trail closures need to be accompanied by active enforcement.
