Trail Rehabilitation in the Castle

By Joanna Skrajny, AWA Conservation Specialist

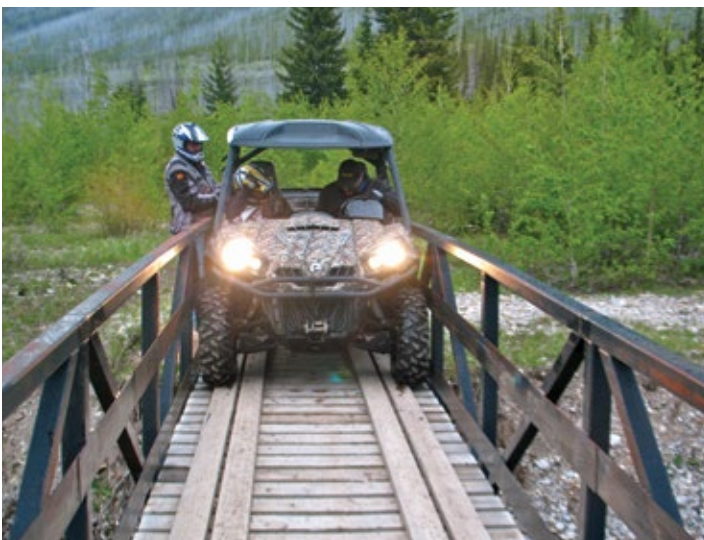
Many ATVs don’t fit ATV bridges. Trying to do right thing, this one got stuck. After backing out, he forded threatened cutthroat trout designated critical habitat during the spawning period when eggs could have been incubating in the gravel at this site. PHOTO: © D. MAYHOOD

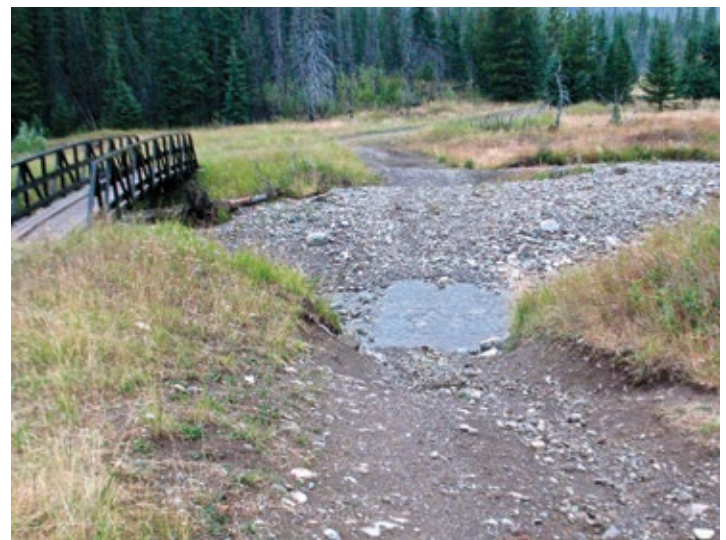
Freshly-used OHV ford over Lynx Creek, within designated westslope cutthroat trout critical habitat, immediately beside a brand new OHV bridge. PHOTO: © D. MAYHOOD

In the Recovery Plan for westslope cutthroat trout (WSCT), for example, “forest harvest, linear disturbance, grazing, OHVs, recreational access, instream construction, municipal runoff” are documented to contribute to sedimentation and therefore adversely affect WSCT habitat. Bridges do not alleviate erosion and do not prevent damage to native fish from the sediment that the trails themselves deliver to streams. Although bridges may reduce sediment delivery at ford crossings, they do not reduce sediment delivery on either side of the bridge and elsewhere along the stream.
