Cold Lake, Hot Bitumen:

CNRL'S BITUMEN BLOWOUT

by CAROLYN CAMPBELL, AWA CONSERVATION SPECIALIST

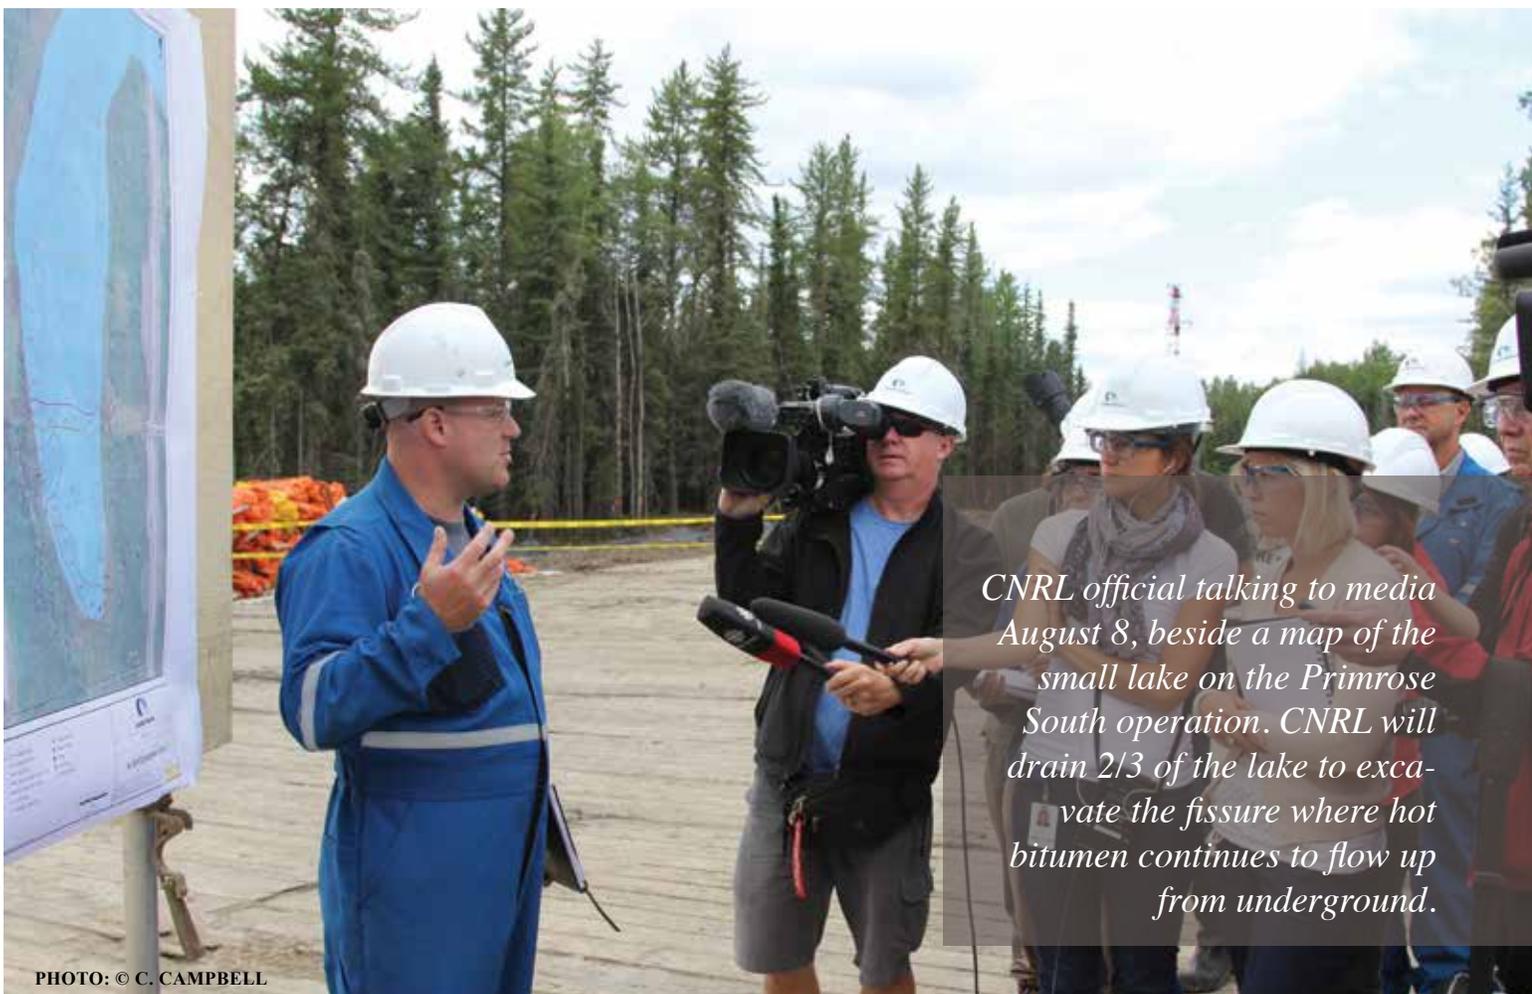
CNRL official talking to media August 8, beside a map of the small lake on the Primrose South operation. CNRL will drain 2/3 of the lake to excavate the fissure where hot bitumen continues to flow up from underground.

At the small lake, clean up has been considerably more difficult. CNRL used booms to contain and skim the contaminated water and set up wildlife deterrents to reduce mortalities. As the bitumen continued to flow into the lake, CNRL sought and was granted permission September 24 to take the unusual step of dewatering about 2/3 of the lake's water by mid-October. Alberta Environment and Sustainable Resource Development (ESRD) issued an environmental protection order directing CNRL to contain the water in a pit and in part of the original lake. The company will then recover the bitumen from the fissure site, and try to prevent and remedy further surface and groundwater contamination. If there's a silver lining here it rests in the fact that, because of the emergency protection order, there may be more transparency and ENGO/First Nations involvement on the clean up and impacts at this site. But more transparency is needed with respect to the other sites and on the broader causes and impacts.

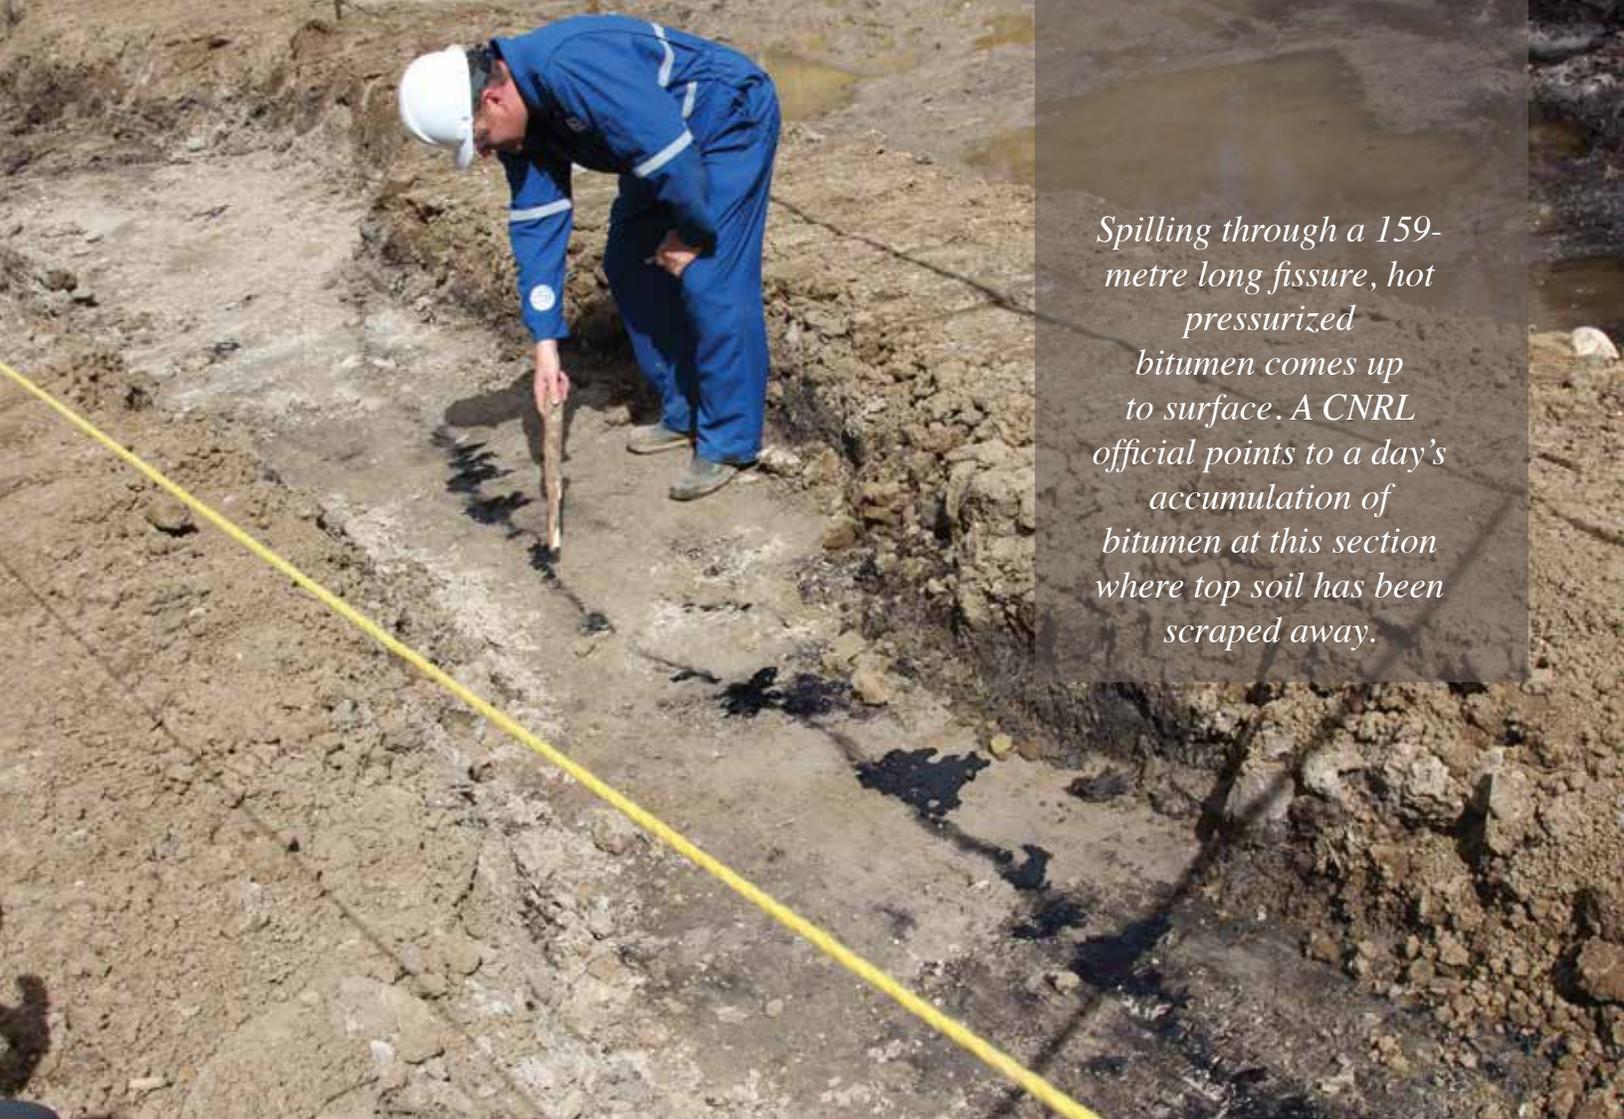
Spilling through a 159-metre long fissure, hot pressurized bitumen comes up to surface. A CNRL official points to a day's accumulation of bitumen at this section where top soil has been scraped away.

We were bussed to the third spill site, a 159 metre long fissure according to company officials. The emphasis throughout the tour was on clean-up procedures. Two months after the spills, much of the contaminated soils and vegetation had been removed from the third site, leaving the fissure with oozing

bitumen. In one part of the fissure, CNRL let the bitumen accumulate so we could see that about 100 litres settled in that section over approximately a two week period. We were also taken to the fourth site, the small lake. There we stood on the shore opposite to where the bitumen fissure was, serenaded by bird deterrent cannons. The fissure there site was estimated to be 30 metres long. We were not taken to the first two spill sites, which were very close to the site of a January 2009 spill to surface at the Primrose East operation.

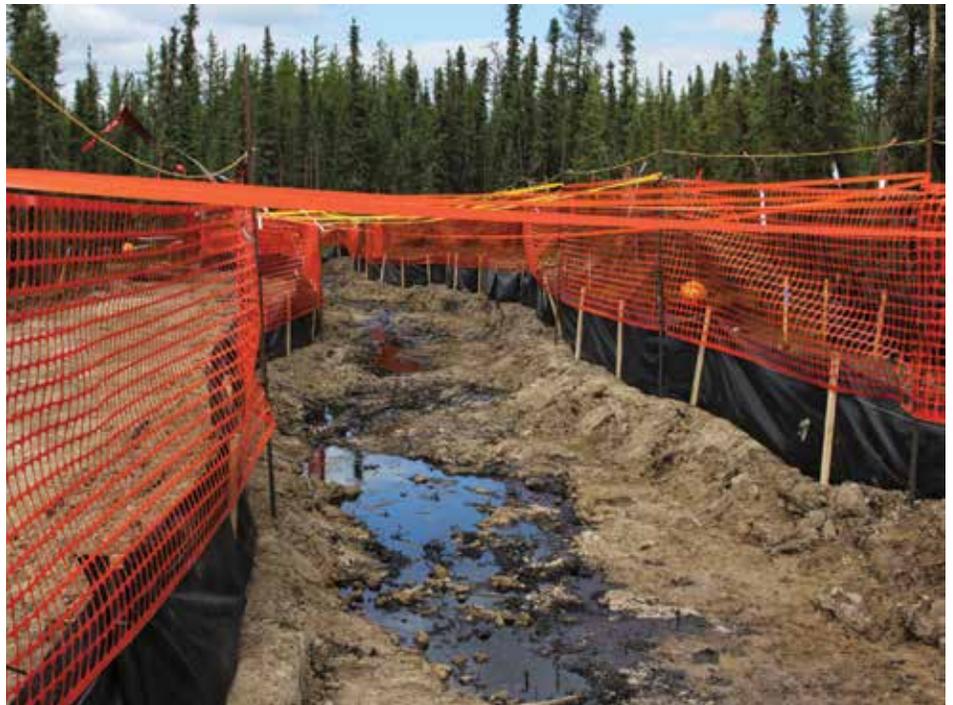
Hot pressurized bitumen spills to surface through soil and vegetation at the same spill site on CNRL's Primrose oil sands project, August 8.

Fencing deters wildlife from entering a section with a leakage amount of about 100 litres that CNRL left to accumulate over a period of two weeks, to compare to the leakage of one day.

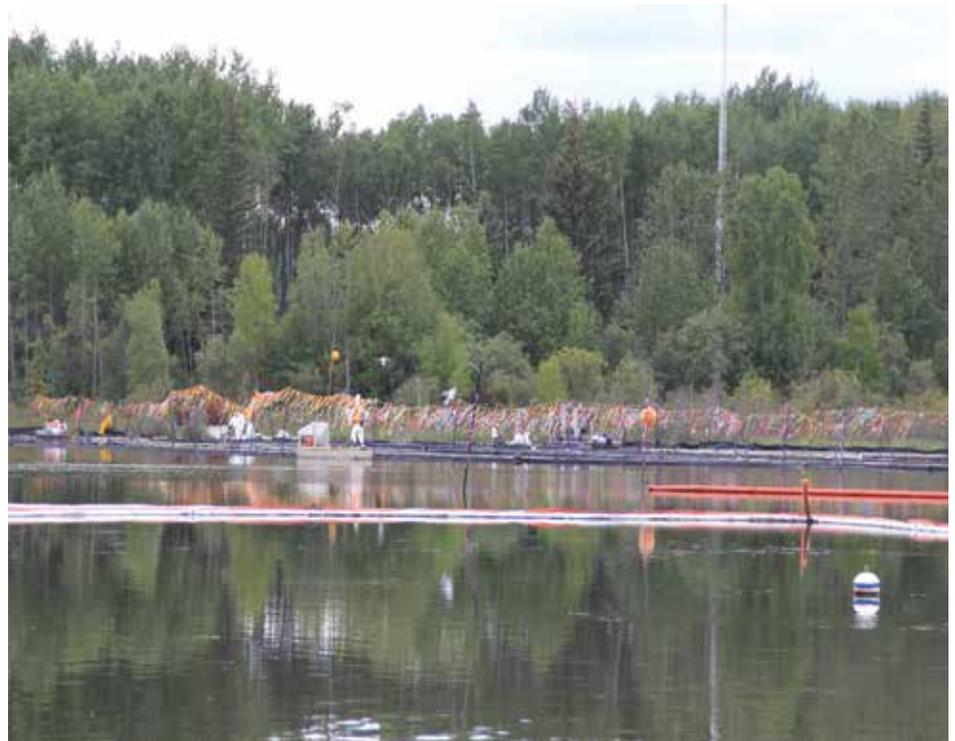
Hot pressurized bitumen leaks into the bottom of a small lake through a 30-metre long fissure. Wildlife deterrents, including “bitu-men,” have been set up to try to prevent migrating birds from landing.
