Once Upon a Time in the Rockies:

The Enduring Legacy of Too Many Trails

The Failure of the Canary Creek Trail

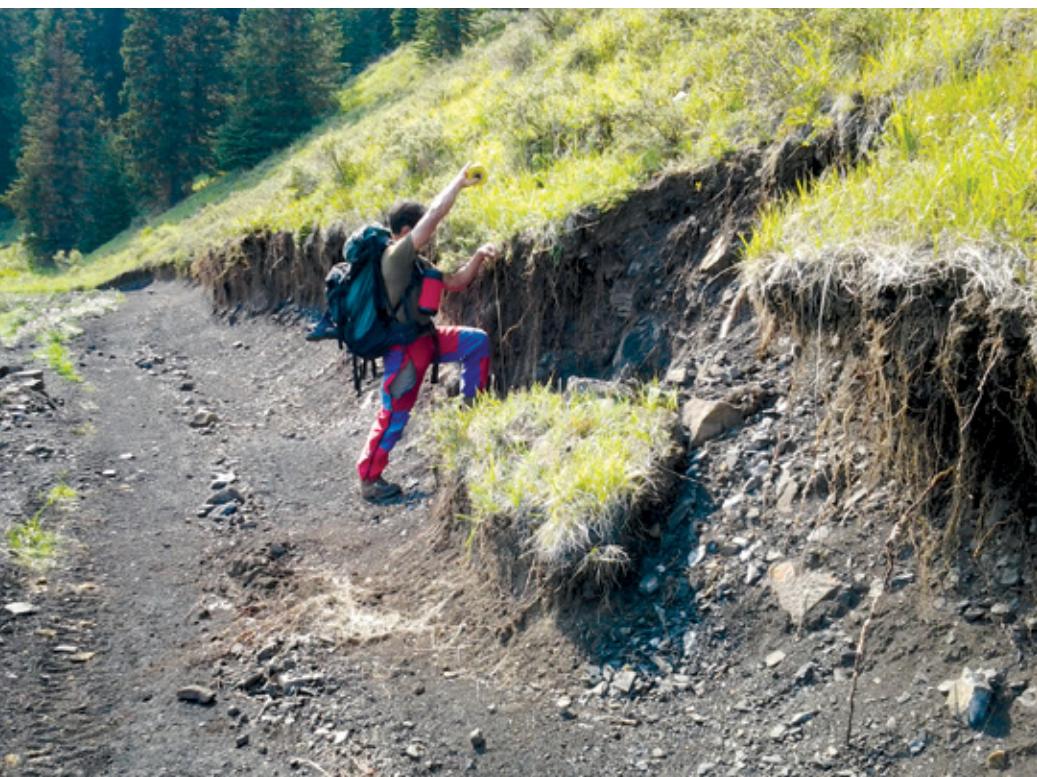
Volunteer Ken Lee measures collapsed sections of trail along Canary Creek, less than 10 months after the trail was constructed by the Government of Alberta. PHOTO: © S. NICHOLS

best of our ability, they still may fail. A trail along Canary Creek in the Bighorn partially collapsed last winter, less than 10 months after it was constructed. It didn't collapse due to negligence or inability. It collapsed for a very simple reason that construction wizardry cannot always address: steep slopes with soft, waterlogged soils are inherently unstable.

The 800 metres of reconstructed trail leading up to the bridge, however, are a different story. Cut into a 33-degree slope made of soft soil, the trail was already slumping and collapsing not ten months after it was first built.

Why not put the trail somewhere else? There isn't any better place to put the trail. Thirty-three degrees is among the gentlest incline anywhere along that slope; elsewhere it would have been steeper and less stable. The valley bottom is a narrow riparian zone with no real place for a trail to go that does not run through sensitive areas or through the creek and flood plain as the

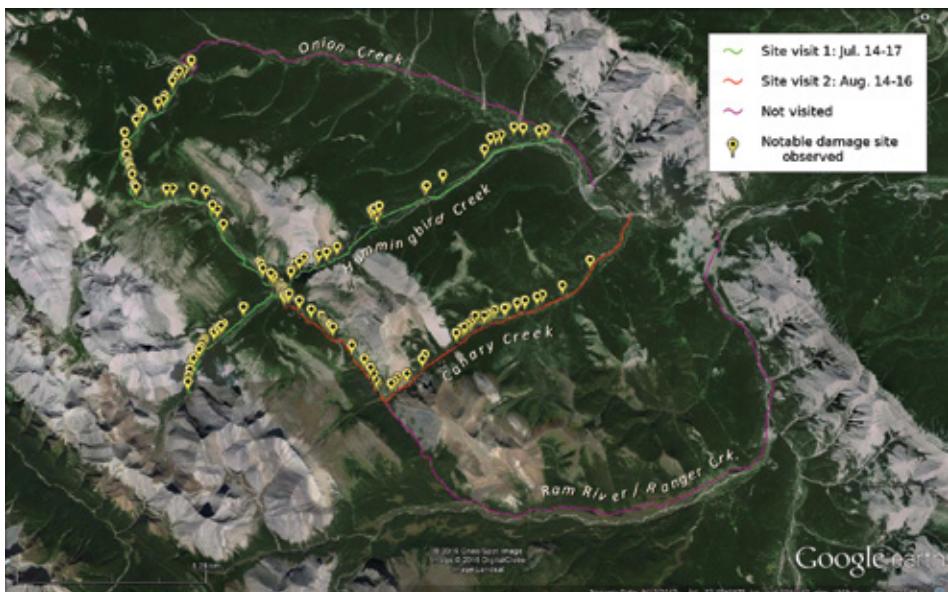
A map of the Hummingbird area trail system showing where AWA undertook monitoring trips during the summer of 2015. AWA recorded 179 notable damage sites (indicated by yellow markers) over about 40km of trail.

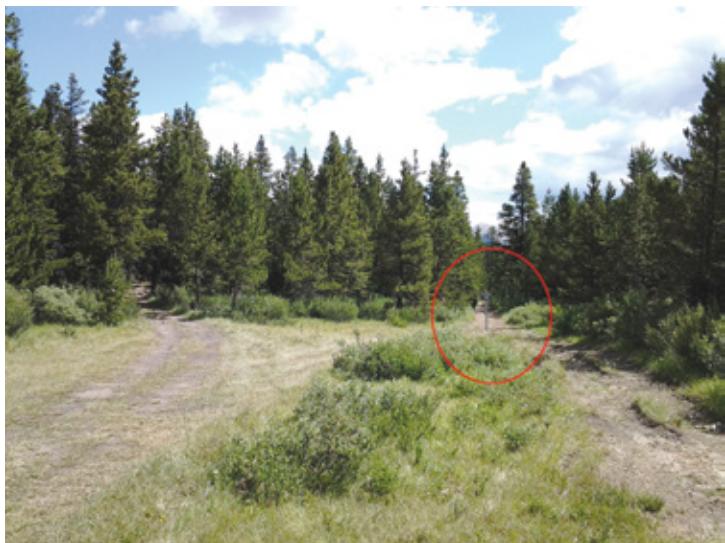
ESRD reconstruction efforts, such as this re-sited trail along Hummingbird Creek (otherwise relatively well done) are undermined when lack of enforcement means that users ignore signage and continue to use the old trail through riparian zones and badly flooded-out creeks.

It's maddening that a simple issue such as signage has been handled so miserably over the years. In many – even most – cases, there is no signage at all. This has been one of our various concerns regarding the often ad-hoc reconstruction performed by user groups; on most cases where a trail has been rerouted, the only indication that a rider should stay off the old trail is a small strip of pink flagging tape. Occasionally there will be branches dragged across the old trail, as if this would seriously discourage its continued use.

Even recently-reconstructed BTFRP trails do not have signage. Surely this must change.

The upshot of trail reconstruction is that users now see two trails before them. They may continue to use the old trail (so far as possible) as well as the new trail. We have essentially doubled the footprint on the landscape for these sections.

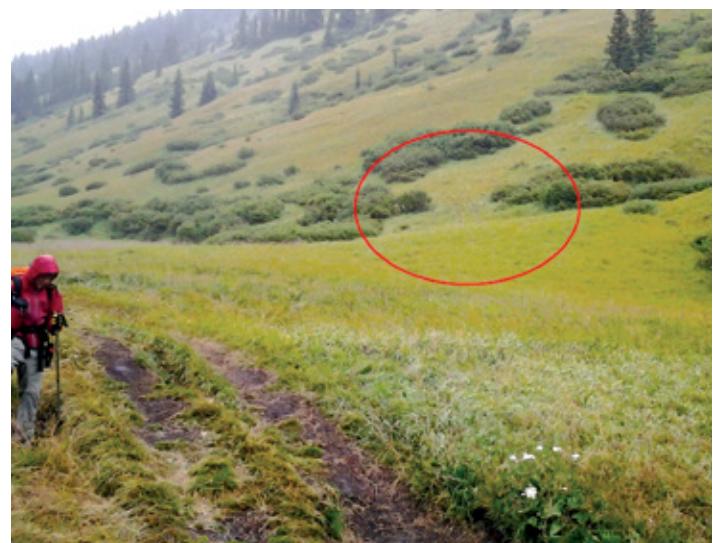
Users have been going off trail and creating "frolic areas" on the hills along the back trail between Canary and Hummingbird Creeks PHOTO: © S. NICHOLS
